Coal Combustion Residuals Landfill Annual Inspection
Nucla Station Ash Disposal Site

Tri-State Generation and Transmission Association, Inc.
1100 West 116th Avenue Westminster, Colorado 80234

Golder Associates Inc.
44 Union Boulevard, Suite 300 Lakewood, Colorado 80228

December 21, 2018

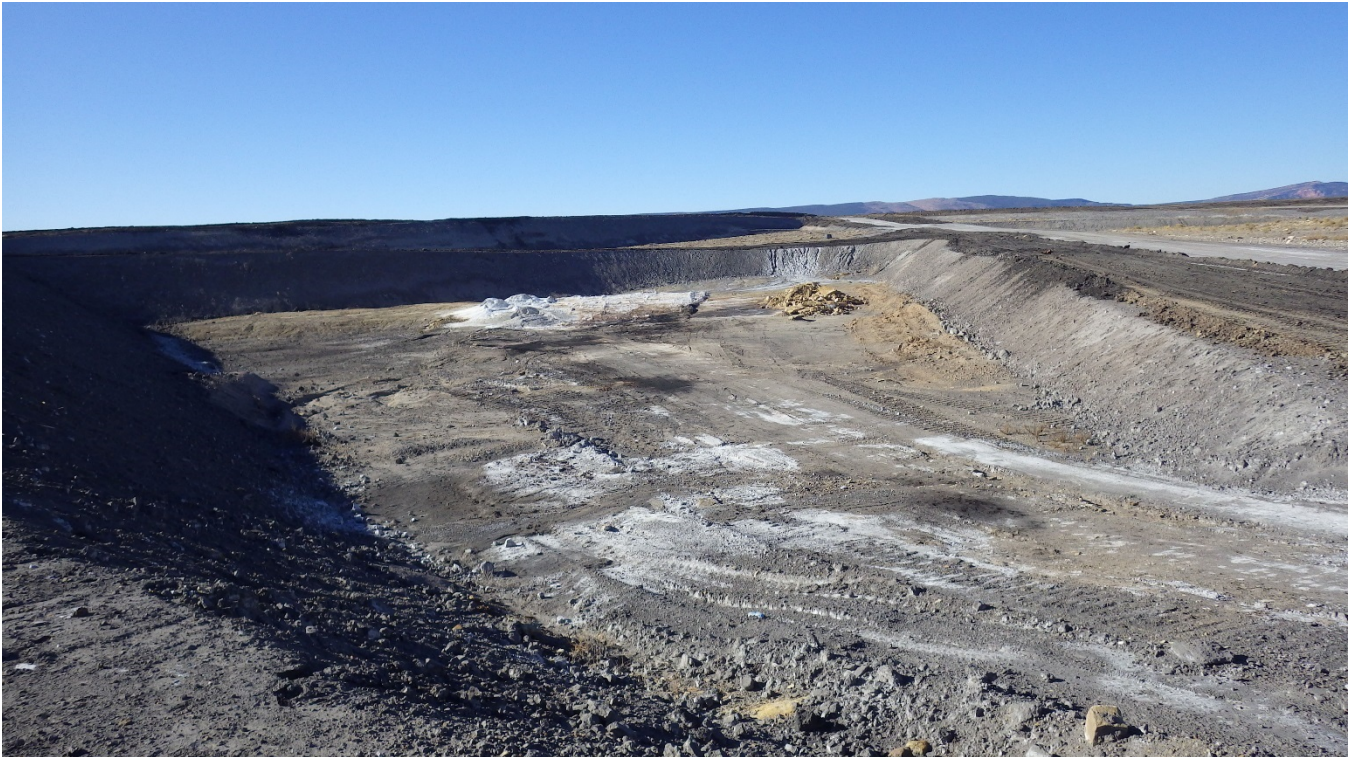
The ash deposition area was observed to be in good condition. Signs of ground movement, such as sloughing or sliding, cracking, subsidence, or bulging, were not observed in the ash deposition area. Ash deposition was not occurring at the time of the visual observation because the generating unit was not operating. The ash deposition area was appropriately graded so that ash contact water would collect within the ash deposition area. A berm that was several feet in height was in place around the perimeter of the ash deposition area to prevent migration of ash contact water out of the ash deposition area. Fugitive dust was not observed at the time of the visual observation. The typical condition of the ash deposition area is depicted in Photograph 1.

Photograph 1: Typical Ash Deposition Area Condition

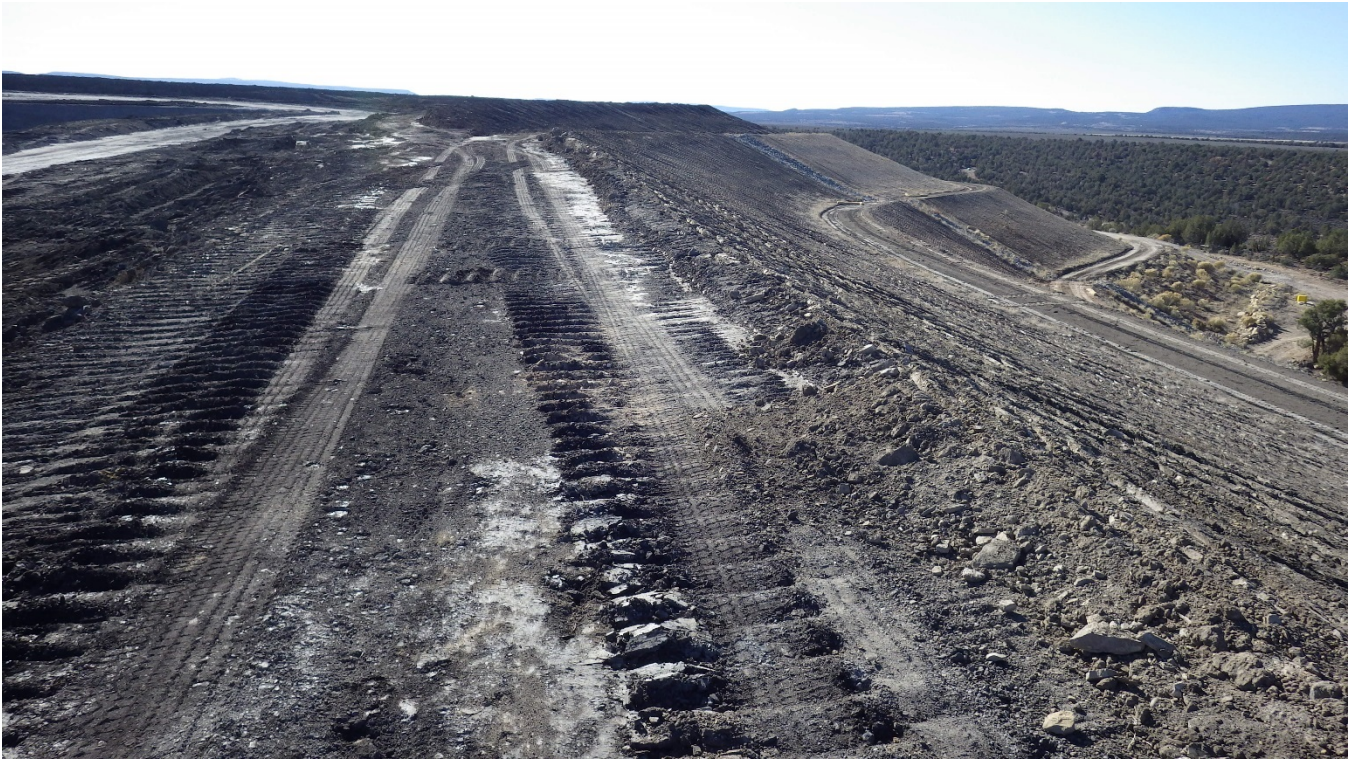
The embankment crest was observed to be in good condition. Cracking that would be indicative of ground movement was not observed along the embankment crest. Low areas that would be indicative of differential settlement were not observed along the embankment crest. The typical condition of the embankment crest is depicted in Photograph 2.

Photograph 2: Typical Embankment Crest Condition

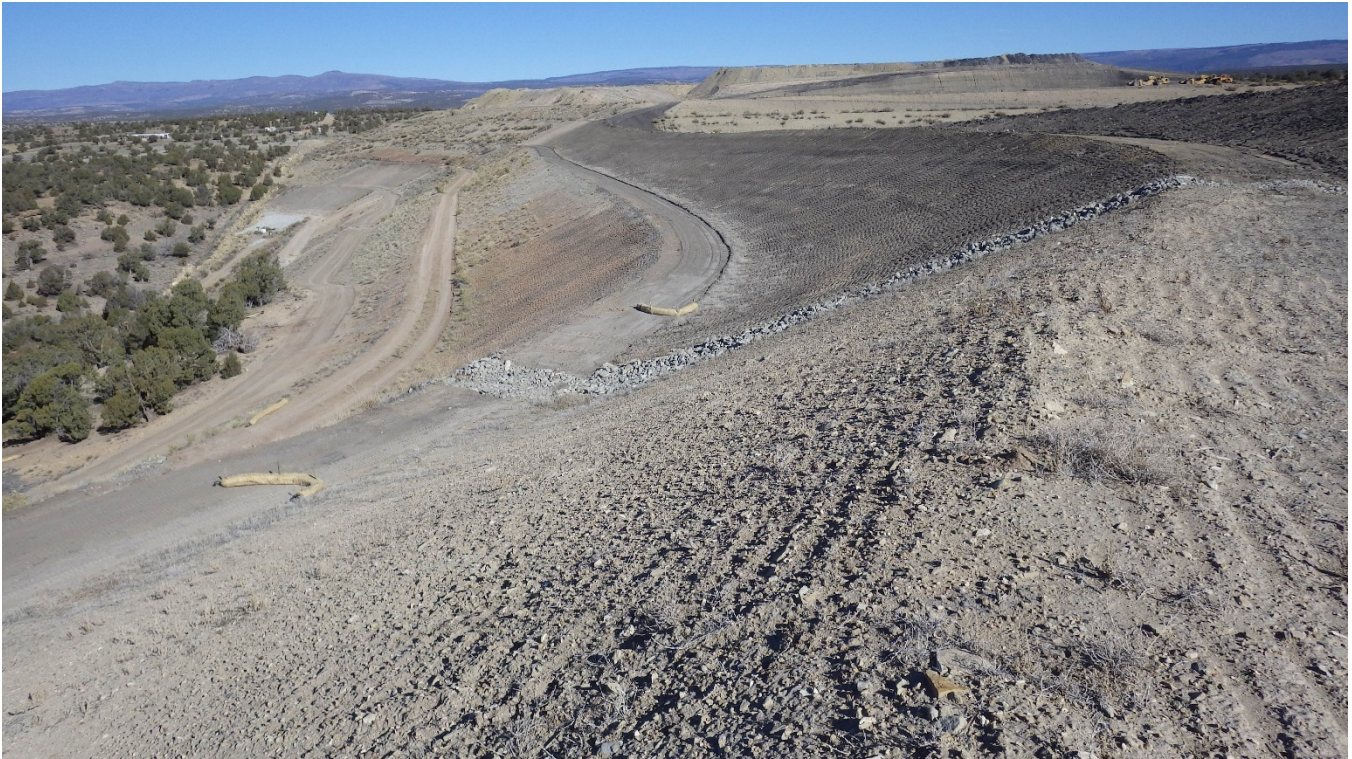
The embankment slopes were observed to be in good condition. Signs of ground movement, such as sloughing or sliding, cracking, subsidence, or bulging, were not observed on the embankment slopes. Evidence of significant or excessive erosion or slope deterioration was not observed on the embankment slopes. It was apparent from visual observation that repair of erosion rills is being performed on an ongoing basis, and the weekly inspection forms confirm that repair work was completed in October and November 2018. Native vegetation has been established on the embankment slopes as the facility has been progressively built higher. Portions of the embankment slopes had adequate vegetative coverage at the time of the visual observation, while other portions had been disturbed by recent erosion repair efforts and did not yet have established vegetation. Weekly inspection forms indicated that reseeding efforts in 2017, aimed at establishing a more robust vegetative coverage in certain areas (particularly the south embankment slopes), were largely unsuccessful due to drought conditions in 2018. Other than these areas, unusually poor or thriving vegetative growth was not observed on the embankment slopes. Tri-State personnel indicated that reseeding would be attempted again in December 2018. No trees or woody vegetation were observed on the embankment slopes. No evidence of recent animal burrowing was observed on the embankment slopes. Tri-State personnel indicated that an extermination effort was undertaken in April 2018. The typical condition of the embankment slopes is depicted in Photograph 3. Some of the embankment slopes shown in Photograph 3 are among those that underwent erosion repairs in 2018, and vegetative coverage on these embankment slopes is therefore limited.

Photograph 3: Typical Embankment Slope Condition

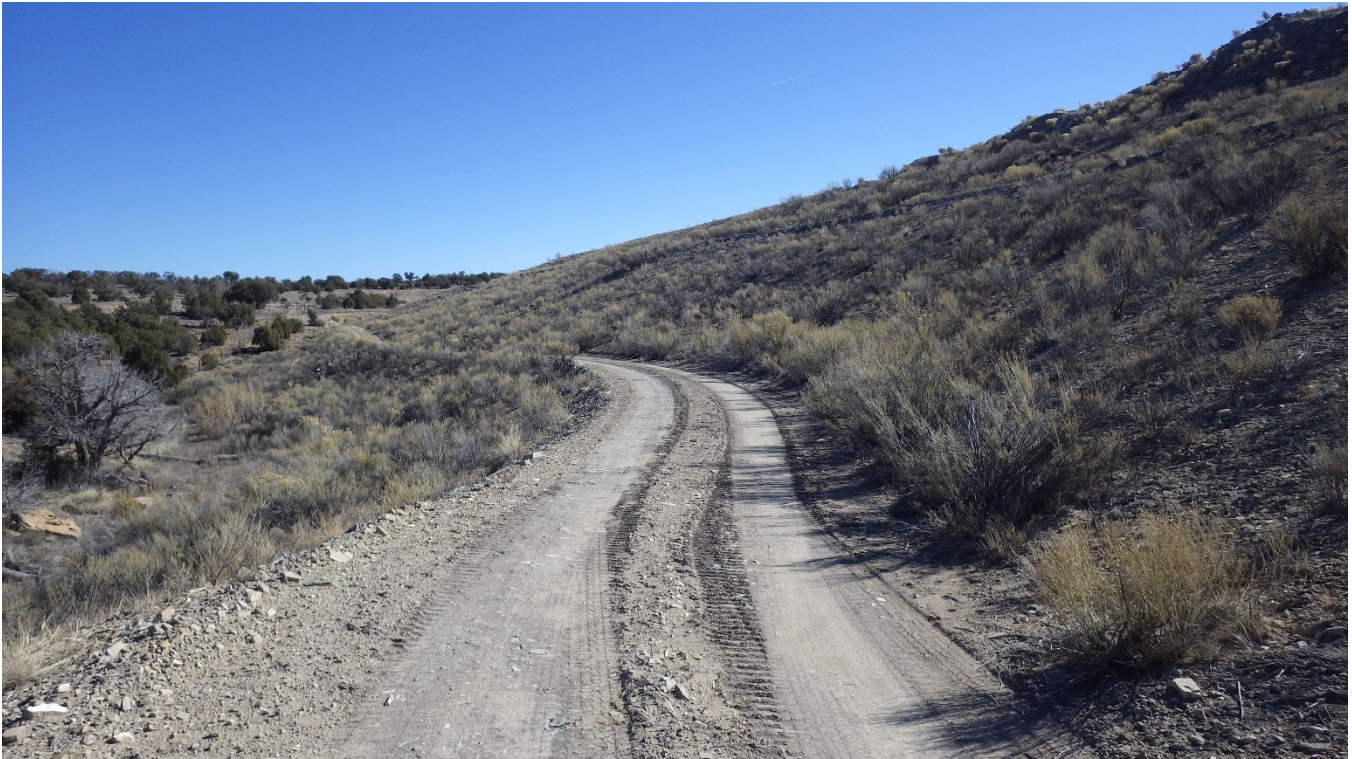
The embankment toe was observed to be in good condition. Signs of seepage, such as springs or boggy areas, were not observed along the embankment toe. The typical condition of the embankment toe is depicted in Photograph 4.

Photograph 4: Typical Embankment Toe Condition

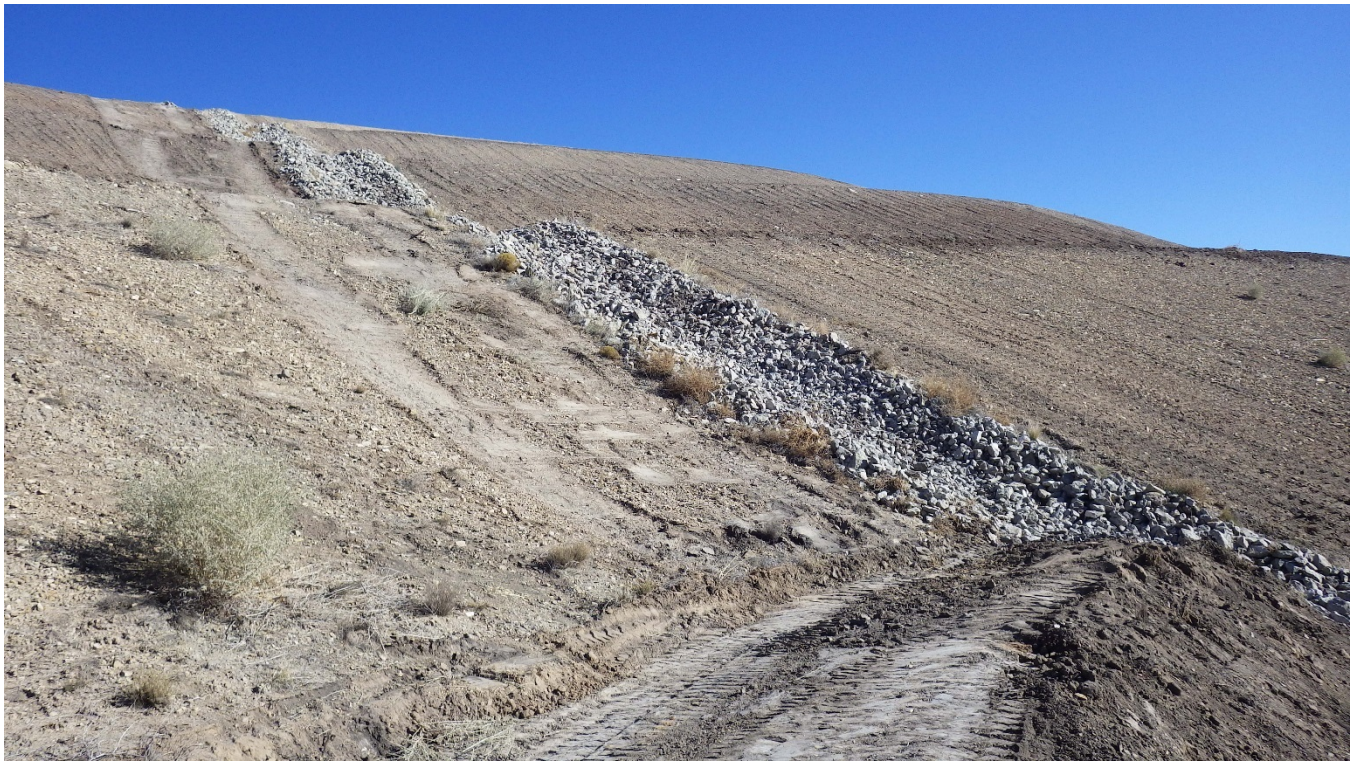
The storm water control features at the facility were observed to be in good condition. Downchute channels and energy dissipation basins at the facility are constructed with riprap. Some of the downchute channels had small shrubs growing in the flow path, and Golder recommends that the shrubs be removed periodically if they become large enough to impede flow or cause riprap to shift. However, the shrubs do not pose a threat to structural stability and did not impact Golder's ability to inspect the facility. The typical condition of the downchute channels is depicted in Photograph 5. Terrace channels at the facility are provided at approximate 20-foot vertical intervals. Erosion control wattles have been installed to control erosion and capture sediment in the terrace channels at appropriate intervals. The typical condition of the terrace channels is depicted in Photograph 6. Perimeter channels are in place around the facility where they are needed. Perimeter channels at the facility are generally constructed with soil and rock. Erosion control wattles have been installed at appropriate intervals in the perimeter channels to control erosion and capture sediment. The typical condition of the perimeter channels is depicted in Photograph 7.

Photograph 5: Typical Downchute Channel Condition

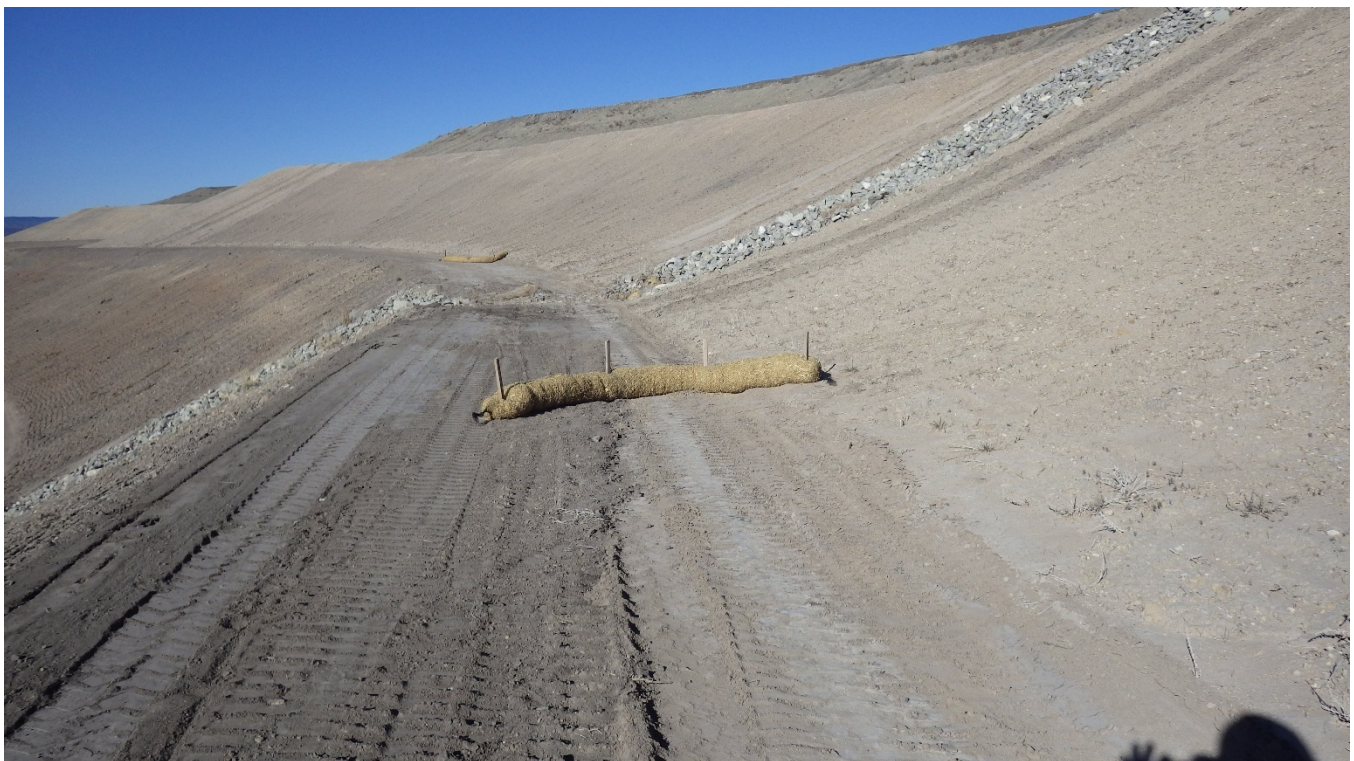
Photograph 6: Typical Terrace Channel Condition

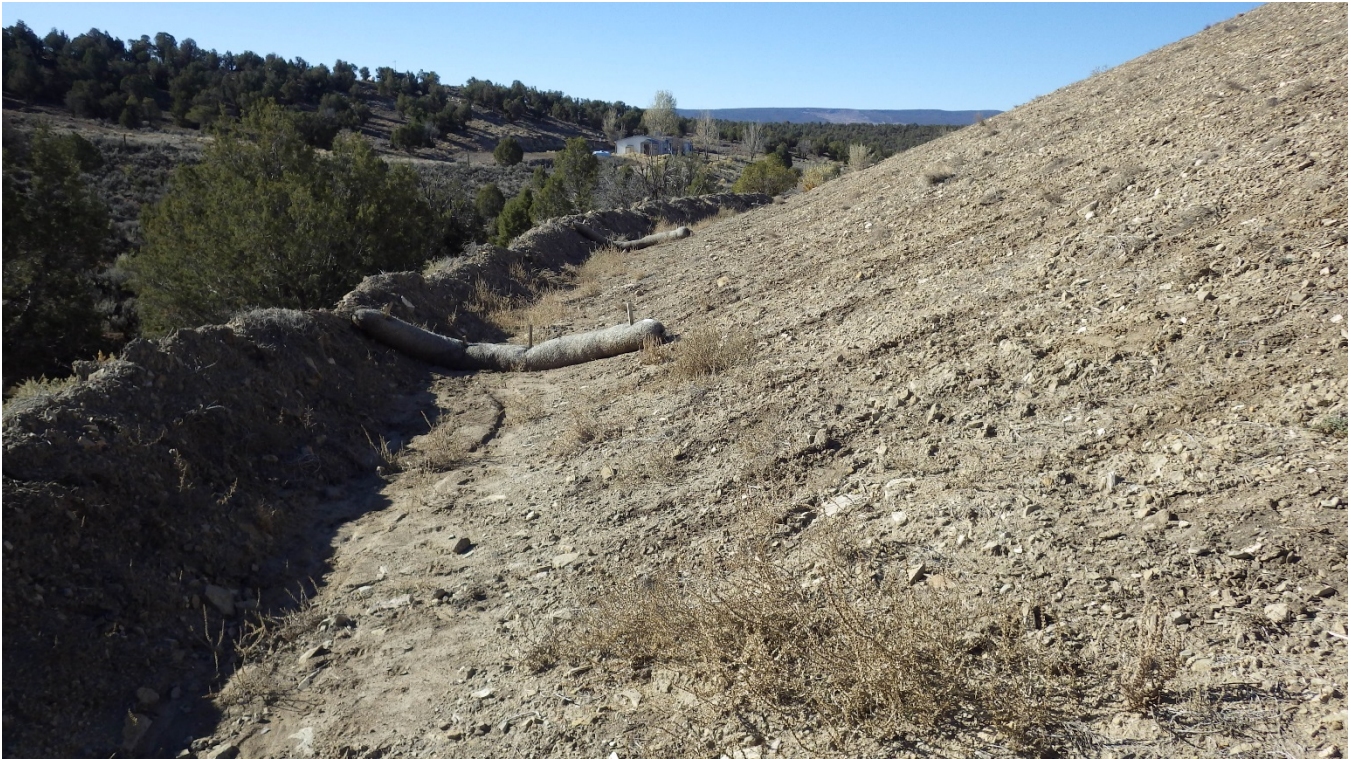
Photograph 7: Typical Perimeter Channel Condition
