COAL COMBUSTION RESIDUALS LANDFILL ANNUAL INSPECTION REPORT

Nucla Station Ash Disposal Site

January 16, 2017

1657746

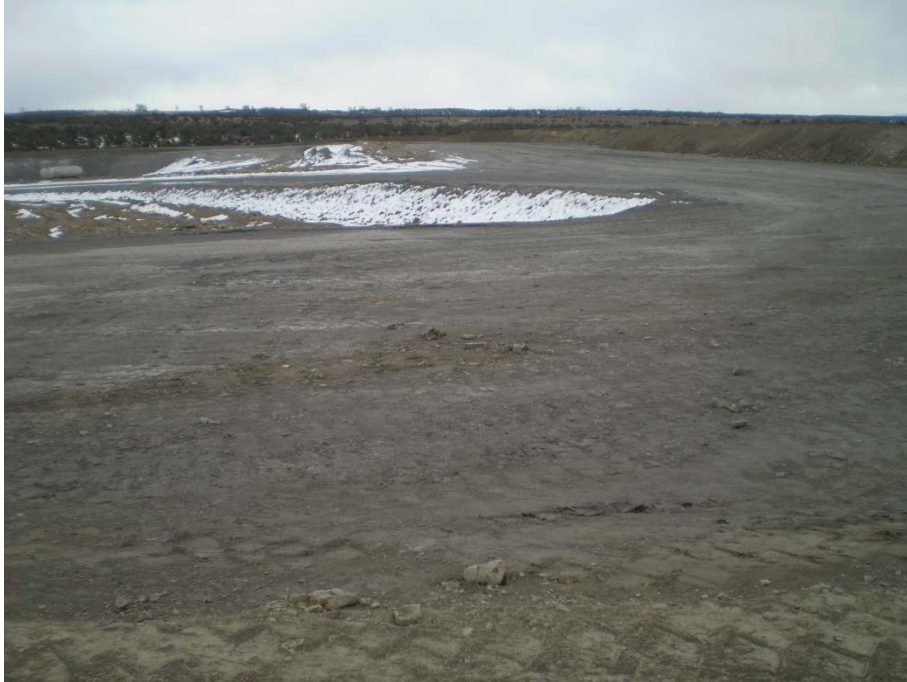
The ash deposition area was observed to be in good condition. Signs of ground movement, such as sloughing or sliding, cracking, subsidence, or bulging, were not observed in the ash deposition area. Ash deposition was not occurring at the time of the visual observation because the generating unit was not operating. The ash deposition area was graded so that ash contact water would collect within the ash deposition area. A berm that was several feet in height was in place around the perimeter of the ash

deposition area to prevent migration of ash contact water out of the ash deposition area. Fugitive dust was not observed at the time of the visual observation. The typical condition of the ash deposition area is depicted in Photograph 1.

Photograph 1: Typical Ash Deposition Area Condition

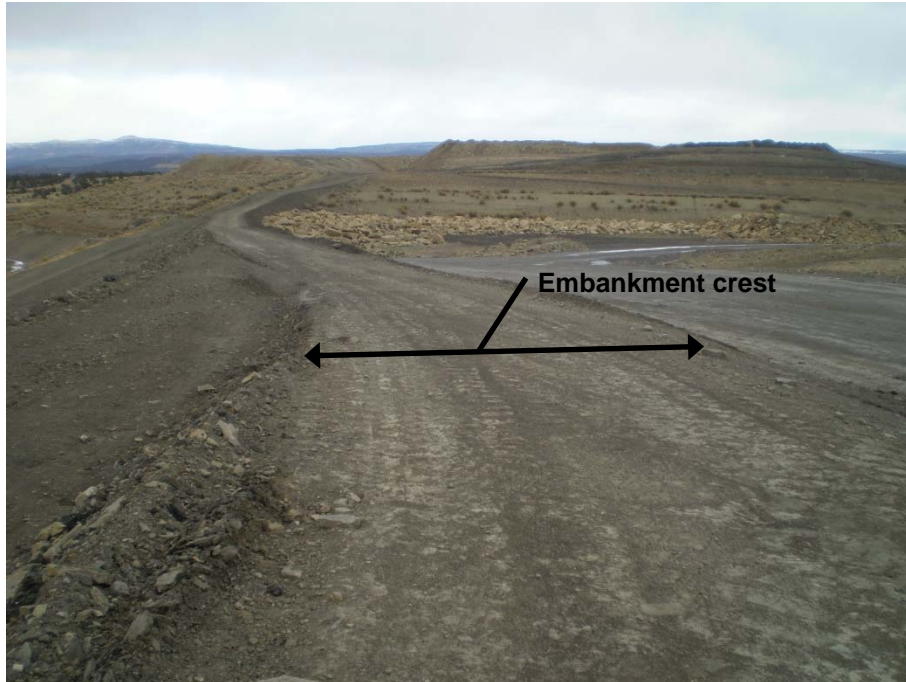
The embankment crest was observed to be in good condition. Cracking that would be indicative of ground movement was not observed along the embankment crest. Low areas that would be indicative of differential settlement were not observed along the embankment crest. The typical condition of the embankment crest is depicted in Photograph 2.

Photograph 2: Typical Embankment Crest Condition

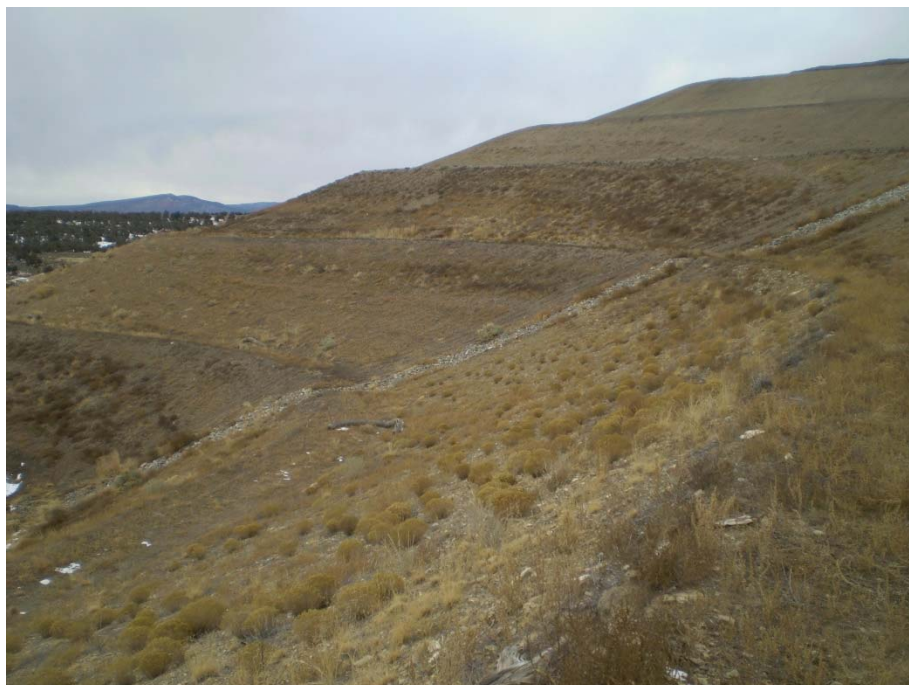
The embankment slopes were observed to be in good condition. Signs of ground movement, such as sloughing or sliding, cracking, subsidence, or bulging, were not observed on the embankment slopes. Evidence of significant or excessive erosion or slope deterioration was not observed on the embankment slopes. Some areas of minor rilling were noted, as shown on the plan view included in Appendix C. The observed rills do not pose a threat to structural stability, and it was evident that repair of erosion rills is being conducted on an ongoing basis. Slope stability calculations completed by Golder indicate that the embankment slopes at the facility are expected to remain stable with acceptable factors of safety under anticipated maximum loading conditions (static and seismic). Native vegetation is being established on the embankment slopes as the facility is progressively built higher. Lower portions of embankment slopes have adequate vegetative coverage, while upper portions of embankment slopes have not yet been in place long enough for a mature vegetative community to be established. Unusually poor or thriving vegetative growth was not observed on the embankment slopes. Some shrubs were observed on the embankment slopes. This type of vegetation is typical of the surrounding area. The extent of shrubs was minor and does not pose a threat to structural stability. Thus, mitigation is not considered to be necessary. No trees were observed on the embankment slopes. Animal burrows were observed in four areas, as shown on the plan view included in Appendix C. Tri-State indicated that an extermination effort was undertaken in August 2016, and the burrows may have predated that effort. In any case, the extent of burrowing was minor and does not pose a threat to structural stability. The typical condition of the embankment slopes is depicted in Photograph 3. Animal burrows observed on an embankment slope in the southeast portion of the facility are shown in Photograph 4.

Photograph 3: Typical Embankment Slope Condition

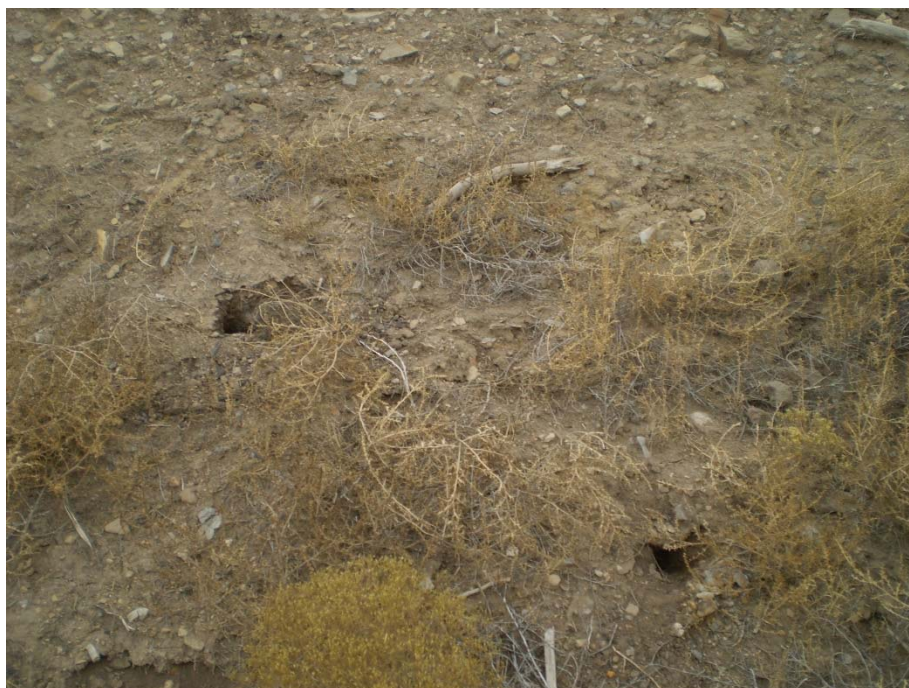
Photograph 4: Animal Burrows on Embankment Slope

a.						
b.						
c.						
d.						
e.						
J. Elaboration						
Identify the specific item number (for instance, F.2.) and elaborate on each deficiency or issue identified during the annual inspection. Attach documentation (photographs or sketches) if practical.						
D.1. The power plant was in a generation outage and was not producing ash at the time of observation. The most recent ash deposition area is shown on page 3.						
F.3. Minor rilling was observed on the west exterior slopes. Rilling was not excessive, and immediate action is not required. Rilling is being proactively addressed within a reasonable timeframe after it is observed during Tri-State's weekly inspections.						
F.4. Some woody shrubs were observed on the embankment slopes. This type of vegetation is typical of the surrounding area, and mitigation is not considered to be necessary.						
F.5. The extent of animal burrows appeared to be minor, and mitigation is not considered to be necessary. Tri-State conducted extermination in August 2016, so the burrows may be inactive.

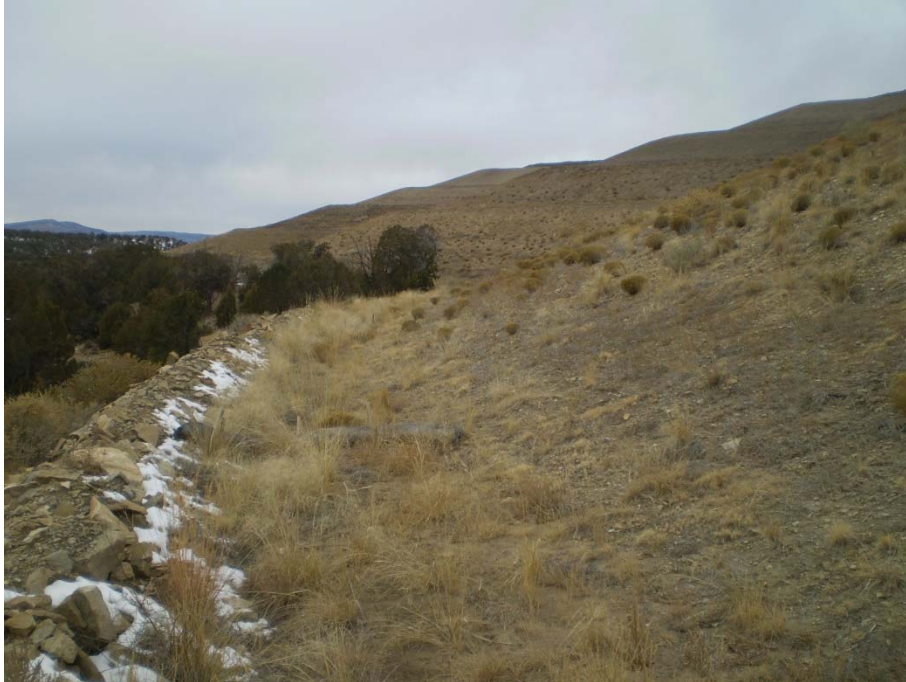
The embankment toe was observed to be in good condition. Signs of seepage, such as springs or boggy areas, were not observed at the embankment toe. The typical condition of the embankment toe is depicted in Photograph 5.

Photograph 5: Typical Embankment Toe Condition

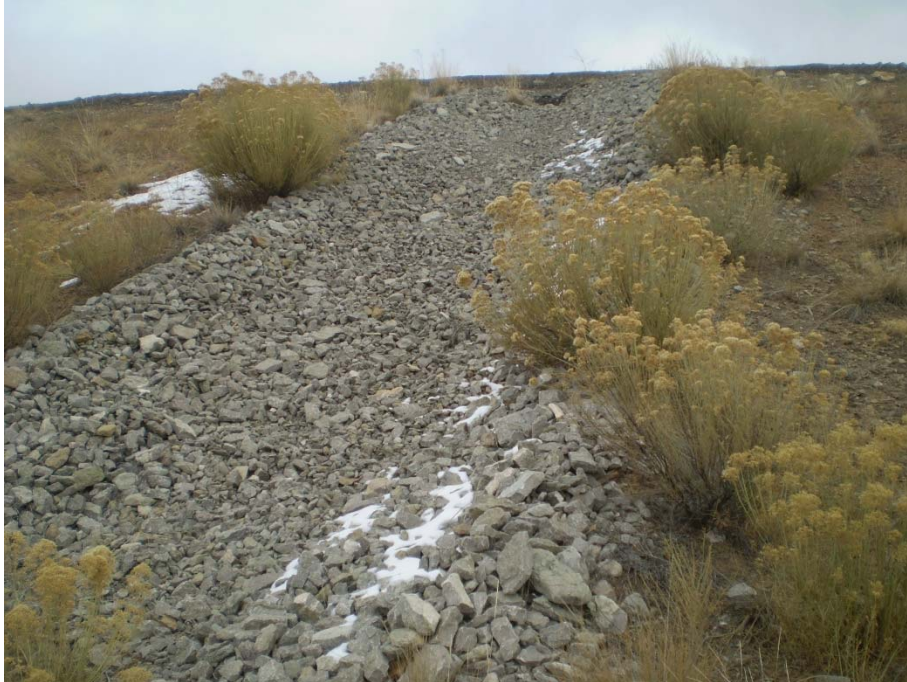
The storm water control features at the facility were observed to be in good condition. Downchute channels and energy dissipation basins at the facility are constructed with riprap. Surface water calculations completed by Golder indicate that the downchute channels are located and sized appropriately to convey the 100-year, 24-hour storm event. Some of the downchute channels had shrubs growing in the flow path, and Golder recommends that these be removed periodically to maintain proper functionality. However, the shrubs do not pose a threat to structural stability and did not impact Golder's ability to inspect the facility. The typical condition of the downchute channels is depicted in Photograph 6. Terrace channels at the facility are provided at approximate 20-foot vertical intervals and are grass-lined. Straw wattles have been installed to control erosion and capture sediment in the terrace channels at appropriate intervals. Surface water calculations completed by Golder indicate that the terrace channels are located and sized appropriately to convey the 100-year, 24-hour storm event. The typical condition of the terrace channels is depicted in Photograph 7. Perimeter channels are in place around the facility where they are needed. Perimeter channels at the facility are generally constructed with soil and rock. Surface water calculations completed by Golder indicate that the perimeter channels are located and sized appropriately to convey the 25-year, 24-hour storm event. Debris (tumbleweeds) buildup in a perimeter channel at the outlet of the corrugated metal culverts under the entrance road were noted, as shown on the plan view included in Appendix C. This buildup should be removed periodically, but does not pose a threat to structural stability and did not impact Golder's ability to inspect the facility. Straw wattles have been installed at appropriate intervals in the perimeter channels to control erosion and capture sediment. The typical condition of the perimeter channels is depicted in Photograph 8.

Photograph 6: Typical Downchute Channel Condition

H.1. Removal of shrubs from flow paths should be conducted periodically.						
H.3. Removal of debris buildup should be conducted at the outlet of the corrugated metal culverts under the entrance road as soon as practical and periodically thereafter.

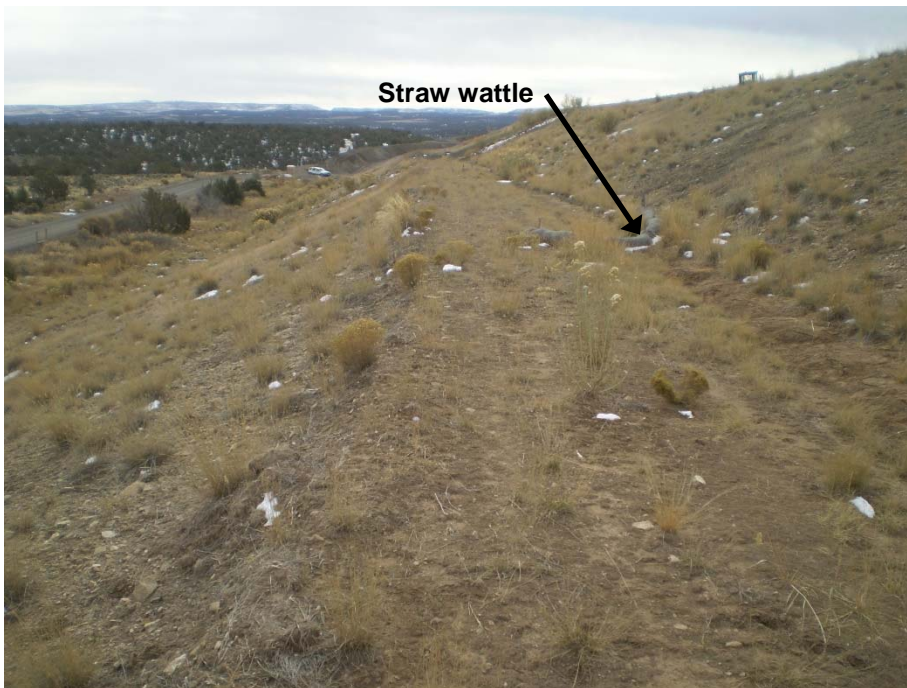
Photograph 7: Typical Terrace Channel Condition

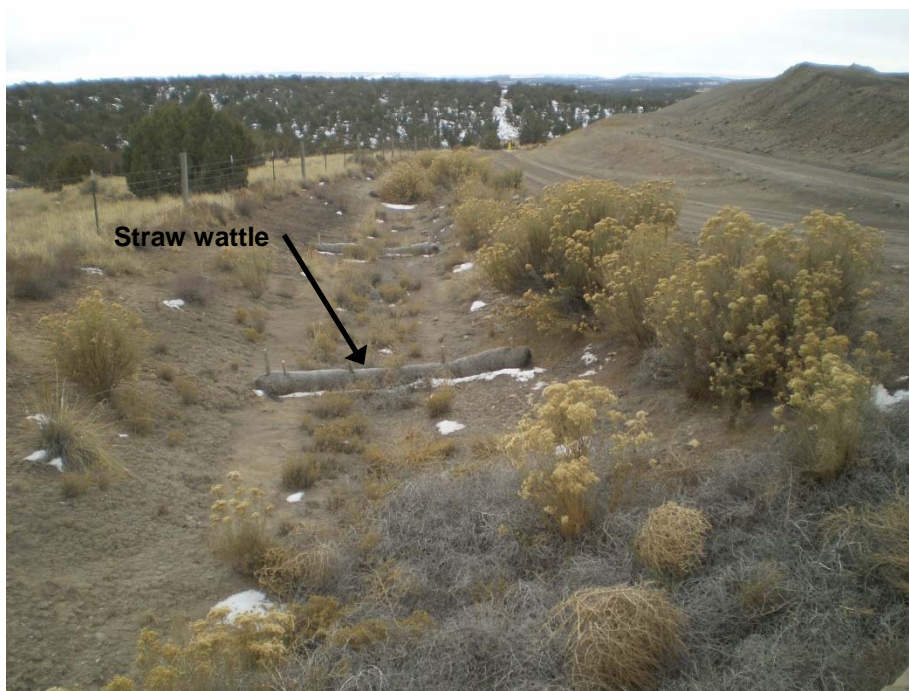
Photograph 8: Typical Perimeter Channel Condition
