# COAL COMBUSTION RESIDUALS LANDFILL ANNUAL INSPECTION REPORT

Escalante Generating Station

January 18, 2017

1663066

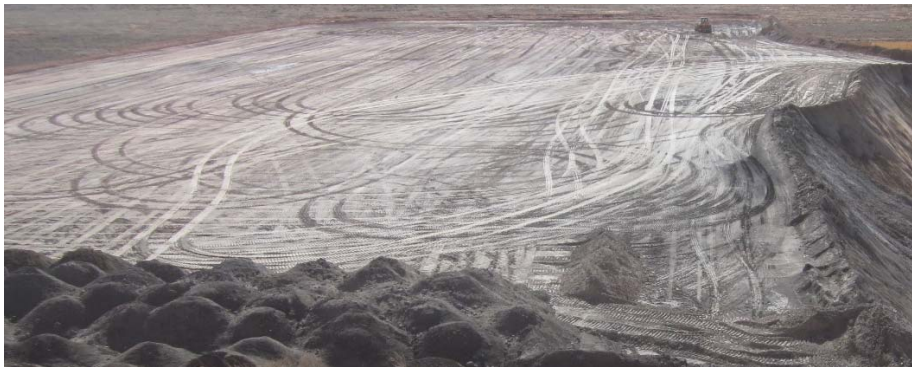
**Figure 2: Typical Deposition Area Condition**

The deposition area was observed to be in good condition. Signs of ground movement, such as sloughing or sliding, cracking, subsidence, or bulging, were not observed in the deposition area. Deposition of CCRs was occurring at the time of the visual observation. The deposition methodology appeared to be appropriate. Contact water was being collected within the deposition area. A berm that was several feet in height was in place around the perimeter of the deposition area to prevent migration of contact water out

of the deposition area. Fugitive dust was being adequately controlled at the time of the visual observation. The typical condition of the deposition area is depicted in Figure 2.

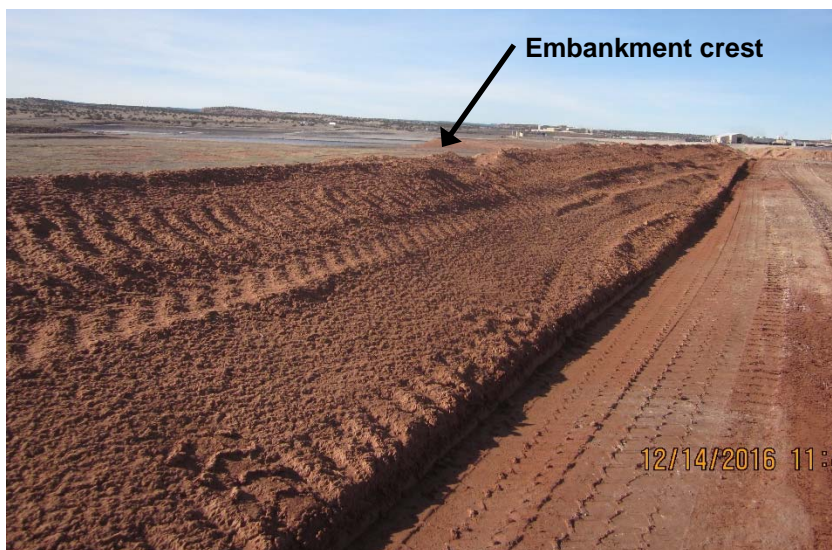
**Figure 3: Typical Embankment Crest Condition**

The embankment crest was observed to be in good condition. Cracking that would be indicative of ground movement was not observed along the embankment crest. Low areas that would be indicative of differential settlement were not observed along the embankment crest. The typical condition of the embankment crest is depicted in Figure 3.

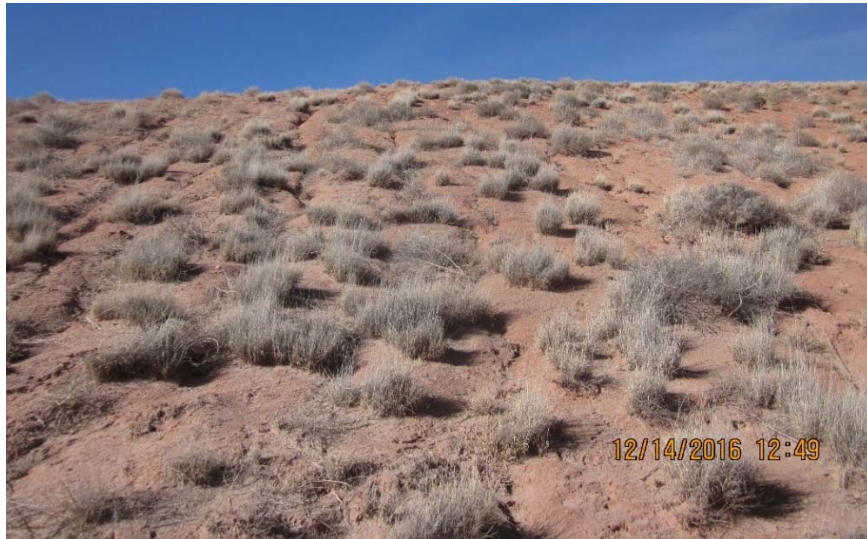
**Figure 4: Typical East-embankment Slope Condition**

The embankment slope along the east-side of the facility was observed to be in fair condition. Signs of ground movement, such as sloughing or sliding, cracking, subsidence, or bulging, were not observed on the embankment slope. Significant or excessive erosion or slope deterioration was not observed on the embankment slopes; however, minor erosion rills and small animal burrows were observed in several locations. The minor erosion and animal burrows do not pose a threat to structural stability. Native

vegetation is being established on the embankment slopes. Vegetative coverage on the embankment slopes has not yet been in place long enough for a mature vegetative community to be established. Unusually poor or thriving vegetative growth was not observed on the embankment slopes. Woody vegetation was not observed on the embankment slopes. The typical condition of the east-embankment slopes is depicted in Figure 4.

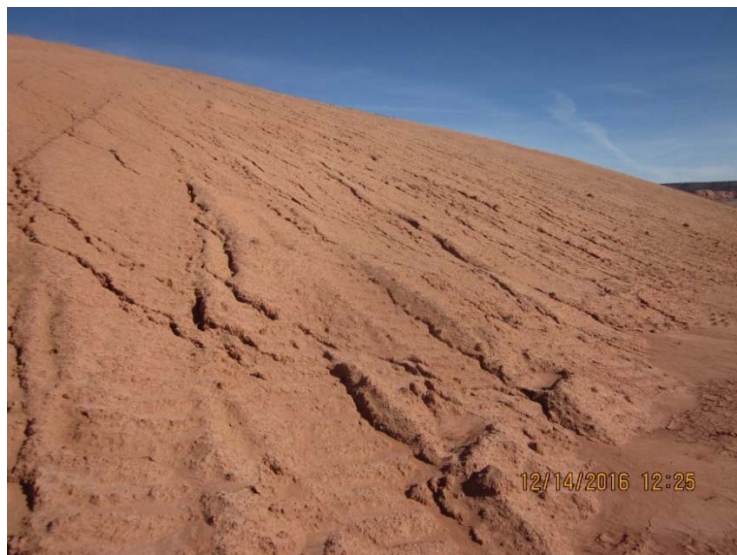
The south-embankment slopes were observed to be in fair condition. Signs of ground movement, such as sloughing or sliding, cracking, subsidence, or bulging, were not observed on the embankment slope. Significant or excessive erosion or slope deterioration was not observed on the embankment slopes; however, minor erosion rills were observed across most of the slope. The minor erosion does not pose a threat to structural stability. Native vegetation is being established on the embankment slopes. Vegetative coverage on the embankment slopes has not yet been in place long enough for a mature vegetative community to be established. Unusually poor or thriving vegetative growth was not observed on the embankment slopes. Woody vegetation was not observed on the embankment slopes. The minor erosion rills on the south-embankment slopes are depicted in Figure 5.

**Figure 5: Minor Erosion Rills on South-embankment Slope**

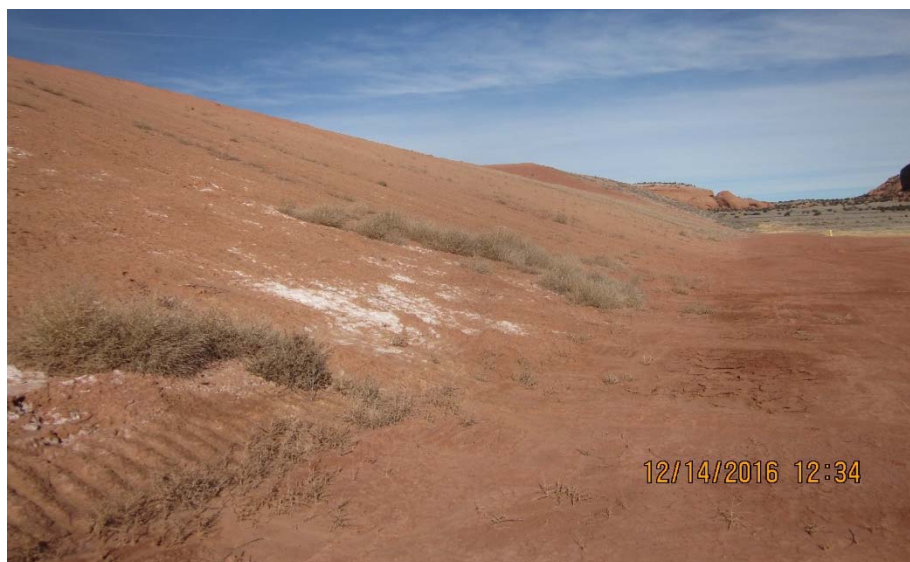
**Figure 6: Typical Embankment Toe Condition**

The embankment toe was observed to be in good condition. Signs of seepage, such as springs or boggy areas, were not observed at the embankment toe. The typical condition of the embankment toe is depicted in Figure 6.

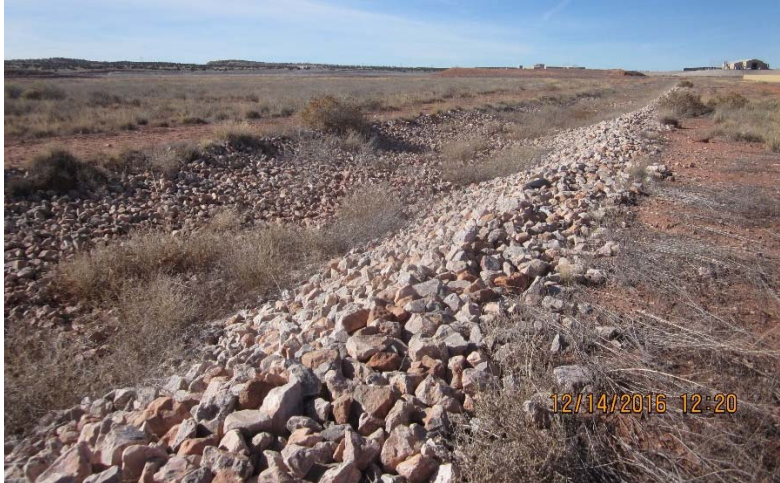
**Figure 7: Typical Storm Water Channel Condition**

The storm water control features at the facility were observed to be in fair condition. At the time of the visual observation, the only permanent storm water control feature at the facility was a run-on control channel that is designed to convey storm water from west to east along the south end of the facility. The run-on control channel is armored with riprap. Relatively large shrubs were observed growing in the flow path. However, the shrubs do not pose a threat to structural stability. The typical condition of the run-on control channel is depicted in Figure 7.
