ACTIVE COAL COMBUSTION RESIDUALS LANDFILL ANNUAL INSPECTION REPORT

Escalante Generating Station

January 15, 2018

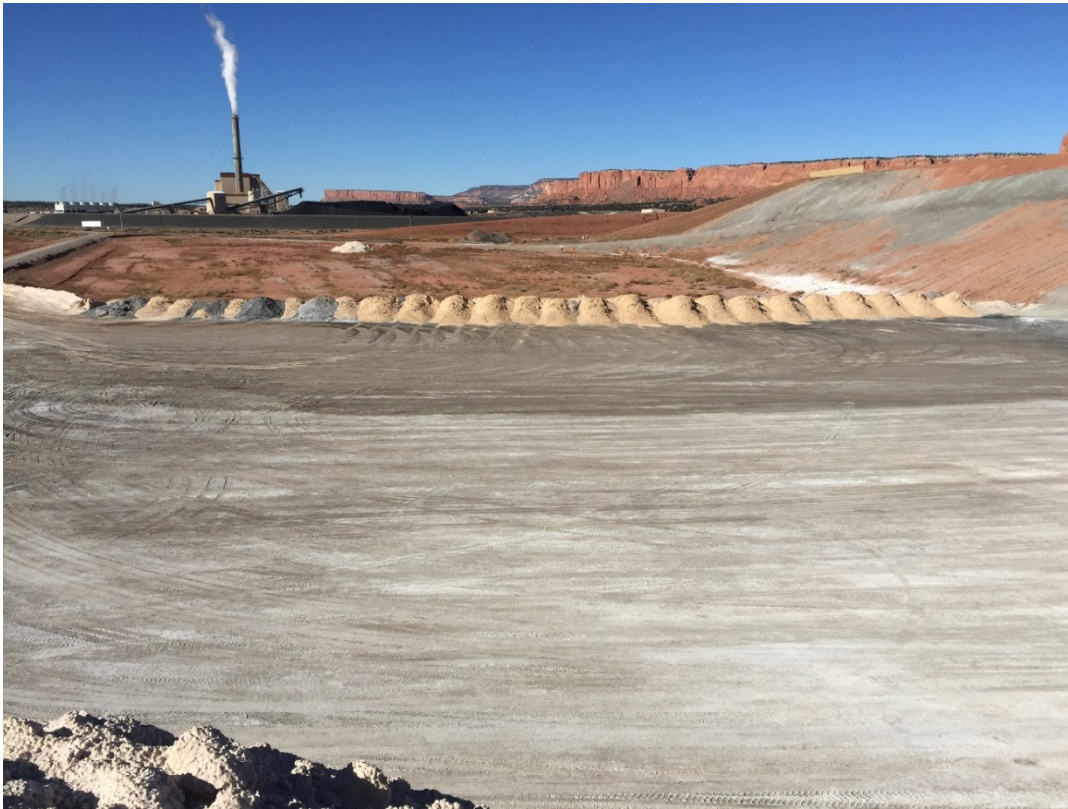
Photograph 2: Typical Deposition Area Condition

The deposition area was observed to be in good condition. Signs of ground movement, such as sloughing or sliding, cracking, subsidence, or bulging, were not observed in the deposition area. Deposition of CCRs was occurring at the time of the visual observation. The deposition methodology appeared to be appropriate. Appropriate grading had been established to collect contact water within the deposition area. A berm that was several feet in height was in place around the perimeter of the deposition area to prevent

migration of contact water out of the deposition area. Fugitive dust was being adequately controlled at the time of the visual observation. The typical condition of the deposition area is depicted in Photograph 2.

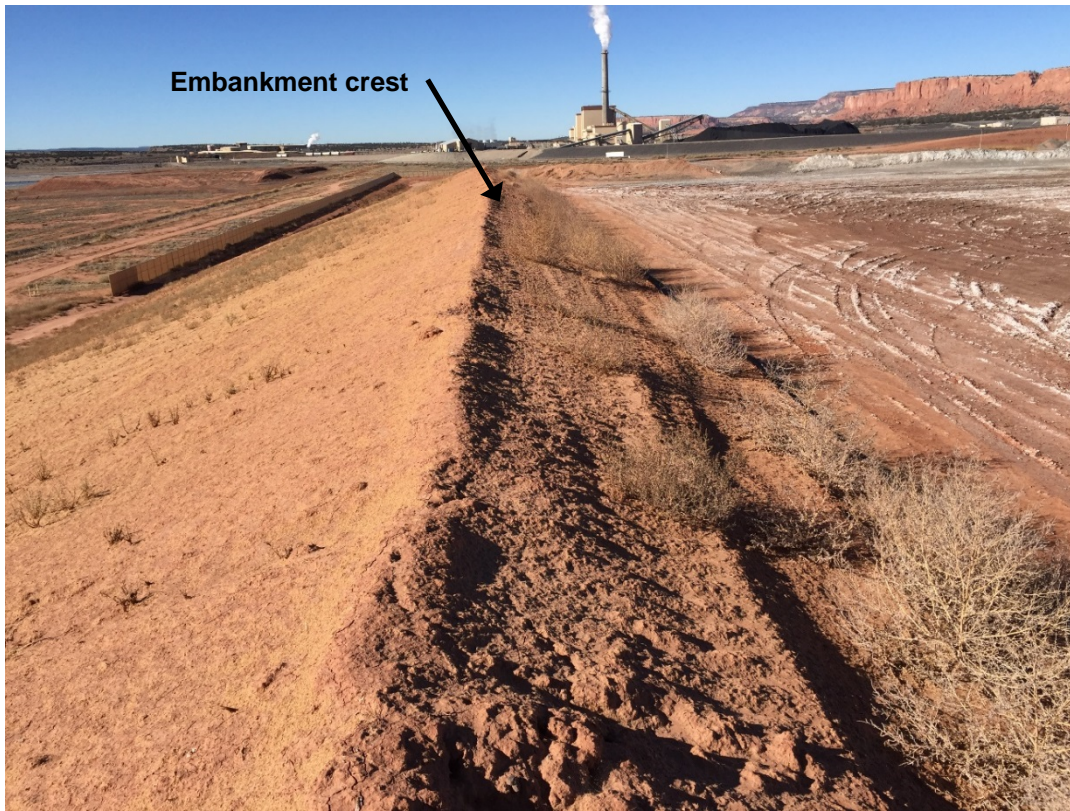
Photograph 3: Typical Embankment Crest Condition

The embankment crest was observed to be in good condition. Cracking that would be indicative of ground movement was not observed along the embankment crest. Low areas that would be indicative of differential settlement were not observed along the embankment crest. The typical condition of the embankment crest is depicted in Photograph 3.

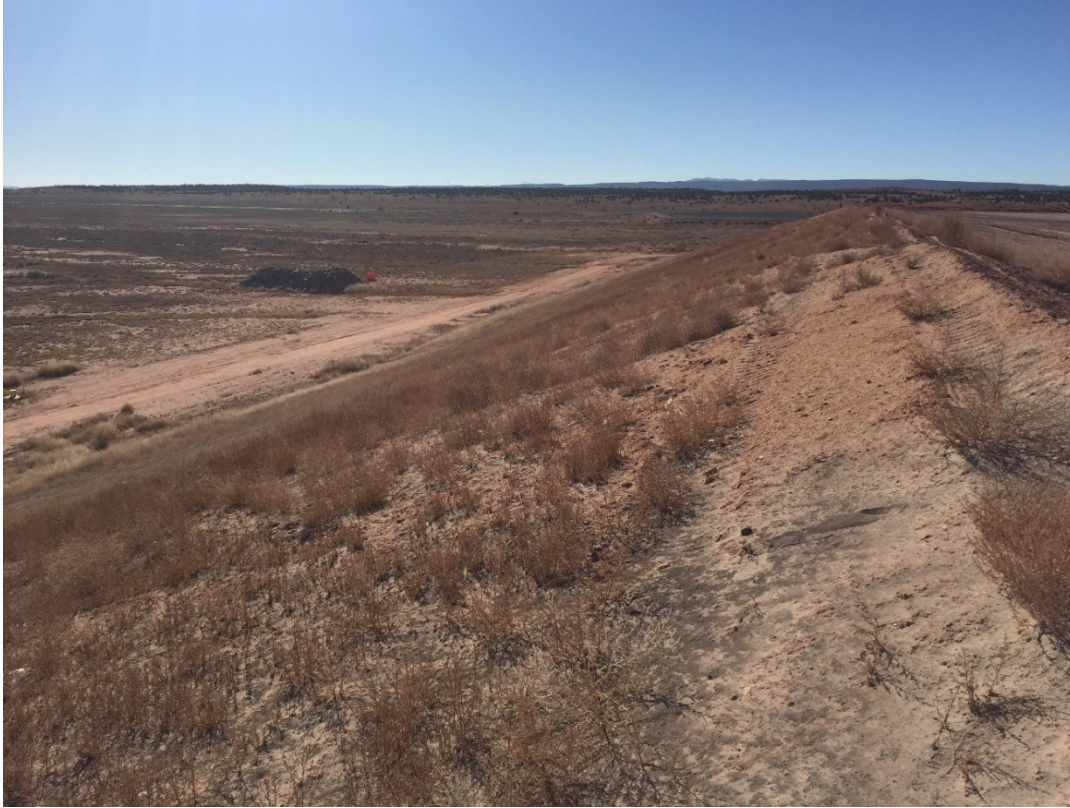
Photograph 4: Typical East Embankment Slope Condition

The embankment slope along the east side of the facility was observed to be in fair condition. Signs of ground movement, such as sloughing or sliding, cracking, subsidence, or bulging, were not observed on the east embankment slope. Significant or excessive erosion or slope deterioration was not observed on the east embankment slope. Small animal burrows were observed in two locations on the east embankment slope, as shown in Appendix A. The animal burrows do not pose a threat to structural stability. Native vegetation is being established on the east embankment slope, but establishment of a mature vegetative community is challenging given the climatic conditions at the site. Unusually poor vegetative growth (relative to the other portions of the east embankment slope) was observed in one location on the east embankment slope, as shown in Appendix A. The area of poor vegetative growth did not appear to be caused by a stability-related issue and does not pose a threat to structural stability. Woody vegetation was not observed on the east embankment slope. The typical condition of the east embankment slope is depicted in Photograph 4. Animal burrows observed on the east embankment slope are shown in Photograph 5.

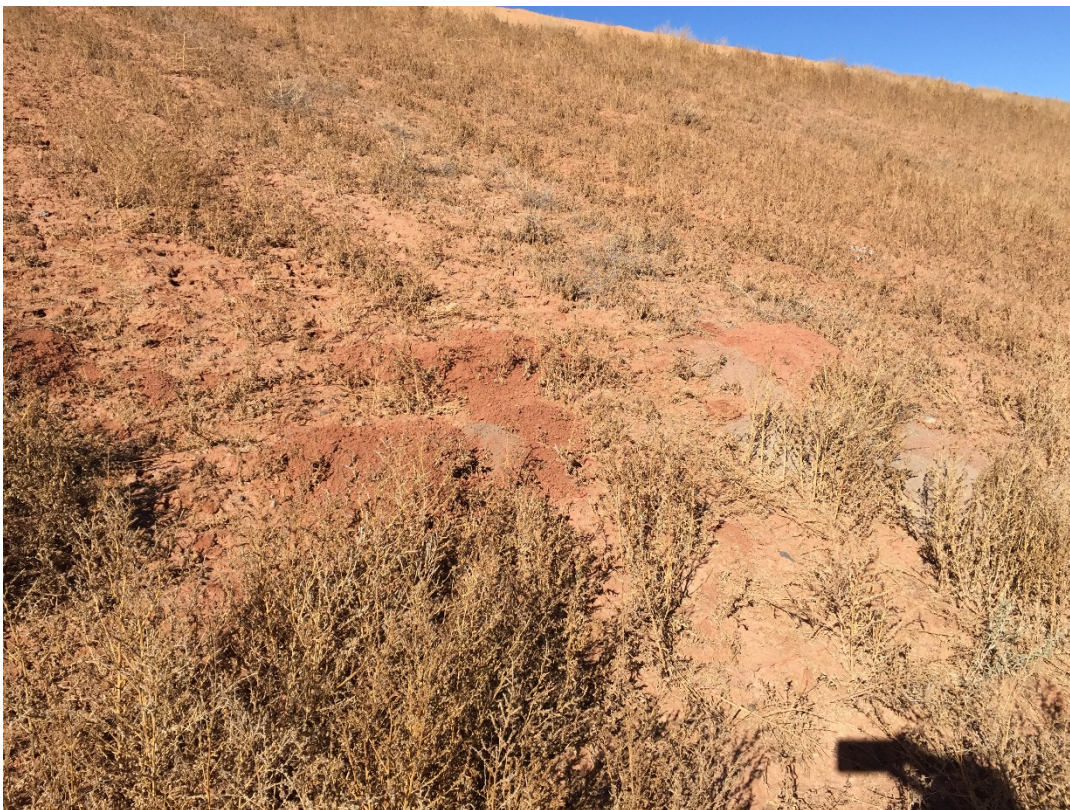
Photograph 5: Animal Burrows on East Embankment Slope

a.						
b.						
c.						
d.						
e.						
J. Elaboration						
Identify the specific item number (for instance, F.2.) and elaborate on each deficiency or issue identified during the annual inspection. Attach documentation (photographs or sketches) if practical.						
F.4. An area of poor vegetative growth was observed on the east embankment slope (see page 3). Site personnel indicated that the embankment slopes were reseeded in the summer of 2017 to promote additional vegetative coverage. The area of poor vegetative growth should be monitored and reseeded if appropriate. The area of poor vegetative growth is not currently of concern for stability of the embankment slope.						
F.5. A few burrows were observed in each of the locations shown on page 3. The burrows are not currently of concern for stability of the embankment slope.

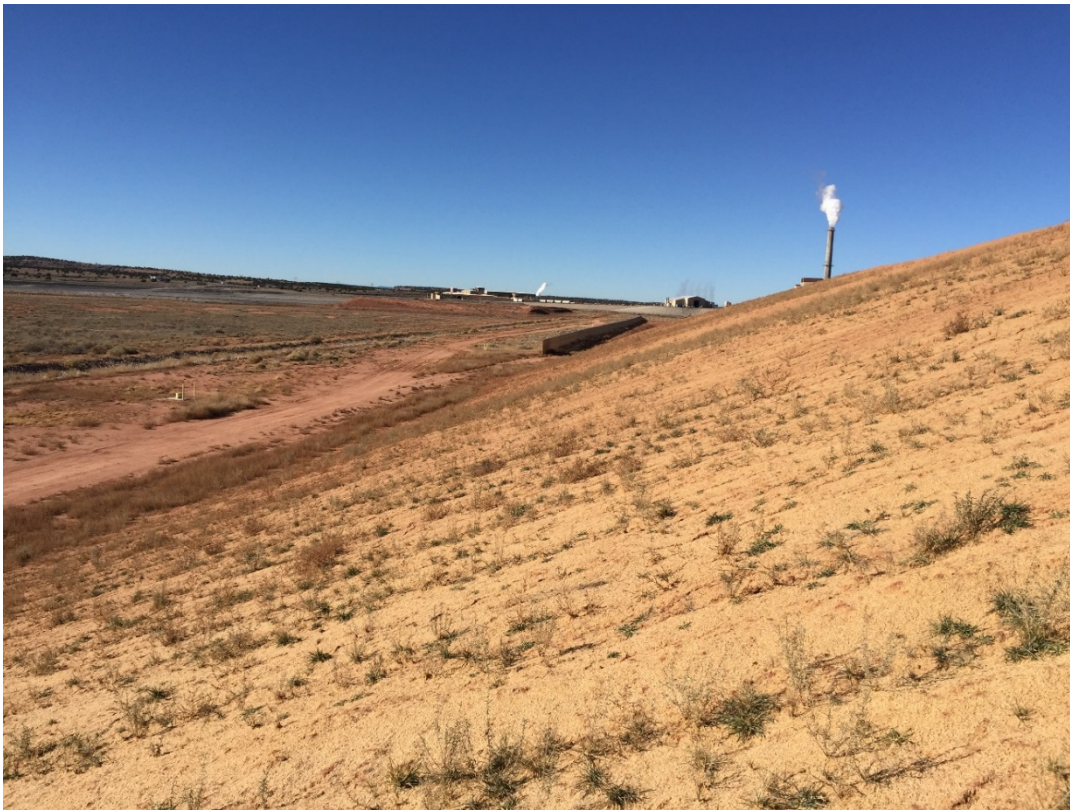
Photograph 6: Typical South Embankment Slope Condition

The embankment slope along the south side of the facility was observed to be in fair condition. Signs of ground movement, such as sloughing or sliding, cracking, subsidence, or bulging, were not observed on the south embankment slope. Significant or excessive erosion or slope deterioration was not observed on the south embankment slope, but minor erosion rills were observed across much of the south embankment slope. The minor erosion does not pose a threat to structural stability. Native vegetation is being established on the south embankment slope, but establishment of a mature vegetative community is challenging given the climatic conditions at the site. Unusually poor or thriving vegetative growth was not observed on the south embankment slope, but there was generally less vegetative coverage on the south embankment slope than on the east embankment slope (likely due to the southern exposure/aspect). Woody vegetation was not observed on the south embankment slopes. The typical condition of the south embankment slope is depicted in Photograph 6.

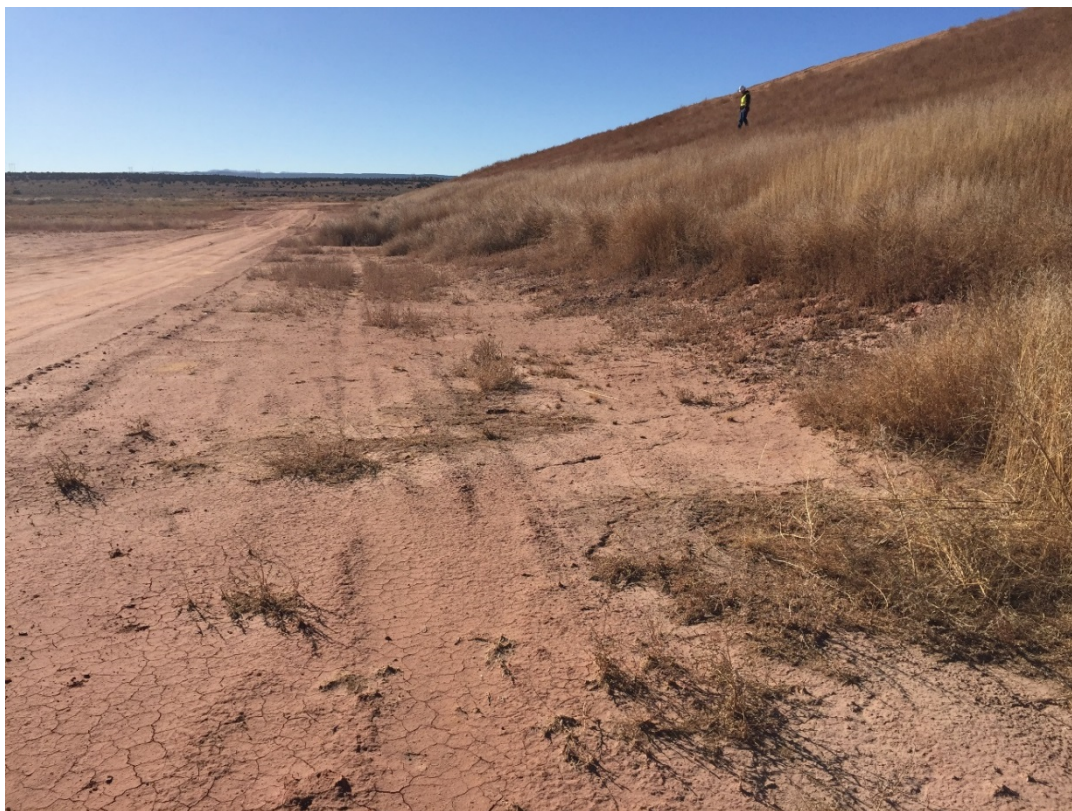
Photograph 7: Typical Embankment Toe Condition

The embankment toe was observed to be in good condition. Signs of seepage, such as springs or boggy areas, were not observed along the embankment toe. The typical condition of the embankment toe is depicted in Photograph 7.

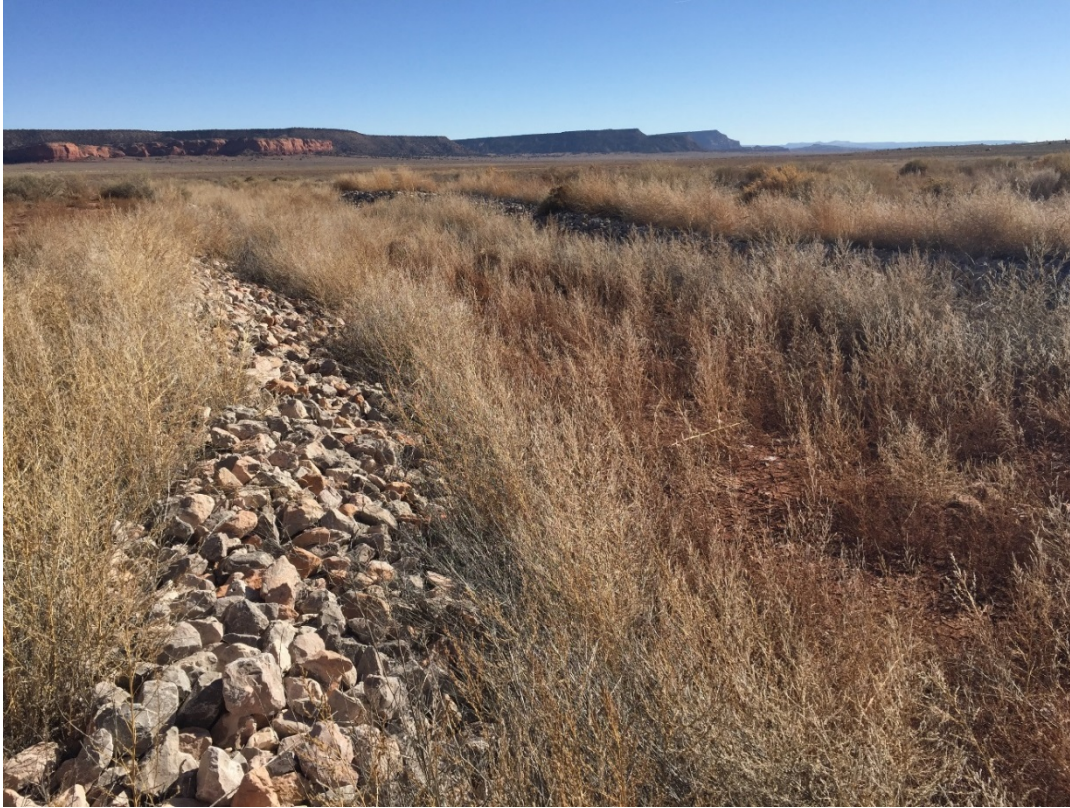
Photograph 8: Typical Storm Water Channel Condition

The storm water control features at the facility were observed to be in good condition. At the time of the visual observation, the only permanent storm water control feature at the facility was a run-on control channel that is designed to convey storm water from west to east along the south end of the facility. The run-on control channel is armored with riprap. Relatively large shrubs were observed to be growing in the flow path. The shrubs do not pose a threat to structural stability, but they should be removed periodically to help maintain the channel's flow capacity. The typical condition of the run-on control channel is depicted in Photograph 8.

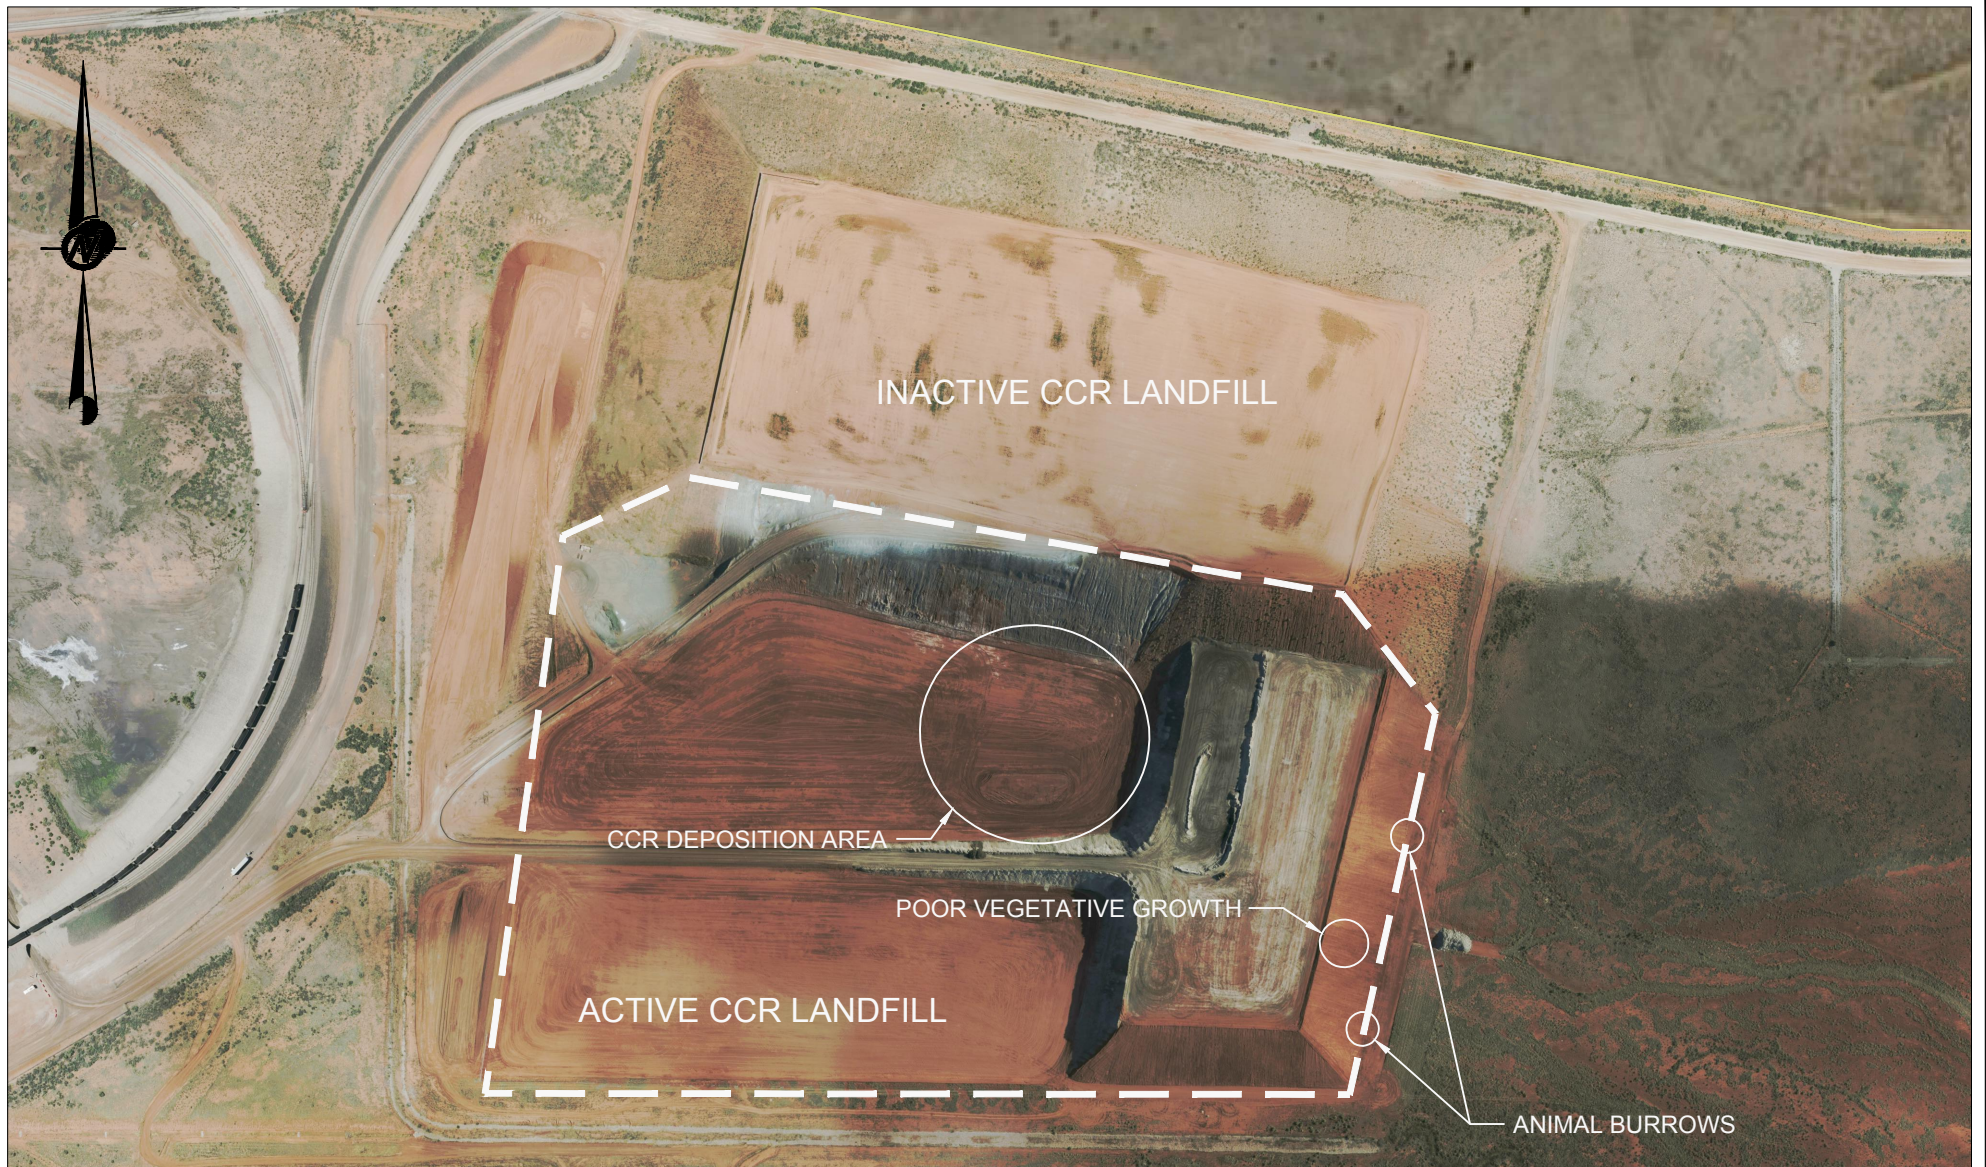
1. Where are ash and/or other materials currently being deposited (indicate on the plan view on page 3 or write N/A)? See page 3
