COAL COMBUSTION RESIDUALS LANDFILL ANNUAL INSPECTION REPORT

Nucla Station Ash Disposal Site

January 12, 2018

1779126B

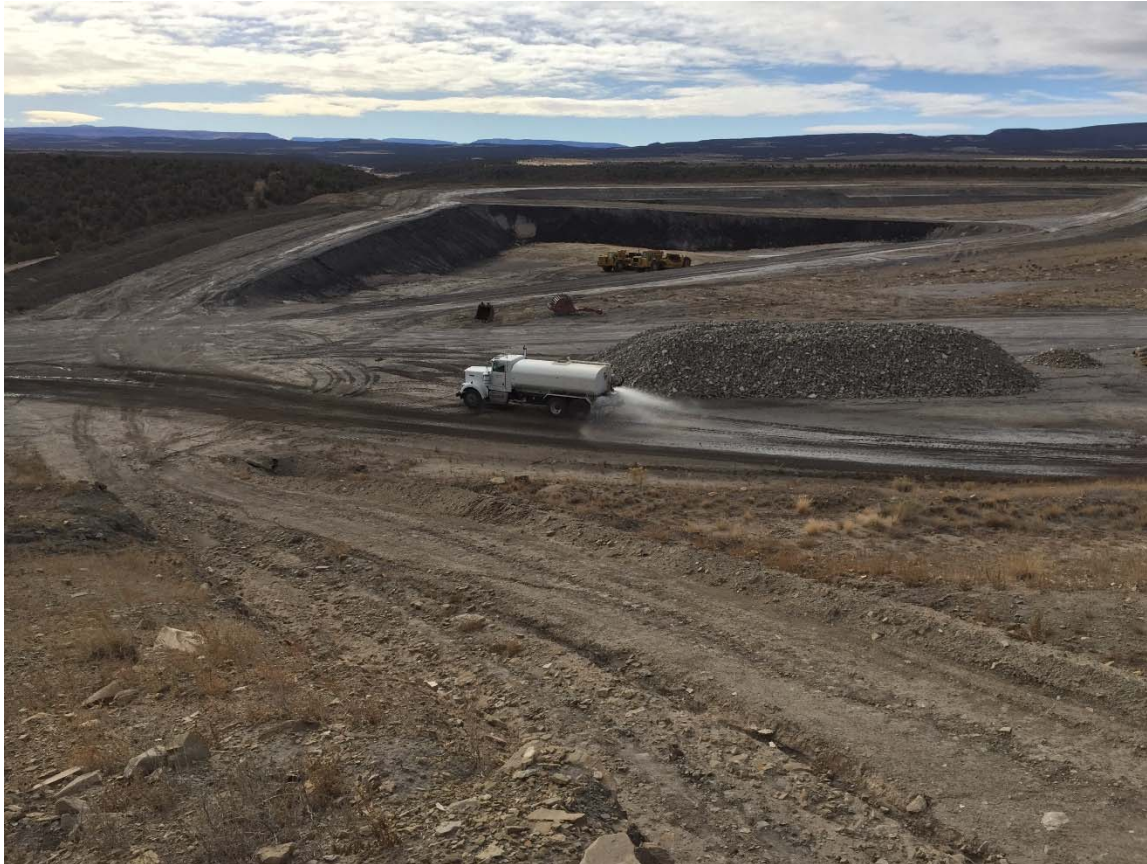
The ash deposition area was observed to be in good condition. Signs of ground movement, such as sloughing or sliding, cracking, subsidence, or bulging, were not observed in the ash deposition area. Ash deposition was not occurring at the time of the visual observation because the generating unit was not operating. The ash deposition area was appropriately graded so that ash contact water would collect within the ash deposition area. A berm that was several feet in height was in place around the perimeter of the

ash deposition area to prevent migration of ash contact water out of the ash deposition area. Fugitive dust was not observed at the time of the visual observation, and a water truck was observed applying water for dust suppression. The typical condition of the ash deposition area is depicted in Photograph 1.

Photograph 1: Typical Ash Deposition Area Condition

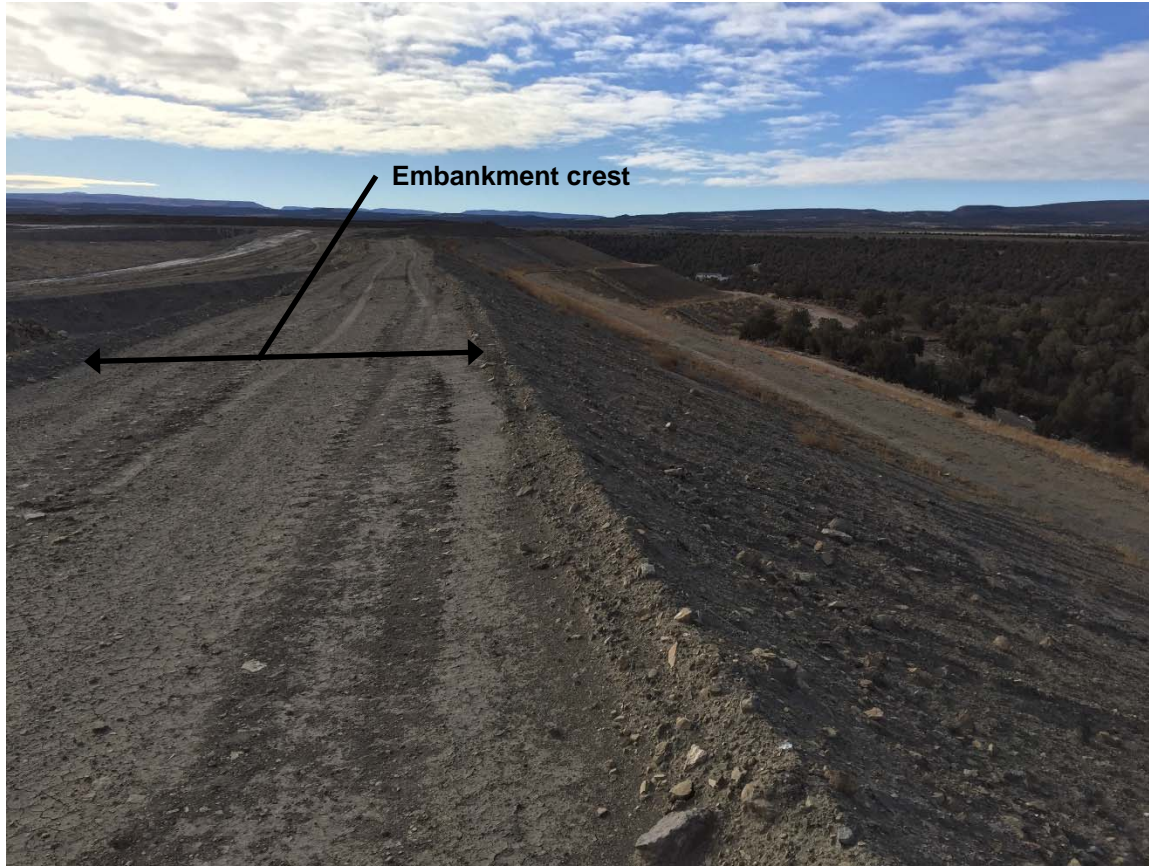
The embankment crest was observed to be in good condition. Cracking that would be indicative of ground movement was not observed along the embankment crest. Low areas that would be indicative of differential settlement were not observed along the embankment crest. The typical condition of the embankment crest is depicted in Photograph 2.

Photograph 2: Typical Embankment Crest Condition

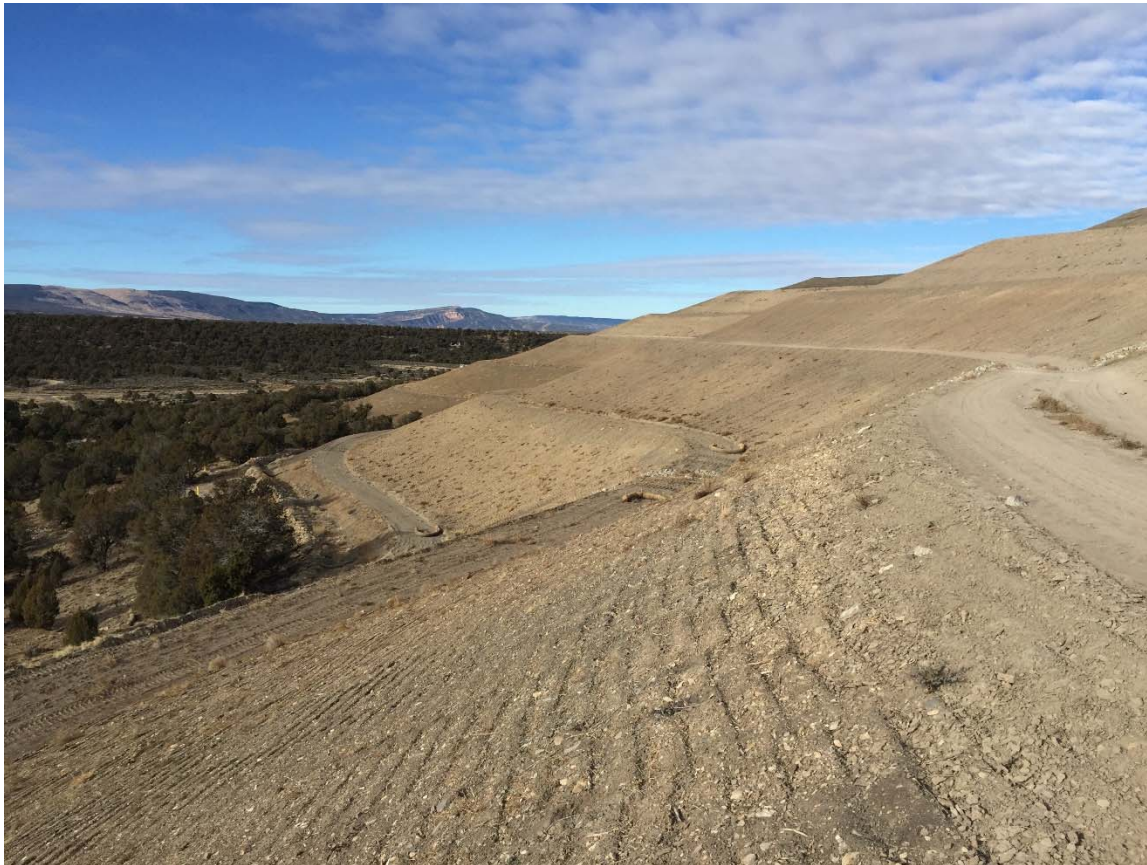
The embankment slopes were observed to be in good condition. Signs of ground movement, such as sloughing or sliding, cracking, subsidence, or bulging, were not observed on the embankment slopes. Evidence of significant or excessive erosion or slope deterioration was not observed on the embankment slopes. Some areas of minor rilling were noted. The observed rills do not pose a threat to structural stability, and it was evident that repair of erosion rills is being conducted on an ongoing basis. Slope stability calculations completed by Golder indicate that the embankment slopes at the facility are expected to remain stable with acceptable factors of safety under anticipated maximum loading conditions (static and seismic). Native vegetation has been established on the embankment slopes as the facility has been progressively built higher. Portions of the embankment slopes had adequate vegetative coverage at the time of the visual observation, while other portions had been reseeded in 2017 in an effort to establish a more robust vegetative coverage in these areas. Other than these reseeded areas, where insufficient time had elapsed to establish mature vegetative communities, unusually poor or thriving vegetative growth was not observed on the embankment slopes. Some shrubs were observed on the embankment slopes. This type of vegetation is typical of the surrounding area. The extent of shrubs was minor and does not pose a threat to structural stability. Thus, mitigation is not considered to be necessary. No trees were observed on the embankment slopes. Minor animal burrowing was observed in three areas, as shown on the plan view

included in Appendix C. Tri-State indicated that an extermination effort was undertaken in 2017; the burrows may have predated that effort, as no sign of active burrowing was observed. The extent of burrowing was minor and does not pose a threat to structural stability. The typical condition of the embankment slopes is depicted in Photograph 3. The embankment slopes shown in Photograph 3 were among those that were reseeded and subsequently tracked with a dozer in 2017, and vegetative coverage on these embankment slopes is therefore limited.

Photograph 3: Typical Embankment Slope Condition

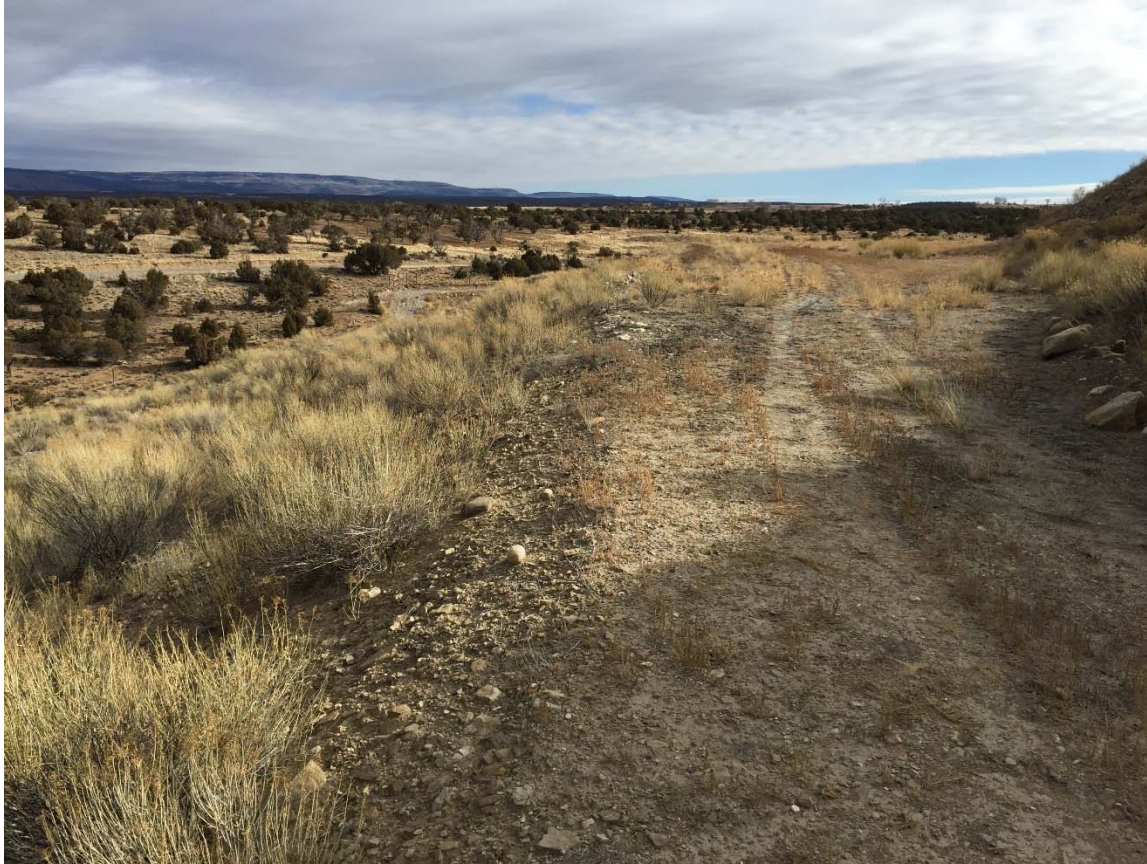
The embankment toe was observed to be in good condition. Signs of seepage, such as springs or boggy areas, were not observed along the embankment toe. The typical condition of the embankment toe is depicted in Photograph 4.

Photograph 4: Typical Embankment Toe Condition

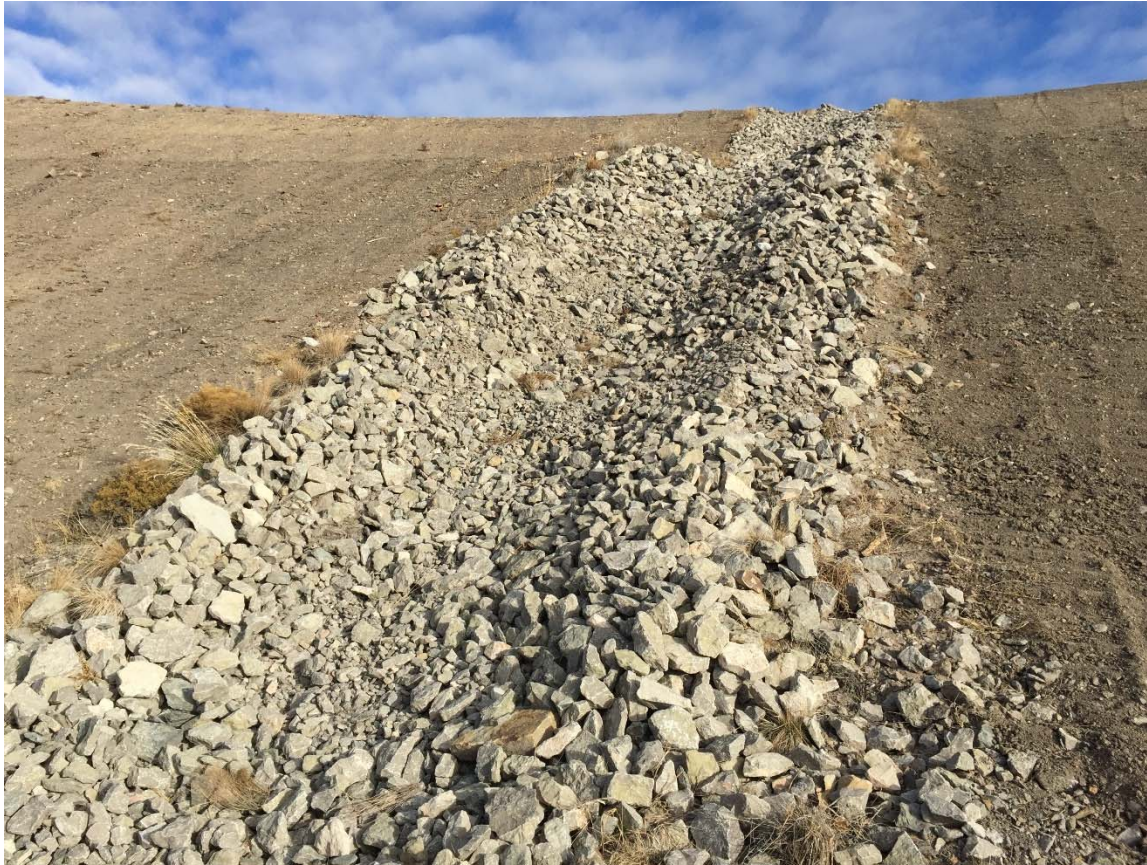
The storm water control features at the facility were observed to be in good condition. Downchute channels and energy dissipation basins at the facility are constructed with riprap. Surface water calculations completed by Golder indicate that the downchute channels are located and sized appropriately to convey the 100-year, 24-hour storm event. Some of the downchute channels had small shrubs growing in the flow path, and Golder recommends that the shrubs be removed periodically if they become large enough to impede flow or cause riprap to shift. However, the shrubs do not pose a threat to structural stability and did not impact Golder's ability to inspect the facility. The typical condition of the downchute channels is depicted in Photograph 5. Terrace channels at the facility are provided at approximate 20-foot vertical intervals and are grass-lined. Erosion control wattles have been installed to control erosion and capture sediment in the terrace channels at appropriate intervals. Surface water calculations completed by Golder indicate that the terrace channels are located and sized appropriately to convey the 100-year, 24-hour storm event. The typical condition of the terrace channels is depicted in Photograph 6. Perimeter channels are in place around the facility where they are needed. Perimeter channels at the facility are generally constructed with soil and rock. Surface water calculations completed by Golder indicate that the perimeter channels are located and sized appropriately to convey the 25-year, 24-hour storm event. Debris (tumbleweeds) buildup in a perimeter channel at the outlet of the corrugated metal culverts under the entrance road were

Photograph 5: Typical Downchute Channel Condition

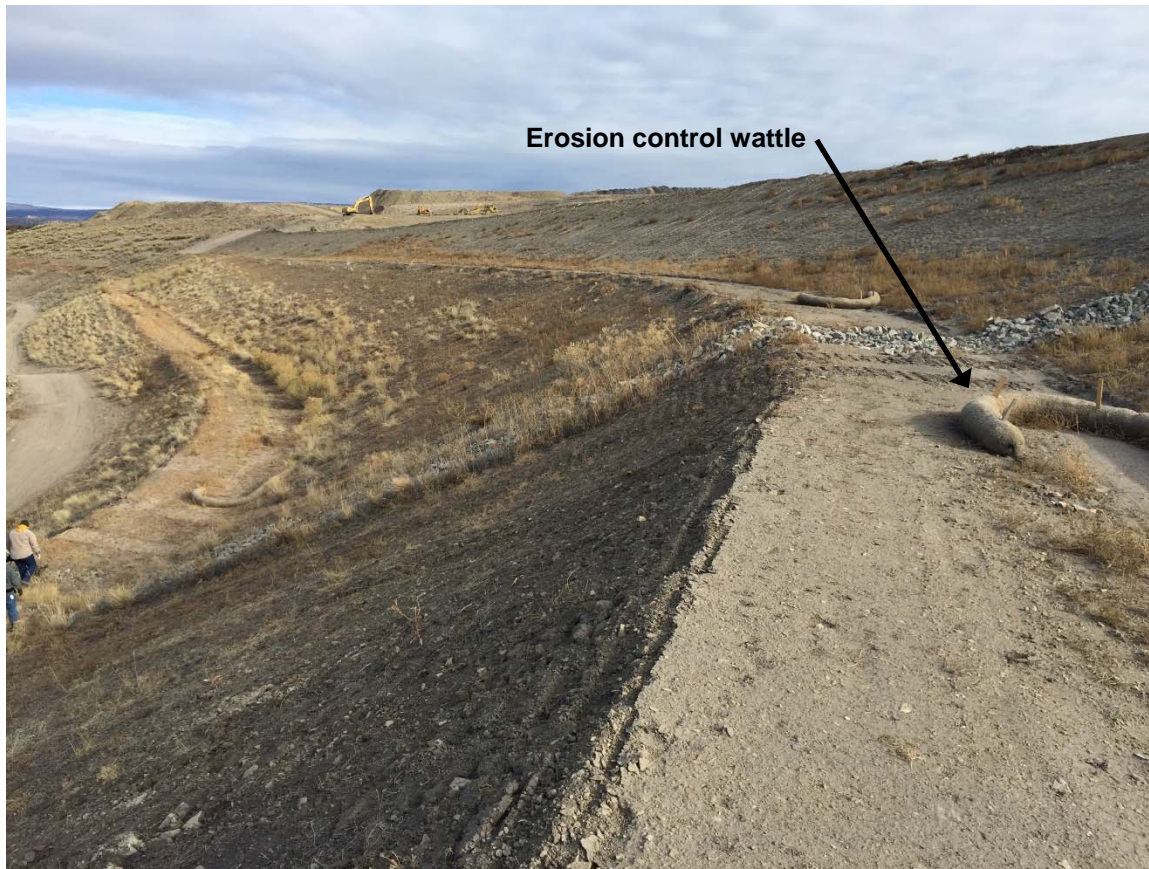
Photograph 6: Typical Terrace Channel Condition

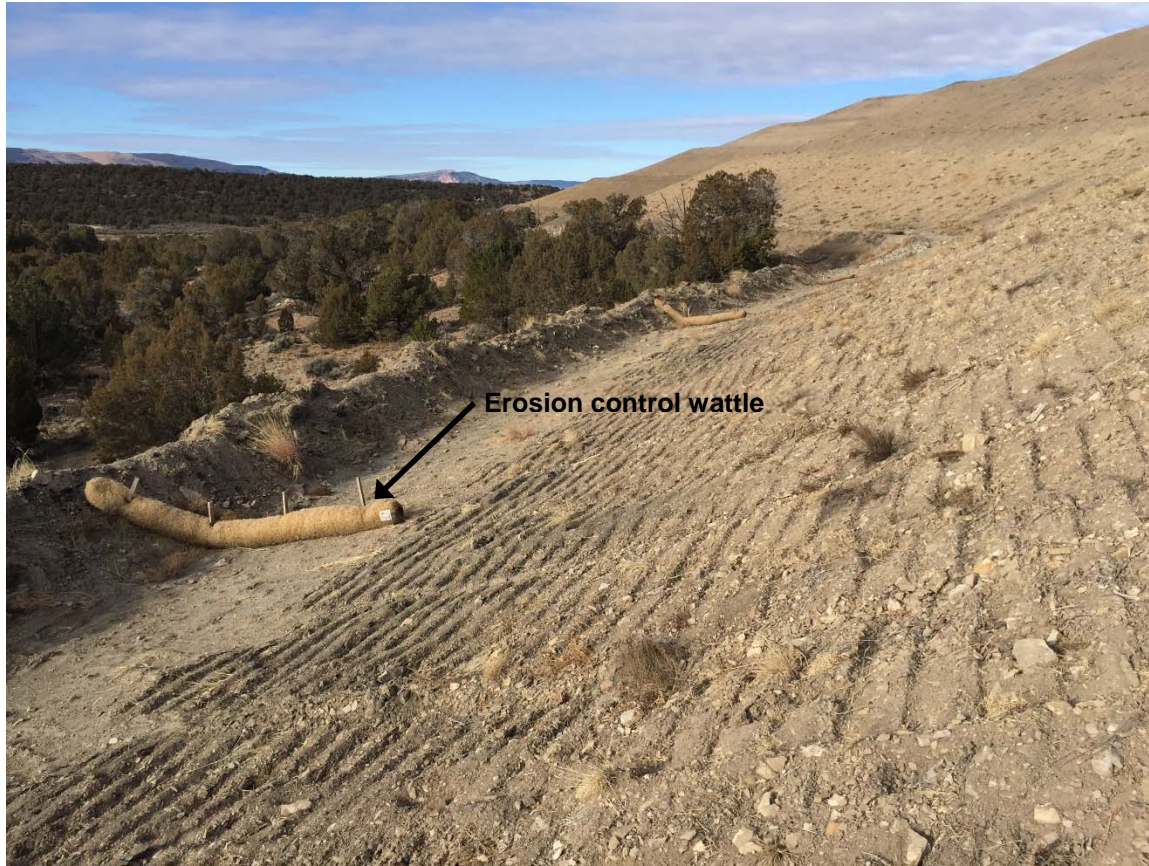
noted, as shown on the plan view included in Appendix C. This buildup should be removed periodically, but does not pose a threat to structural stability and did not impact Golder's ability to inspect the facility. Erosion control wattles have been installed at appropriate intervals in the perimeter channels to control erosion and capture sediment. The typical condition of the perimeter channels is depicted in Photograph 7.

Photograph 7: Typical Perimeter Channel Condition

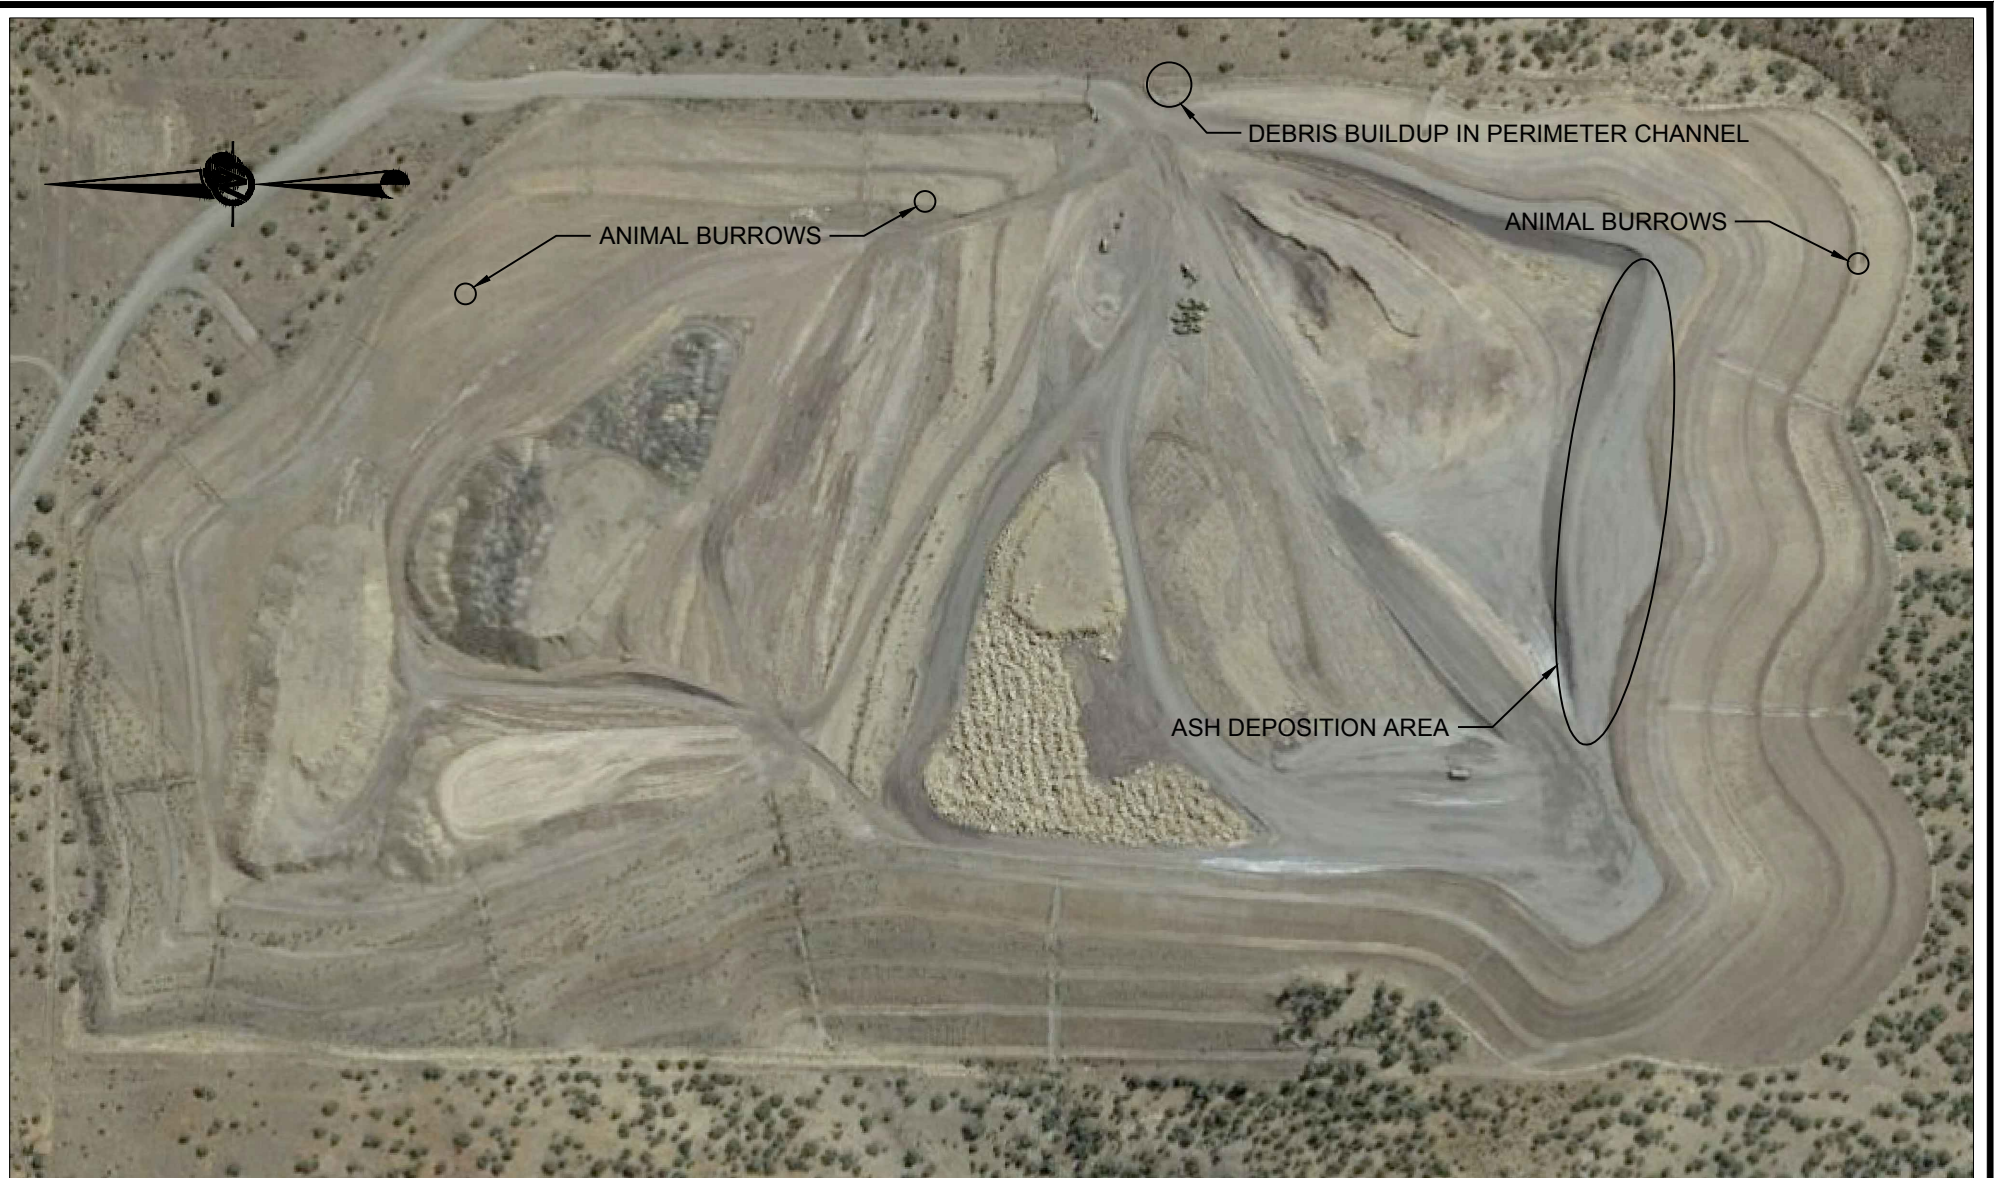
a.						
b.						
c.						
d.						
e.						
J. Elaboration						
Identify the specific item number (for instance, F.2.) and elaborate on each deficiency or issue identified during the annual inspection. Attach documentation (photographs or sketches) if practical.						
F.5. A few burrows were observed in each of the locations shown on page 3. The burrows did not show evidence of recent activity and are not currently of concern for stability of the embankment slopes.
