Coal Combustion Residuals Landfill Annual Inspection

Nucla Station Ash Disposal Facility

Tri-State Generation and Transmission Association, Inc.

December 20, 2019

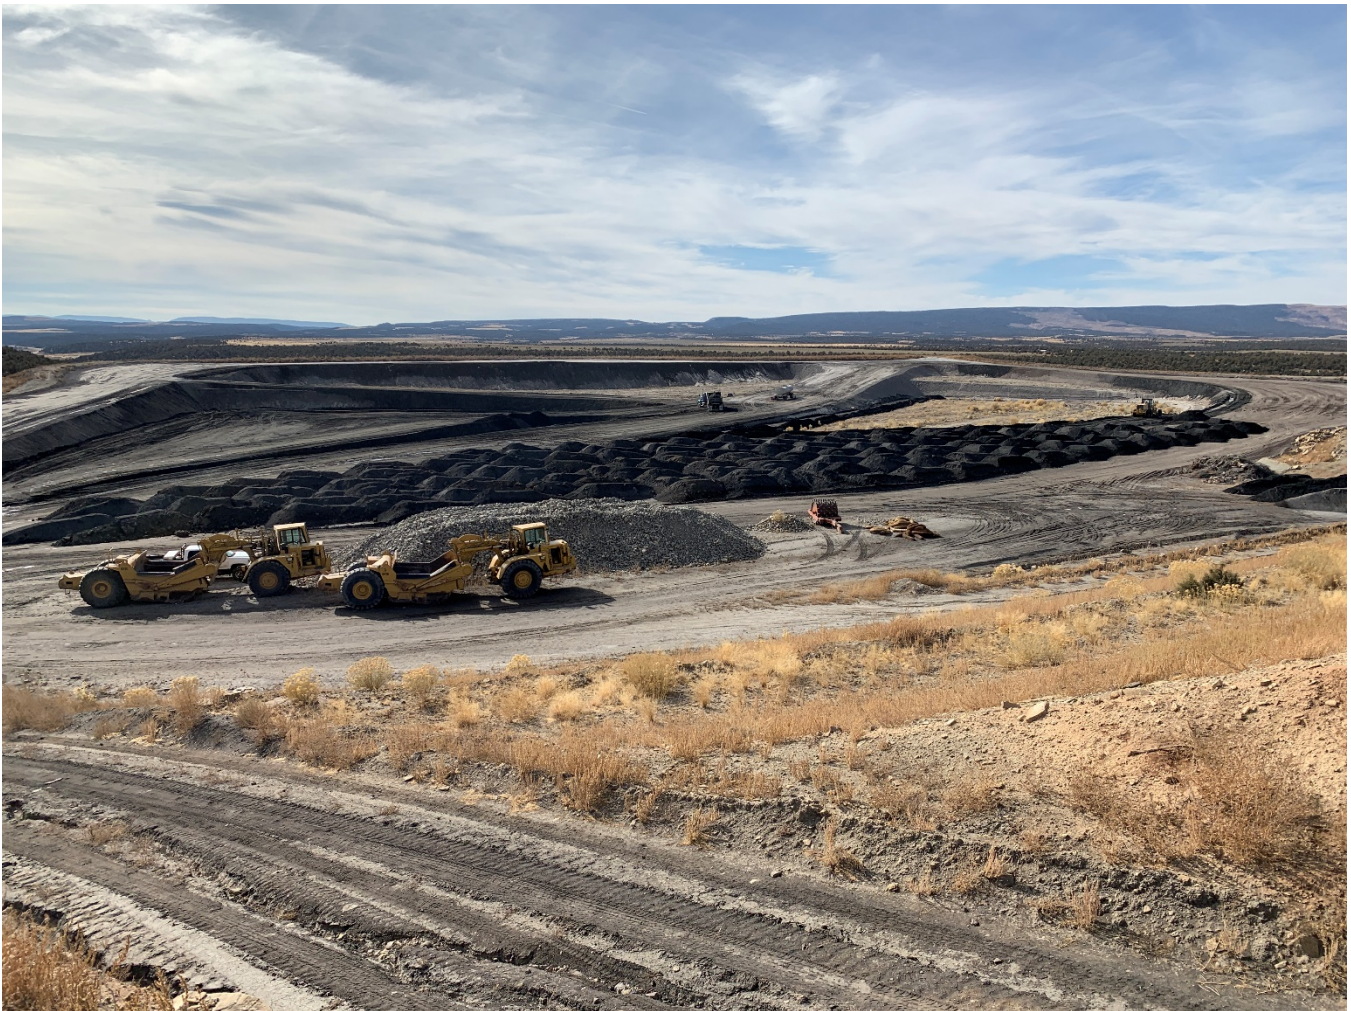
The ash deposition area was observed to be in good condition. Signs of ground movement, such as sloughing or sliding, cracking, subsidence, or bulging, were not observed in the ash deposition area. Ash was being relocated from the power plant site to the facility at the time of the visual observation. The ash deposition area was appropriately graded so that ash contact water would collect within the ash deposition area. A berm that was several feet in height was in place around the perimeter of the ash deposition area to prevent migration of ash contact water out of the ash deposition area. Water (distributed from a water truck) was being used for dust suppression at the time of the visual observation, and fugitive dust was not observed. The typical condition of the ash deposition area is depicted in Photograph 1.

Photograph 1: Typical Ash Deposition Area Condition

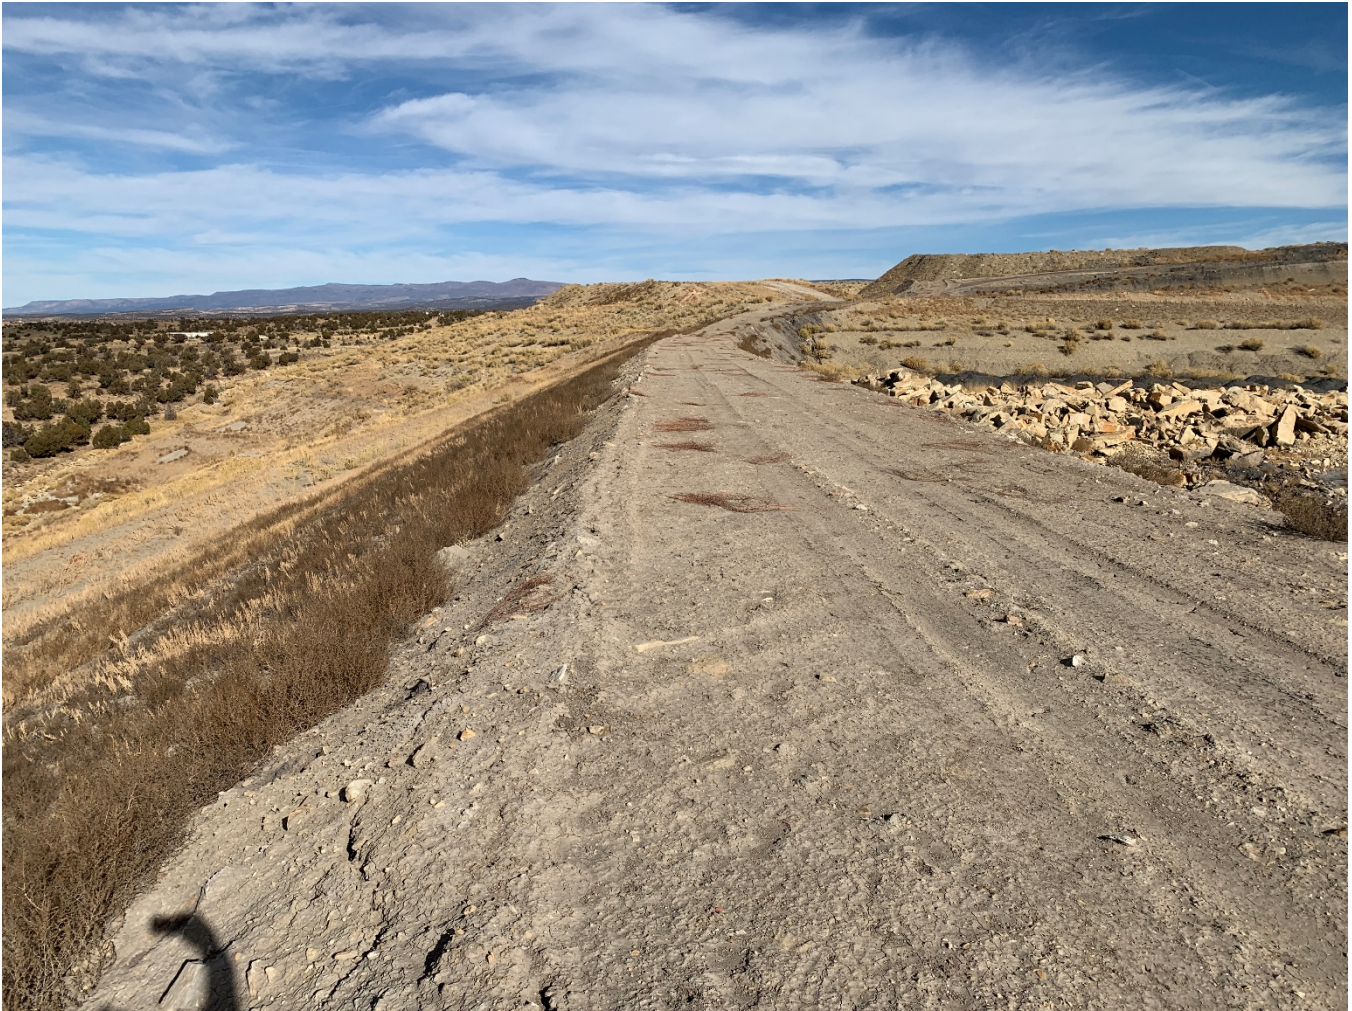
The embankment crest was observed to be in good condition. Cracking that would be indicative of ground movement was not observed along the embankment crest. Low areas that would be indicative of differential settlement were not observed along the embankment crest. The typical condition of the embankment crest is depicted in Photograph 2.

Photograph 2: Typical Embankment Crest Condition

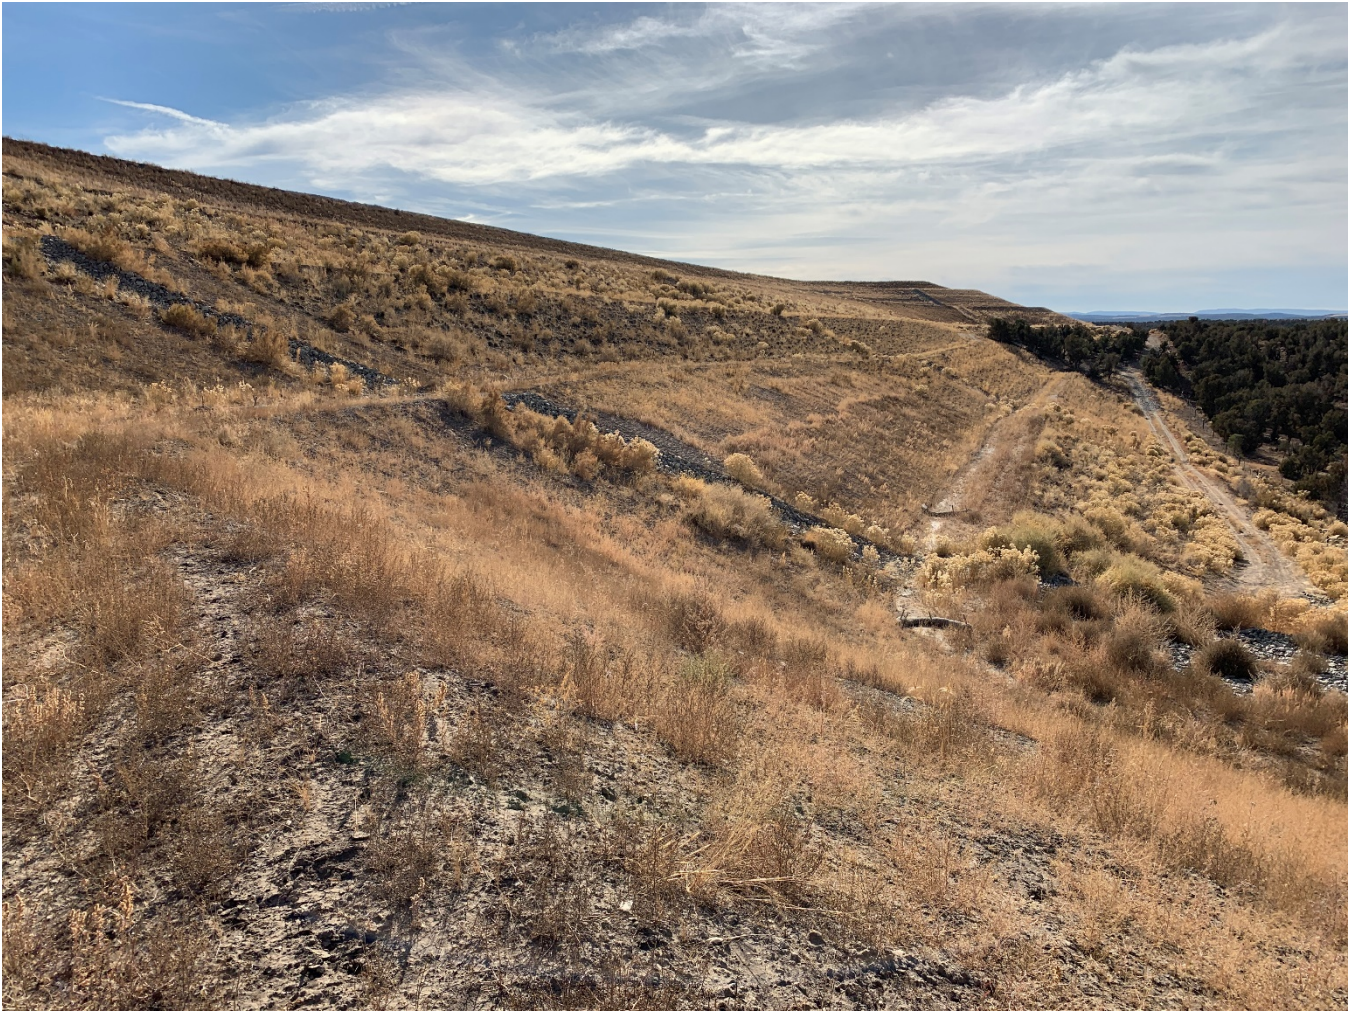
The embankment slopes were observed to be in good condition. Signs of ground movement, such as sloughing or sliding, cracking, subsidence, or bulging, were not observed on the embankment slopes. Evidence of significant or excessive erosion or slope deterioration was not observed on the embankment slopes. It was apparent from visual observation that repair of embankment slopes is being performed as needed, and the weekly inspection forms confirm that repair work was completed in June 2019. Native vegetation has been established on the embankment slopes as the facility has been progressively built higher. The embankment slopes had adequate vegetative coverage at the time of the visual observation, with more mature vegetation on the east, north, and west slopes than on the south slopes. Unusually poor or thriving vegetative growth was not observed on the embankment slopes. Reseeding completed in 2018 appeared to have been successful. No trees or woody vegetation were observed on the embankment slopes. No evidence of recent animal burrowing was observed on the embankment slopes. The typical condition of the embankment slopes is depicted in Photograph 3.

Photograph 3: Typical Embankment Slope Condition

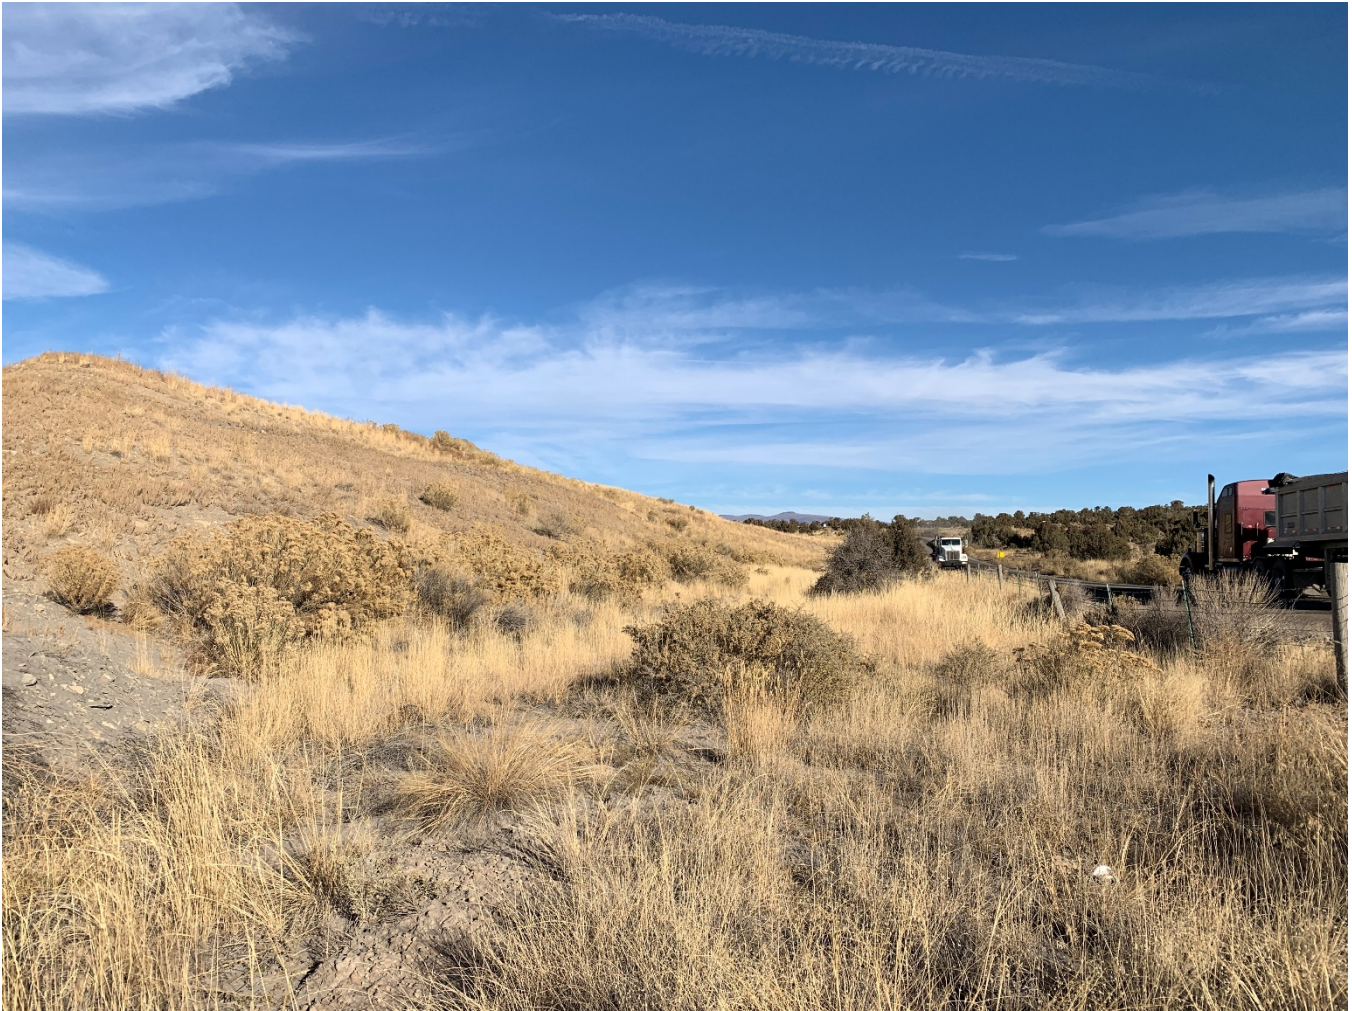
The embankment toe was observed to be in good condition. Signs of seepage, such as springs or boggy areas, were not observed along the embankment toe. The typical condition of the embankment toe is depicted in Photograph 4.

Photograph 4: Typical Embankment Toe Condition

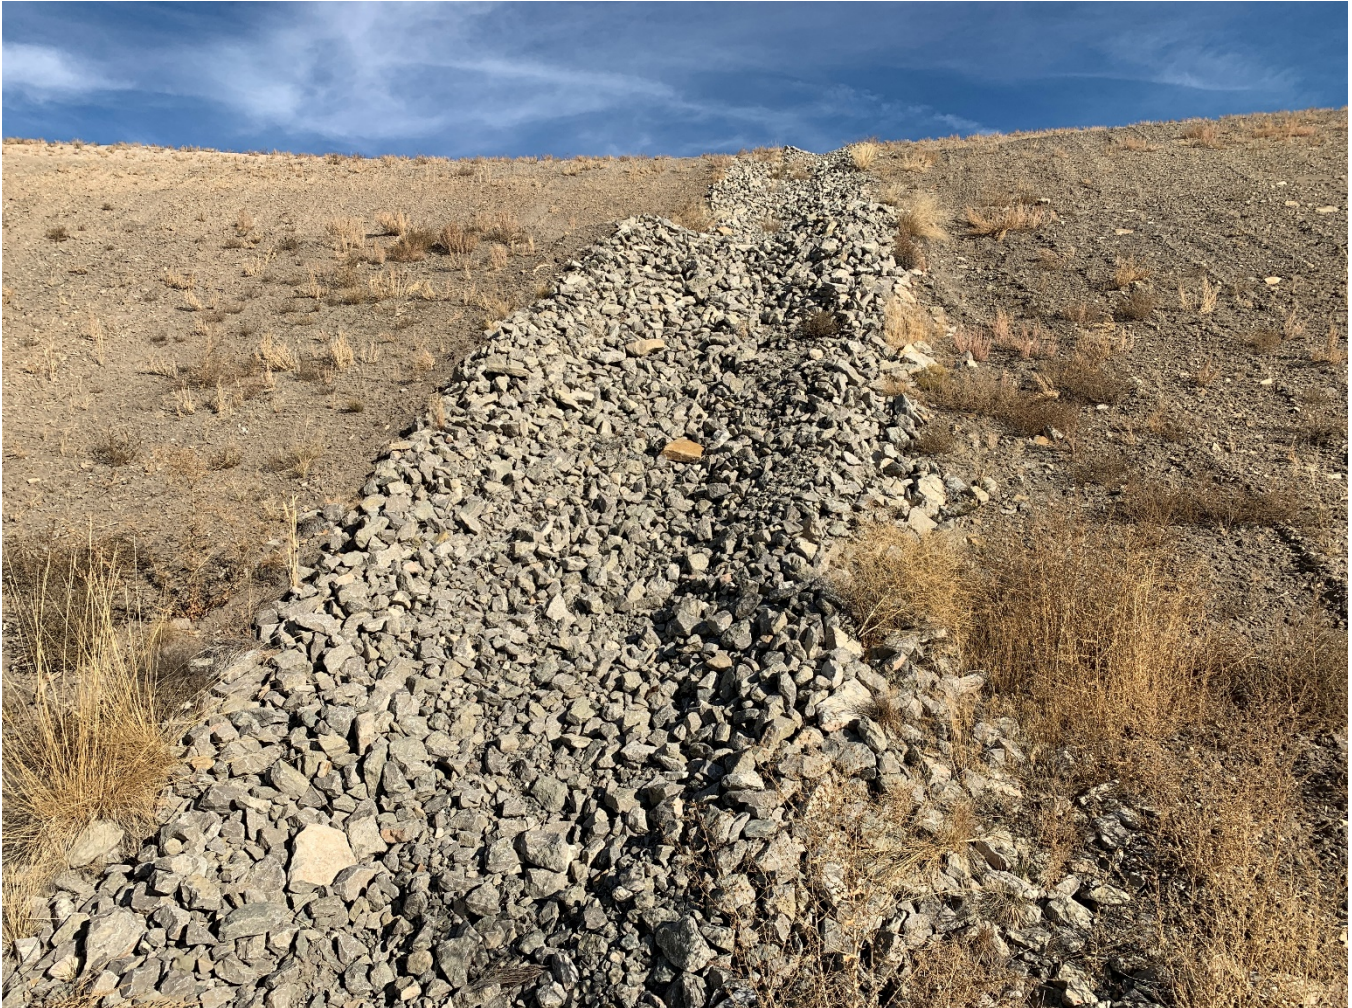
Photograph 5: Typical Downchute Channel Condition

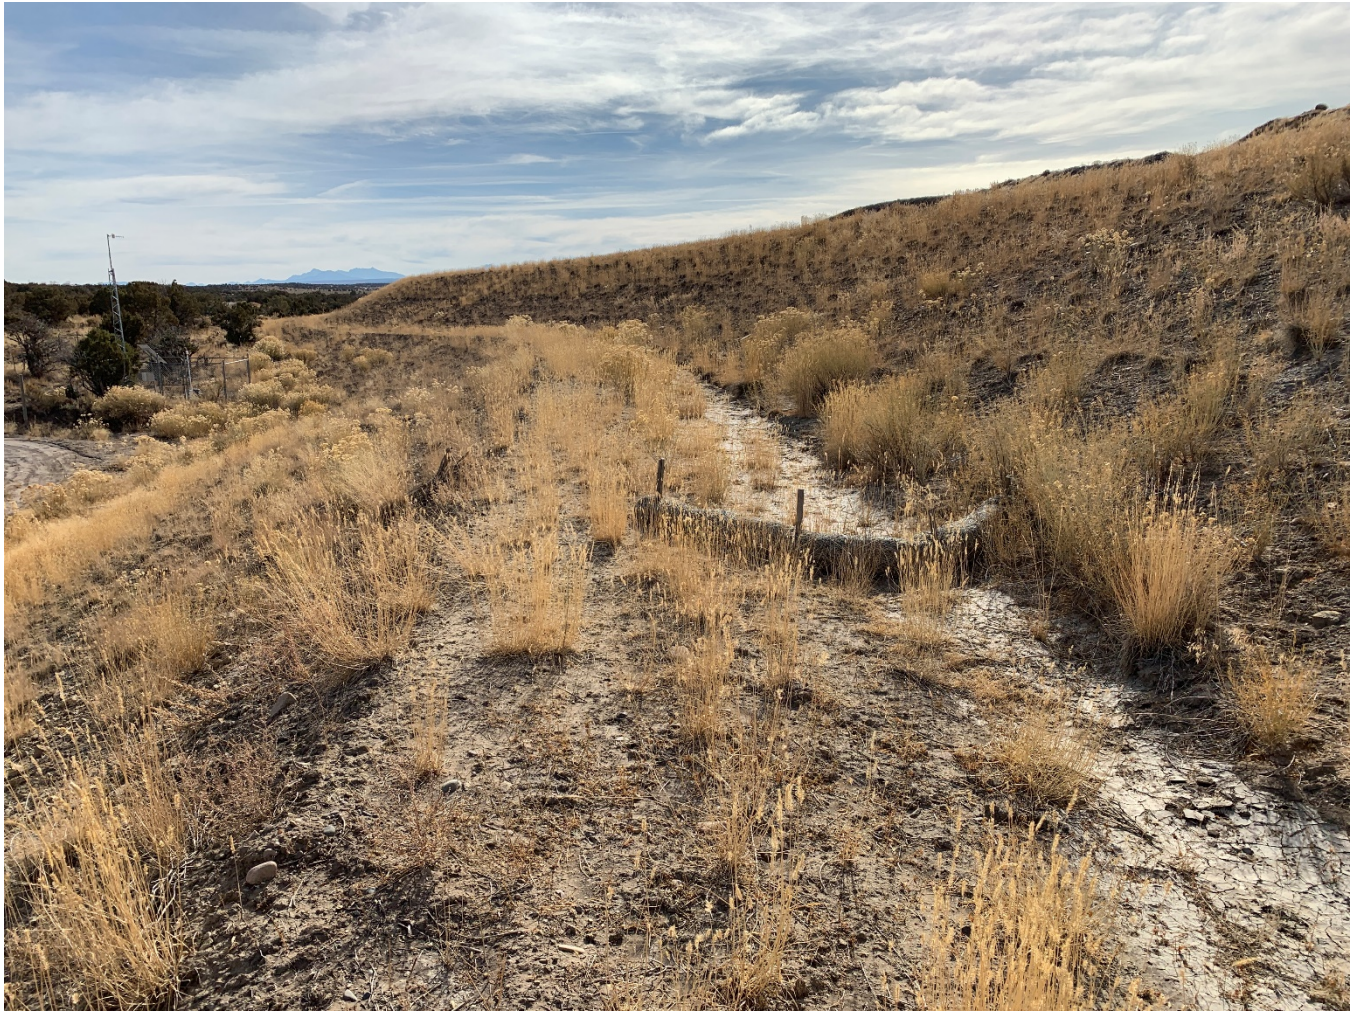
Photograph 6: Typical Terrace Channel Condition

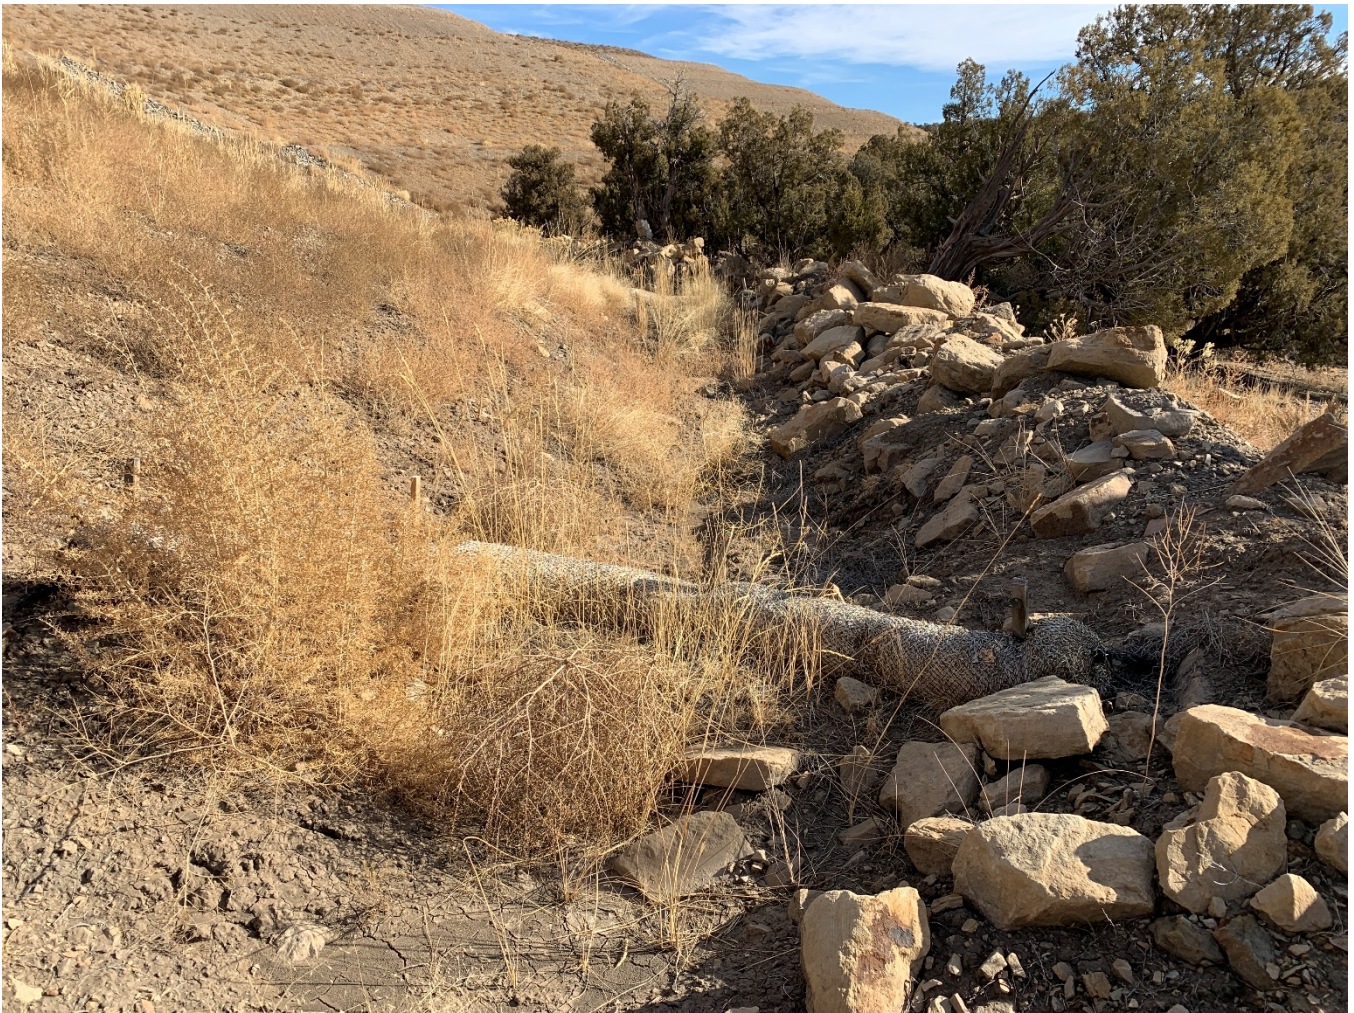
Photograph 7: Typical Perimeter Channel Condition

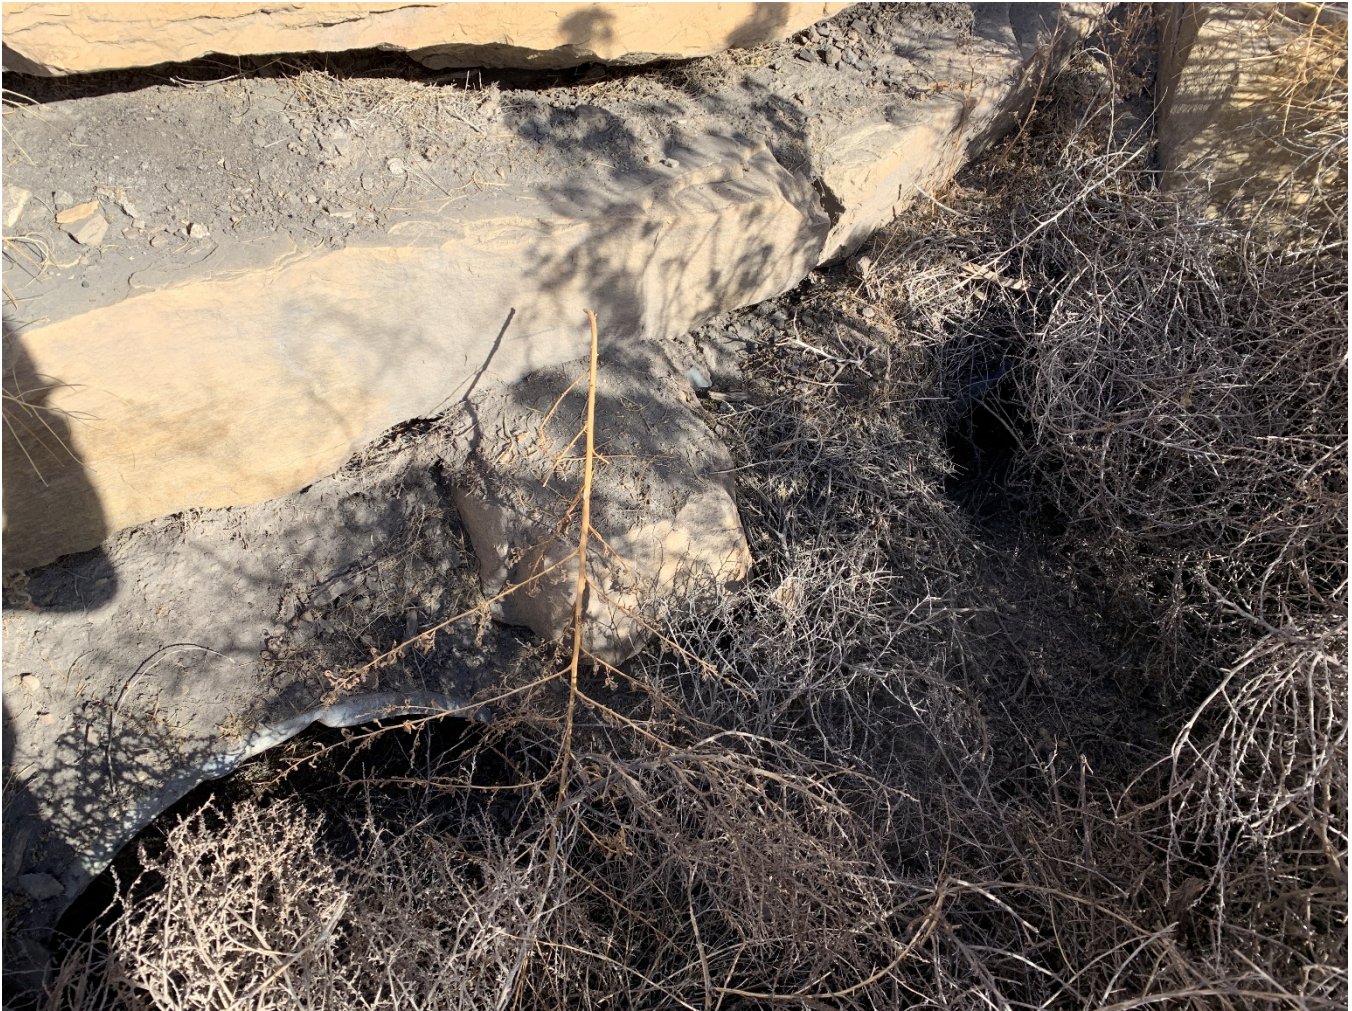
The storm water control features at the facility were observed to be in good condition. Downchute channels and energy dissipation basins at the facility are constructed with riprap. Some of the downchute channels had small shrubs growing in the flow path, and Golder recommends that the shrubs be removed periodically if they become large enough to impede flow or cause riprap to shift. However, the shrubs do not pose a threat to structural stability and did not impact Golder's ability to inspect the facility. The typical condition of the downchute channels is depicted in Photograph 5. Terrace channels at the facility are provided at approximate 20-foot vertical intervals. Erosion control wattles have been installed to control erosion and capture sediment in the terrace channels at appropriate intervals. The typical condition of the terrace channels is depicted in Photograph 6. Perimeter channels are in place around the facility where they are needed. Perimeter channels at the facility are generally constructed with soil and rock. Erosion control wattles have been installed at appropriate intervals in the perimeter channels to control erosion and capture sediment. The typical condition of the perimeter channels is depicted in Photograph 7. During the visual observation, Golder observed that sediment and debris (tumbleweeds) have built up in the perimeter channel along the east side of the facility, at the downstream ends of the culverts that pass beneath the site entrance road, as shown in Photograph 8. Golder recommended that Tri-State remove this

Photograph 8: Buildup in the East Perimeter Channel at the Downstream Ends of the Culverts

d.						
e.						
J. Elaboration						
<i>Identify the specific item number (for instance, F.2.) and elaborate on each deficiency or issue identified during the annual inspection. Attach documentation (photographs or sketches) if practical.</i>						
H.3. Sediment and debris were observed to be partially clogging the outlets of the culverts that pass beneath the site entrance road (see the location marked on page 3).

buildup as soon as practical. This should be done periodically. The buildup does not pose a threat to structural stability and did not impact Golder's ability to inspect the facility.

a. H.3. Clear out the sediment and debris buildup at the downstream ends of the culverts that pass beneath the site entrance road.						
b.						
c.
