**Active Coal Combustion Residuals Landfill
Annual Inspection**
Escalante Generating Station

Tri-State Generation and Transmission Association, Inc.
1100 West 116th Avenue, Westminster, Colorado 80234

19118706-01-4-R-0

January 15, 2020

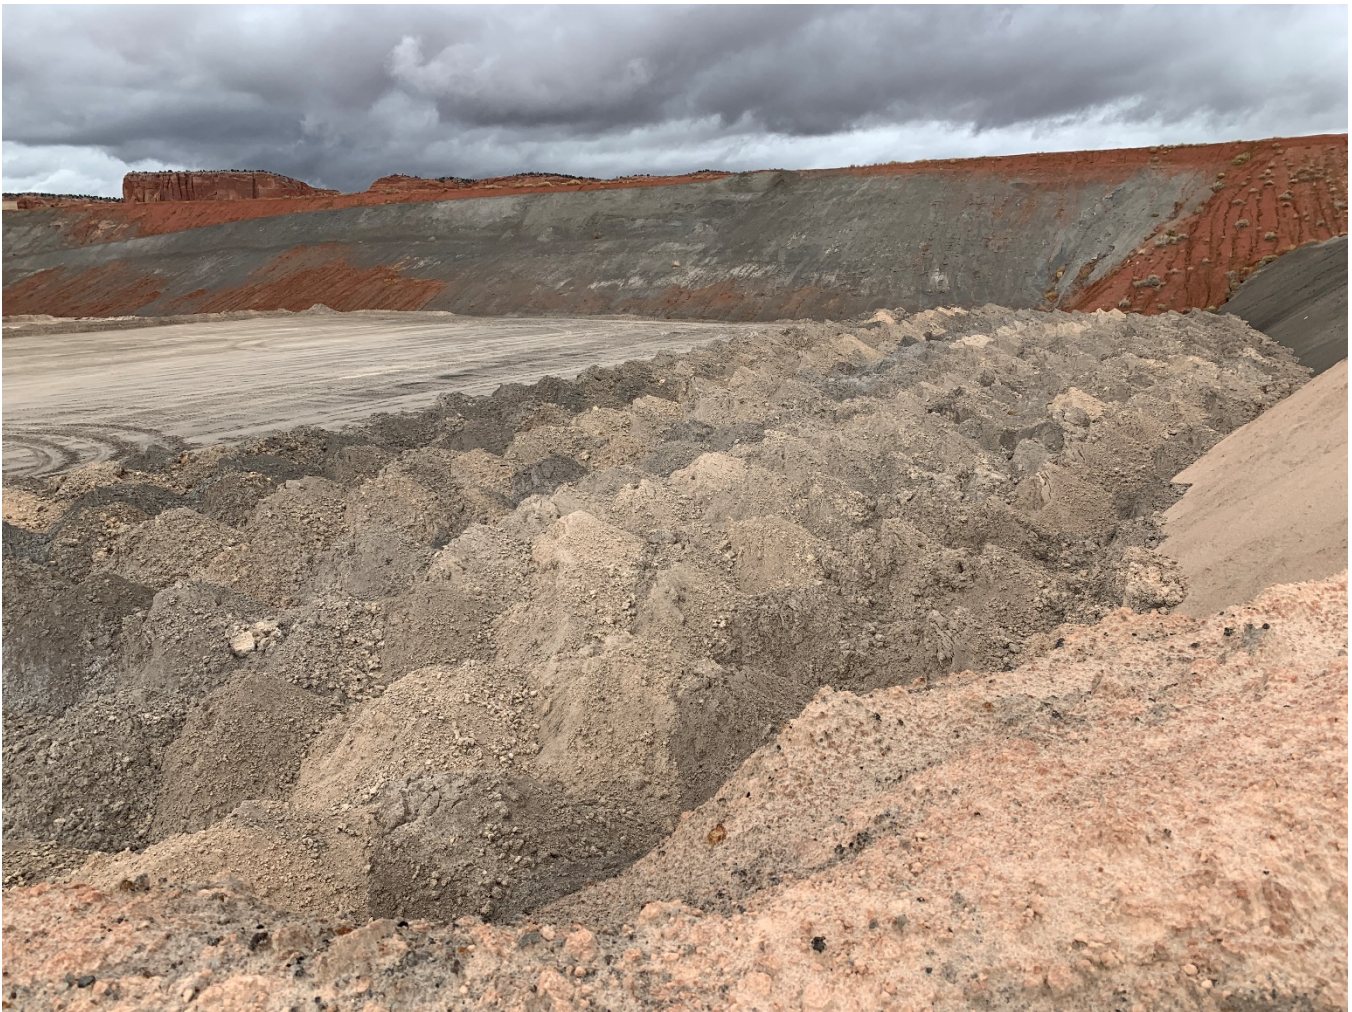
The deposition area was observed to be in good condition. Signs of ground movement, such as sloughing or sliding, cracking, subsidence, or bulging, were not observed in the deposition area. Deposition of CCRs was not occurring at the time of the visual observation. However, the deposition methodology appeared to be appropriate based on observation of the deposition area. Appropriate grading had been established to collect contact water within the deposition area. A berm that was several feet in height was in place around the perimeter of the deposition area to prevent migration of contact water out of the deposition area. Fugitive dust was not observed at the time of the visual observation. The typical condition of the deposition area is depicted in Photograph 1.

Photograph 1: Typical Deposition Area Condition

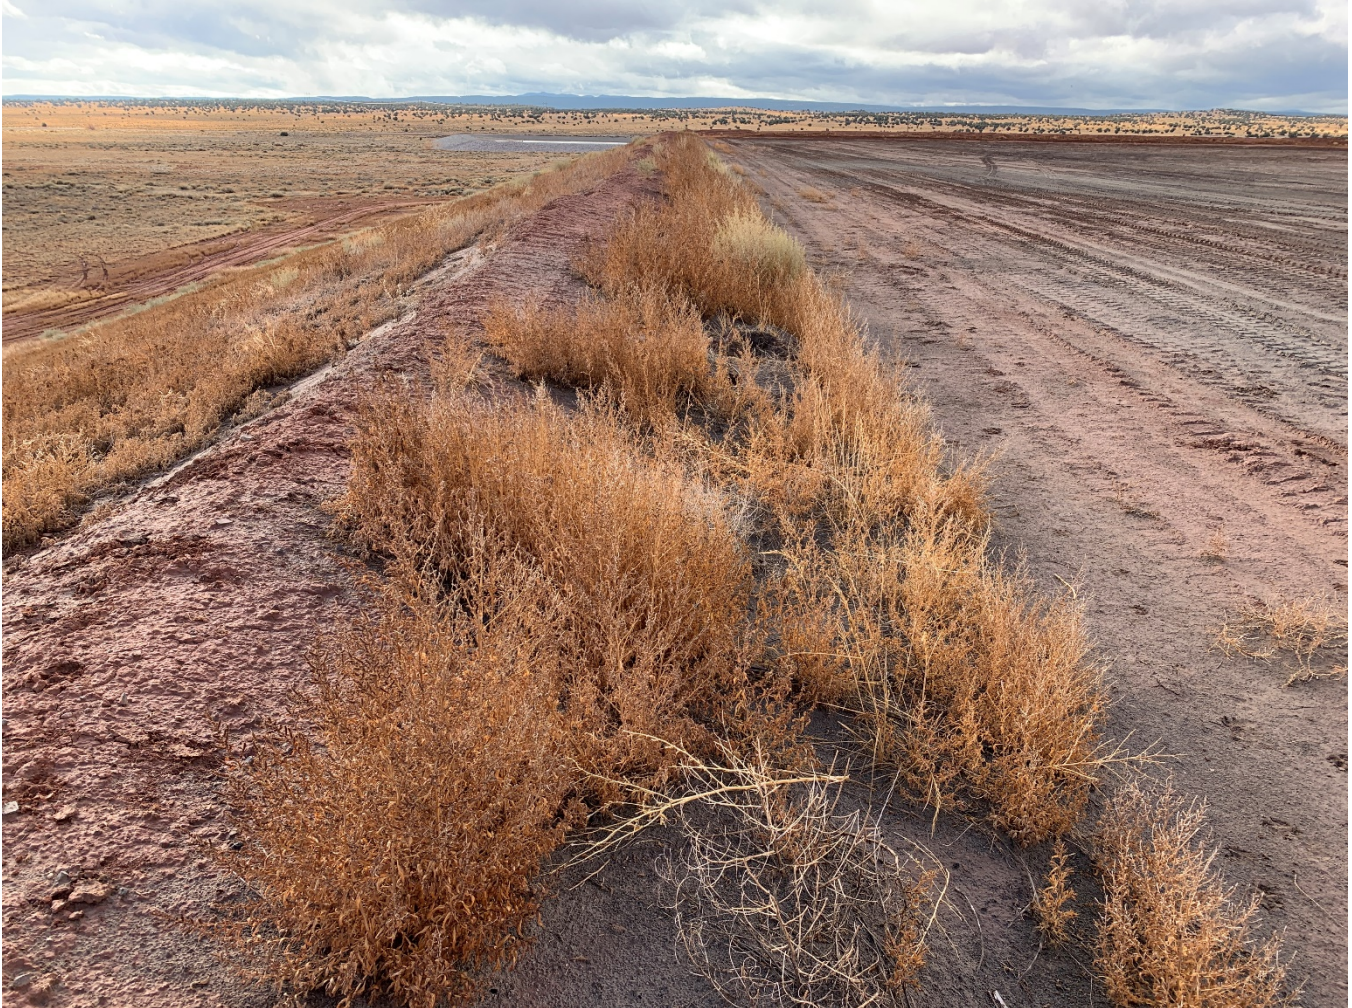
The embankment crest was observed to be in good condition. Cracking that would be indicative of ground movement was not observed along the embankment crest. Low areas that would be indicative of differential settlement were not observed along the embankment crest. The typical condition of the embankment crest is depicted in Photograph 2.

Photograph 2: Typical Embankment Crest Condition

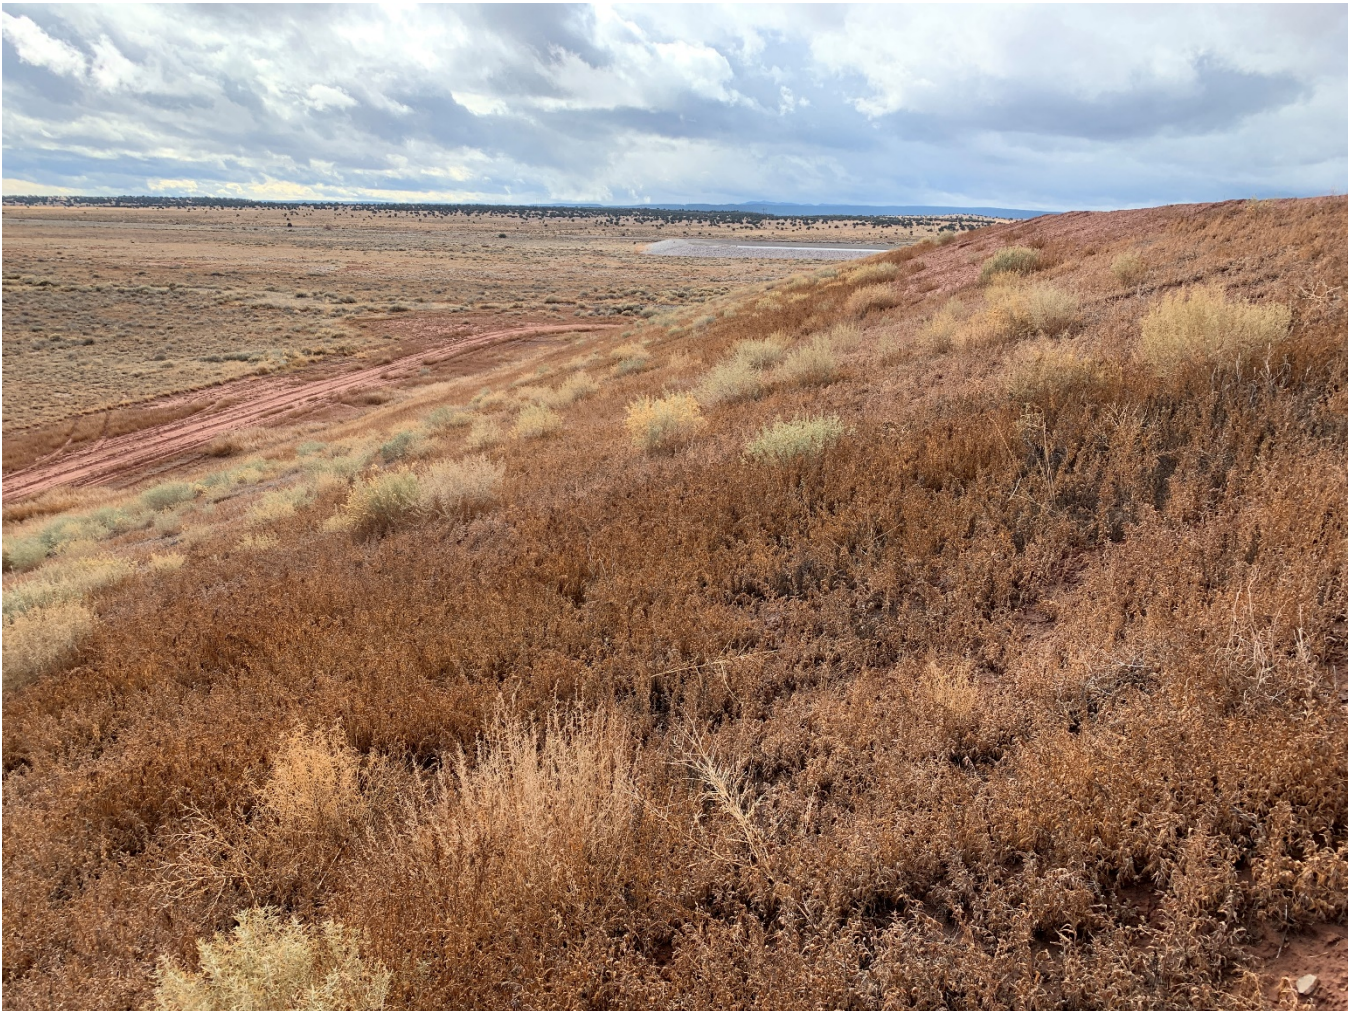
The embankment slopes were observed to be in good condition. Signs of ground movement, such as sloughing or sliding, cracking, subsidence, or bulging, were not observed on the embankment slopes. Evidence of significant or excessive erosion or slope deterioration was not observed on the embankment slopes. Minor rilling was observed on the south embankment slopes. The rilling does not pose a threat to structural stability. Golder recommended that rill repair efforts be deferred until the rills become more severe (at least 12 inches wide or 12 inches deep) or a reseeding attempt is planned, since repair efforts will disturb the vegetation and the crust remaining from the most recent hydraulic mulch application.

Native vegetation is being established on the embankment slopes, but establishment of a mature vegetative community is challenging given the climatic conditions at the site. Unusually poor or thriving vegetative growth was not observed on the embankment slopes, but there was generally less vegetative coverage on the south embankment slope than on the east embankment slope due to the southern aspect. No trees or woody vegetation were observed on the embankment slopes. No evidence of recent animal burrowing was observed on the embankment slopes. The typical condition of the embankment slopes is depicted in Photograph 3.

Photograph 3: Typical Embankment Slope Condition

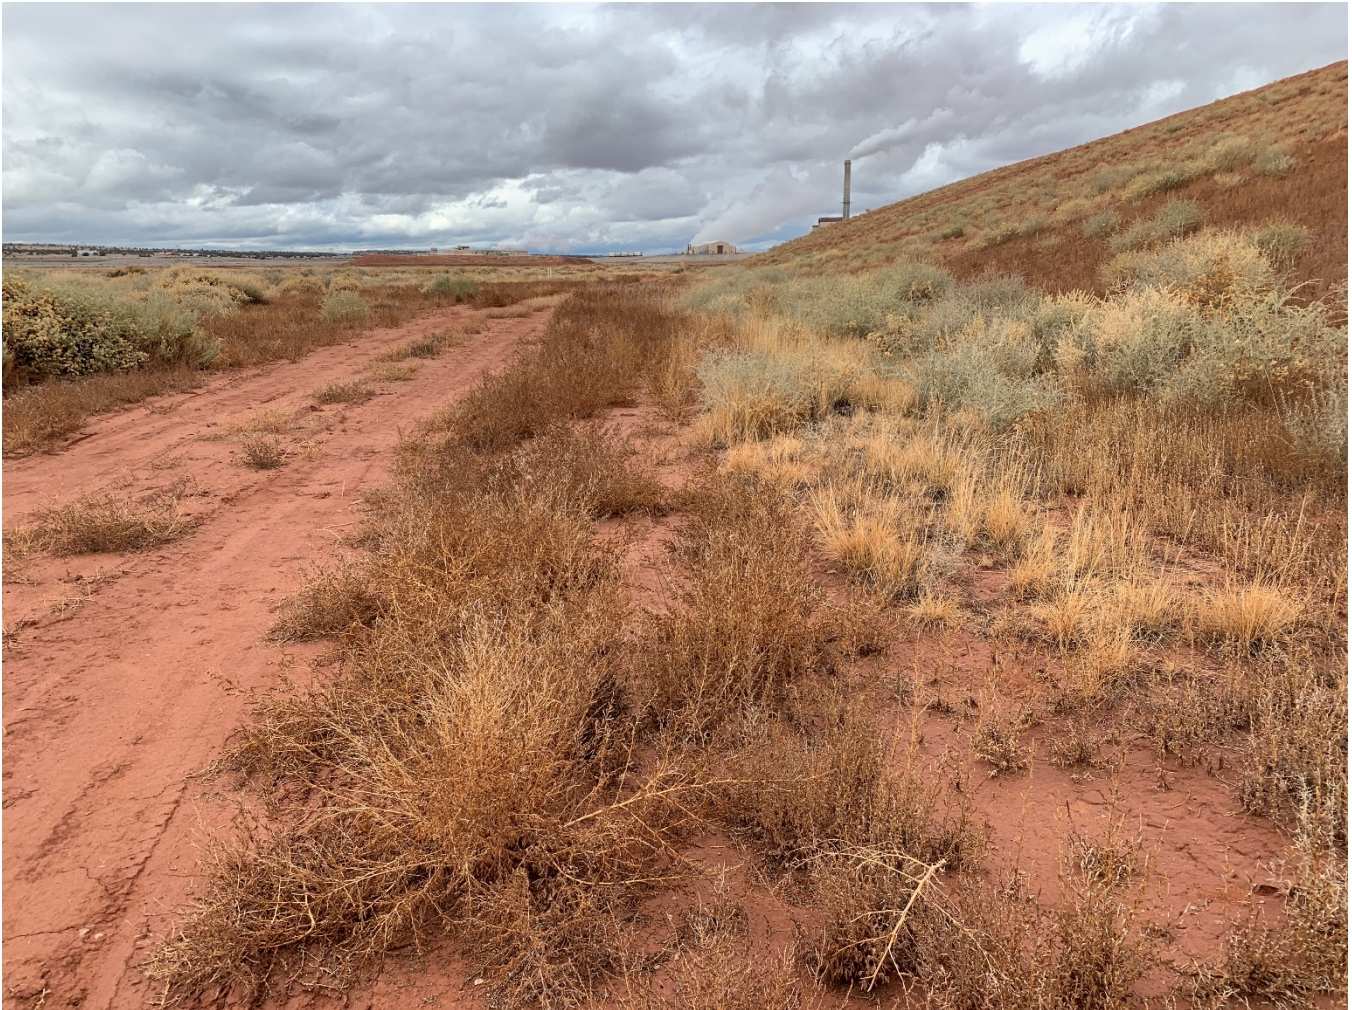
The embankment toe was observed to be in good condition. Signs of seepage, such as springs or boggy areas, were not observed along the embankment toe. The typical condition of the embankment toe is depicted in Photograph 4.

Photograph 4: Typical Embankment Toe Condition

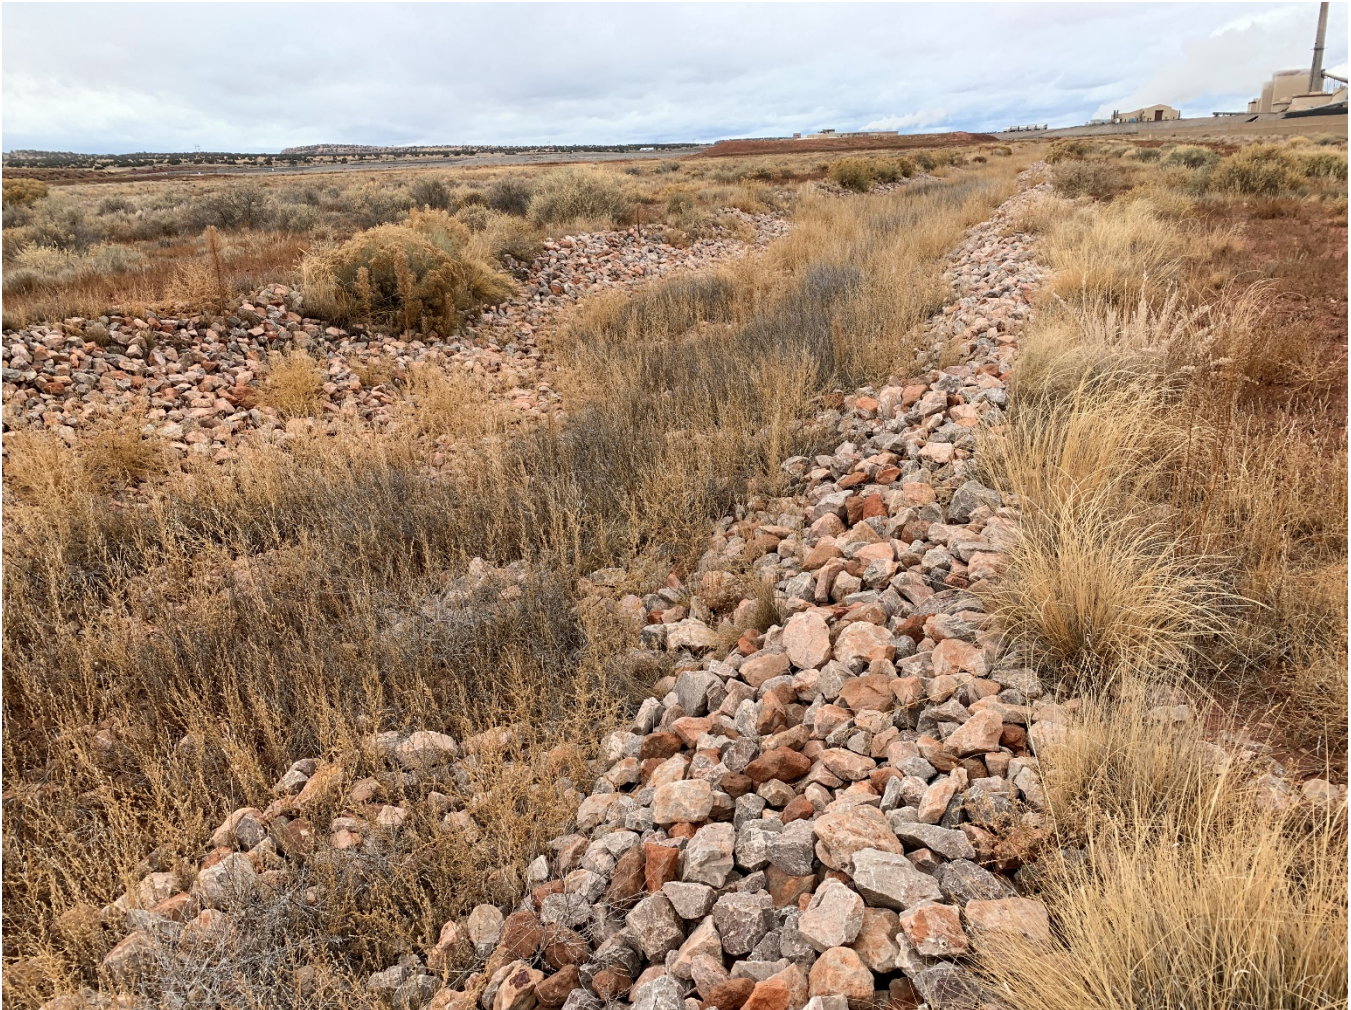
The storm water control features at the facility were observed to be in good condition. At the time of the visual observation, the only permanent storm water control feature at the facility was a run-on control channel that is designed to convey storm water from west to east along the south end of the facility. The run-on control channel is armored with riprap. Relatively large shrubs were observed to be growing in the flow path. The shrubs do not pose a threat to structural stability, but they should be removed periodically to help maintain the channel's flow capacity. The typical condition of the run-on control channel is depicted in Photograph 5.

Photograph 5: Typical Storm Water Channel Condition
