Active Coal Combustion Residuals Disposal Facility 2020 Annual Inspection

Escalante Generating Station

Tri-State Generation and Transmission Association, Inc.

January 15, 2021

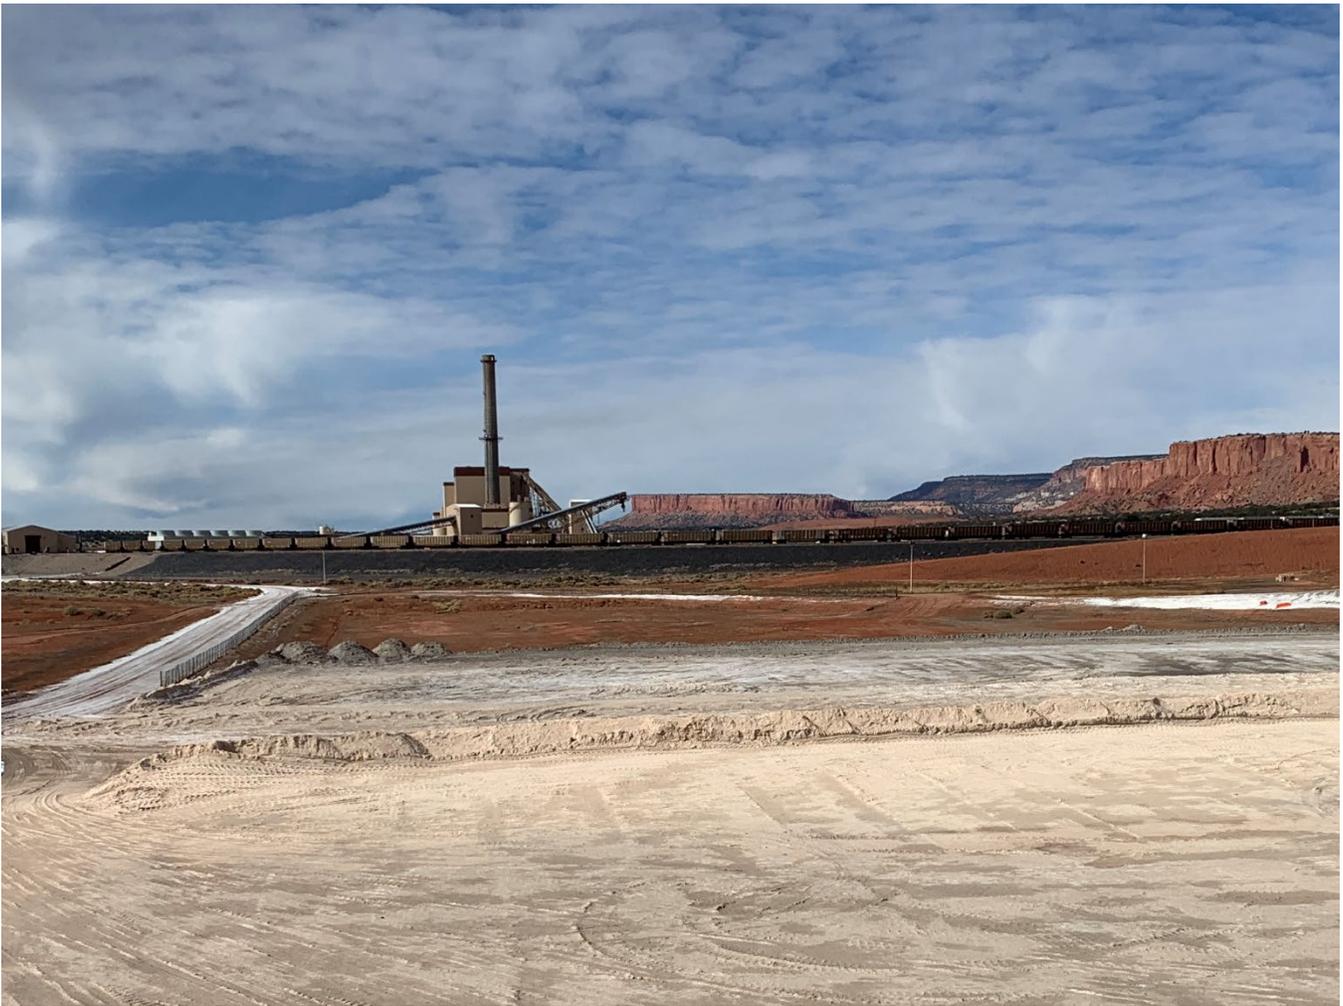
The deposition area was observed to be in good condition (refer to Appendix A for the deposition area location). Signs of ground movement, such as sloughing or sliding, cracking, subsidence, or bulging, were not observed in the deposition area. Deposition of CCRs was not occurring at the time of the visual observation. Appropriate grading had been established to collect CCR contact water within the deposition area. A berm that was several feet in height was in place around the perimeter of the deposition area to prevent migration of CCR contact water off of the deposition area. Fugitive dust was not observed at the time of the visual observation. The typical condition of the deposition area is depicted in Photograph 1.

Photograph 1: Typical Deposition Area Condition

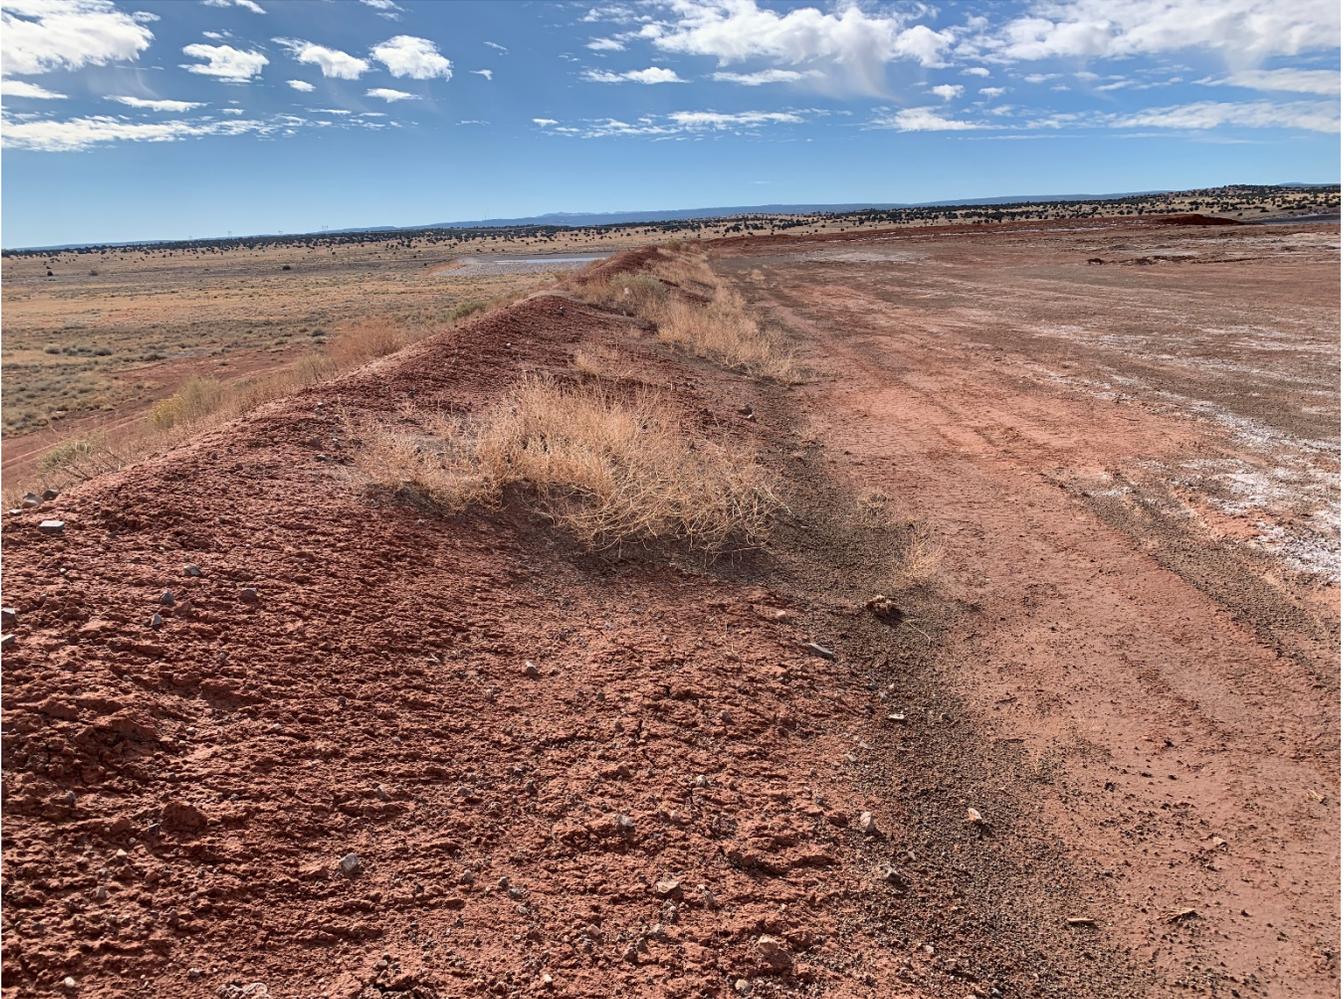
The embankment crest was observed to be in good condition. Cracking that would be indicative of ground movement was not observed along the embankment crest. Low areas that would be indicative of differential settlement were not observed along the embankment crest. The typical condition of the embankment crest is depicted in Photograph 2.

Photograph 2: Typical Embankment Crest Condition

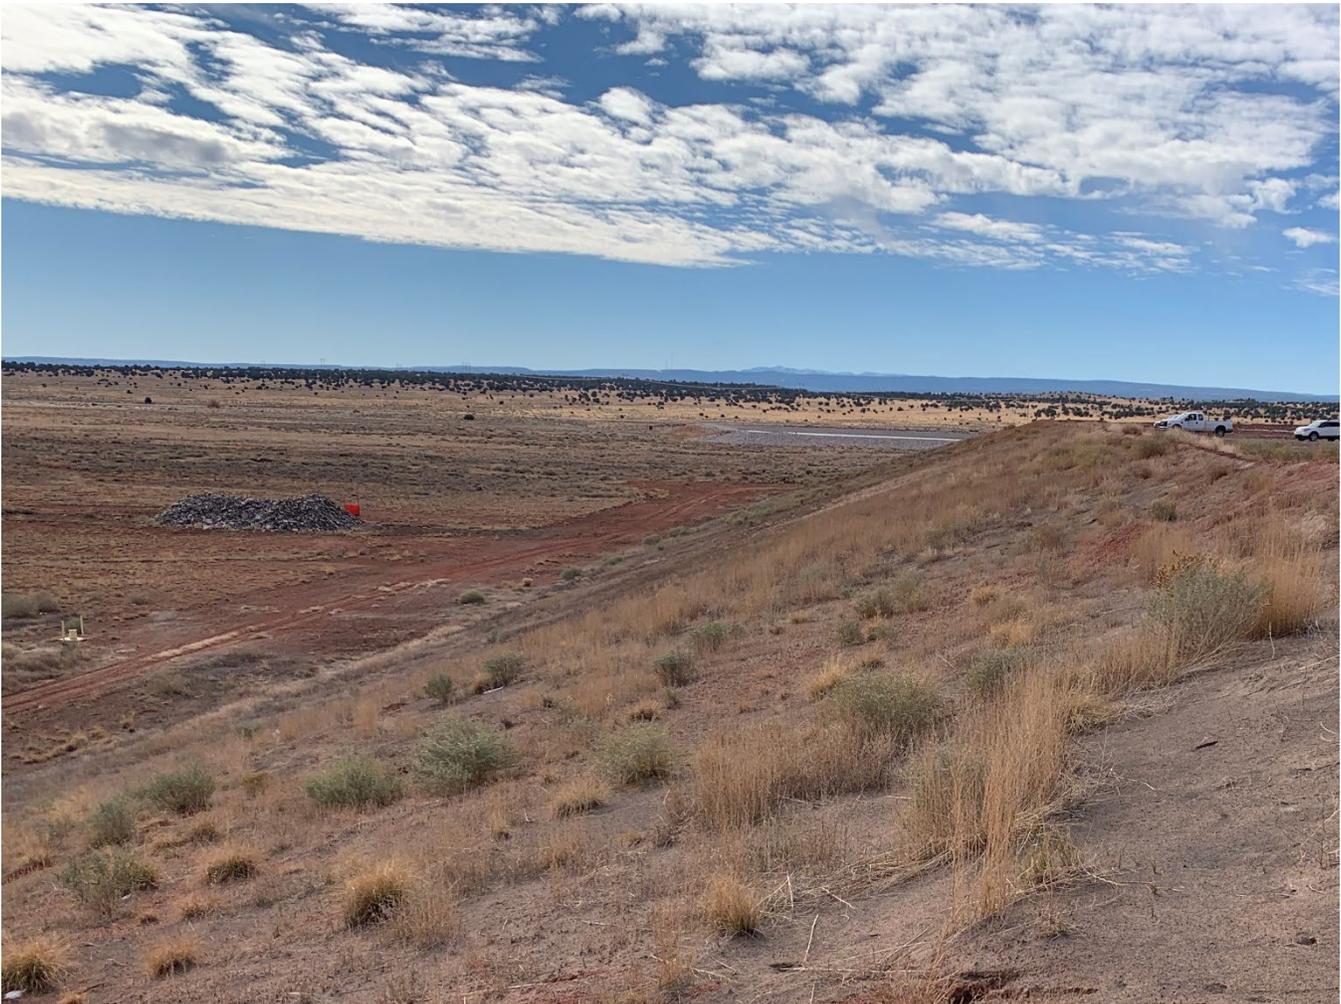
The embankment slopes were observed to be in fair condition. Signs of ground movement, such as sloughing or sliding, cracking, subsidence, or bulging, were not observed on the embankment slopes. Evidence of significant or excessive erosion or slope deterioration was not observed on the embankment slopes. Minor rilling was observed on the embankment slopes. The rilling does not currently pose a threat to structural stability, but it should be monitored and addressed if it becomes significant or excessive. Golder recommended that rill repair efforts be deferred until the rills become more severe or a reseeding attempt is planned, as repair efforts would disturb the vegetation and the crust remaining from the most recent hydraulic mulch application.

Native vegetation is present on the embankment slopes, but establishment of a mature vegetative community is challenging with the climatic conditions at the site. Unusually poor or thriving vegetative growth was not observed on the embankment slopes, but there was generally less vegetative coverage on the south embankment slope than on the east embankment slope due to the southern aspect. No trees or woody vegetation were observed on the embankment slopes. Minor animal burrowing was observed on the east embankment slope. The animal burrowing does not currently pose a threat to structural stability, but it should be monitored and addressed if it becomes significant or excessive. The typical condition of the embankment slopes is depicted in Photograph 3.

Photograph 3: Typical Embankment Slope Condition

| F. Embankment Slopes | | | | | | |
|--|---|---|---|---|---|---|
| F.3. Minor rilling was observed on embankment slopes. The rilling does not currently pose a threat to structural stability, but it should be monitored and addressed if it becomes significant or excessive. | | | | | | |
| F.5. Minor animal burrowing was observed on the east embankment slope. The animal burrowing does not currently pose a threat to structural stability, but it should be monitored and addressed if it becomes significant or excessive. | | | | | | |

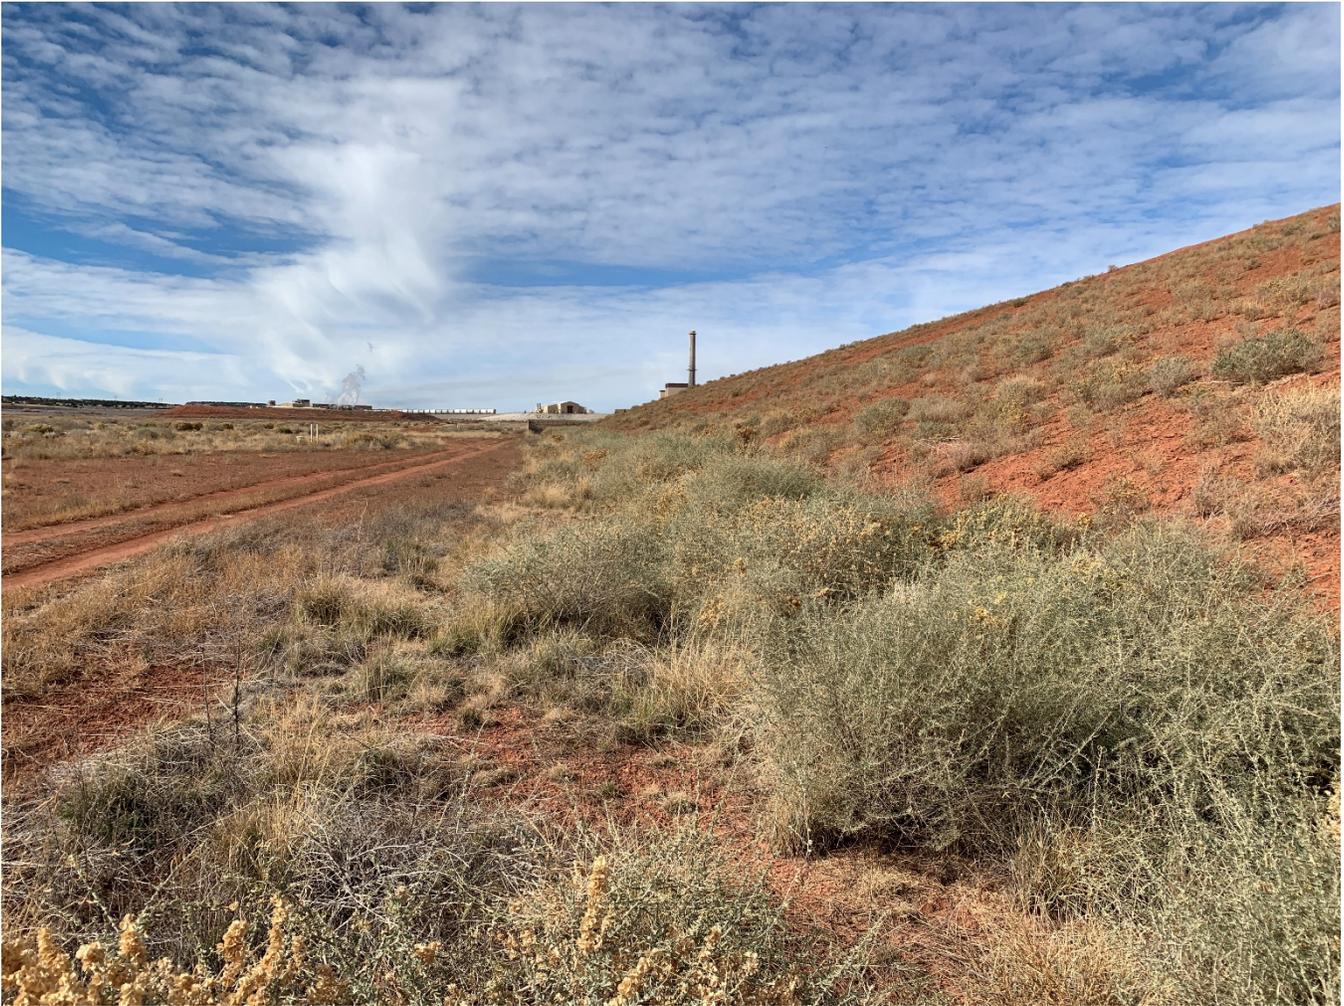
The embankment toe was observed to be in good condition. Signs of seepage, such as springs or boggy areas, were not observed along the embankment toe. The typical condition of the embankment toe is depicted in Photograph 4.

Photograph 4: Typical Embankment Toe Condition

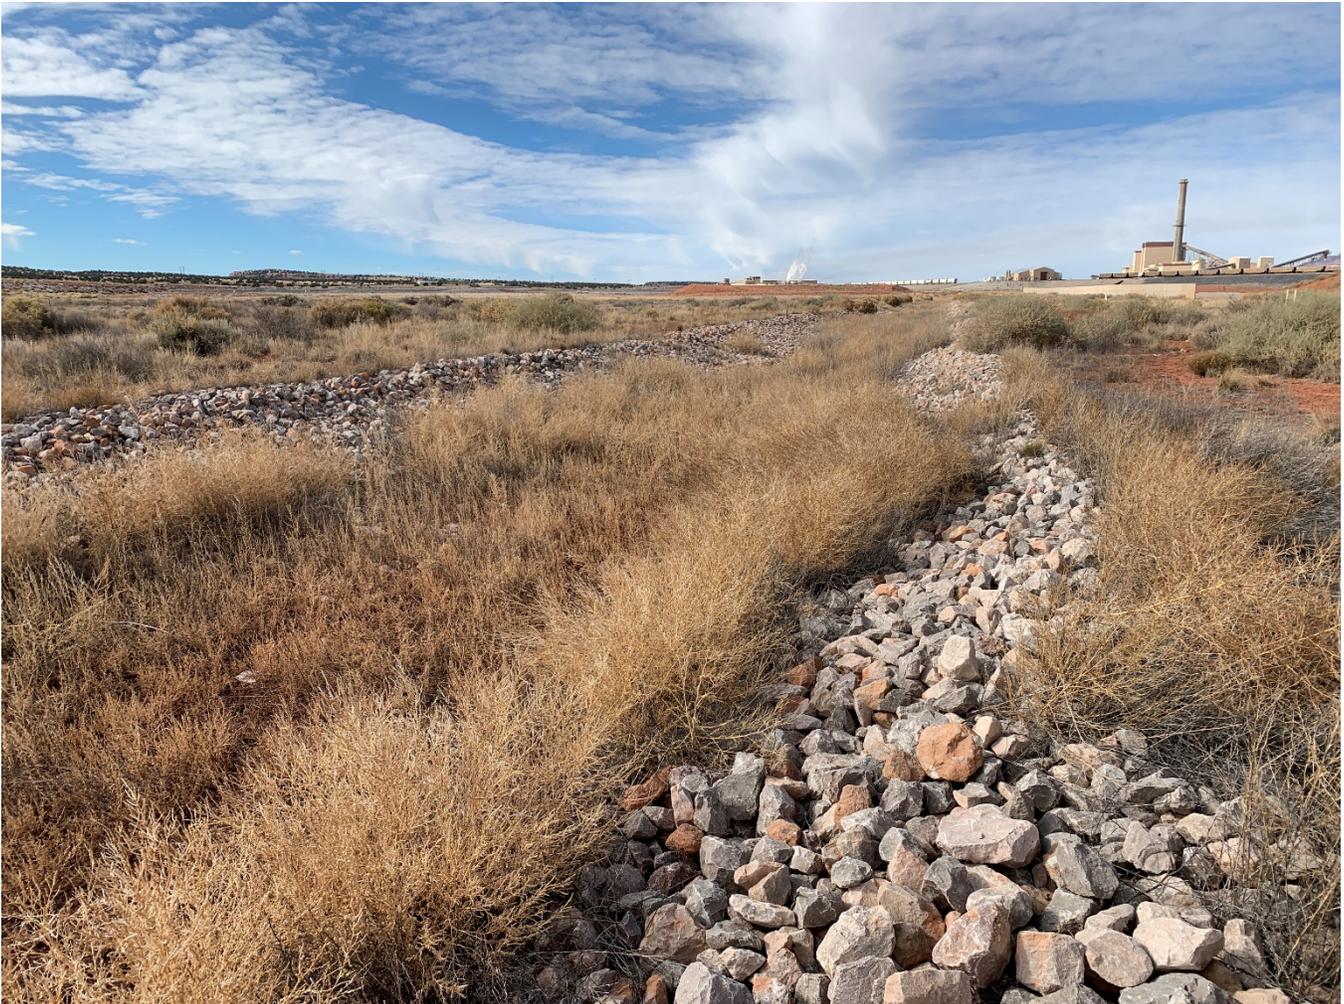
The storm water control features at the facility were observed to be in fair condition. At the time of the visual observation, the only permanent storm water control feature at the facility was a run-on control channel that is designed to convey stormwater from west to east along the south end of the facility. The run-on control channel is armored with riprap. Relatively large shrubs were observed to be growing in the flow path. The shrubs do not pose a threat to structural stability, but they should be removed periodically to help maintain the channel's flow capacity. The typical condition of the run-on control channel is depicted in Photograph 5.

Photograph 5: Typical Storm Water Channel Condition

| F. Embankment Slopes | | | | | | |
|--|---|---|---|---|---|---|
| H.1. Relatively large shrubs were observed to be growing in the run-on control channel. The shrubs do not pose a threat to structural stability, but they should be removed periodically. | | | | | | |

Golder completed an annual inspection of the active CCR disposal facility at Escalante Generating Station to address the requirements of 40 CFR 257.84. Signs of distress or malfunction of the facility were not observed, and appearances of actual or potential structural weakness of the facility were not identified. Facility maintenance activities that should be carried out as the need is indicated by weekly inspections conducted in accordance with 40 CFR 257.84(a) include control of burrowing animals, repair of significant erosion damage on embankment slopes, establishment of suitable vegetation on embankment slopes, control and containment of CCR contact water, periodic removal of shrubs from the run-on control channel, and promotion of positive stormwater drainage away from the facility.
