# Coal Combustion Residuals Landfill Annual Inspection

## *Nucla Station Ash Disposal Facility*

**Tri-State Generation and Transmission Association, Inc.**

December 17, 2021

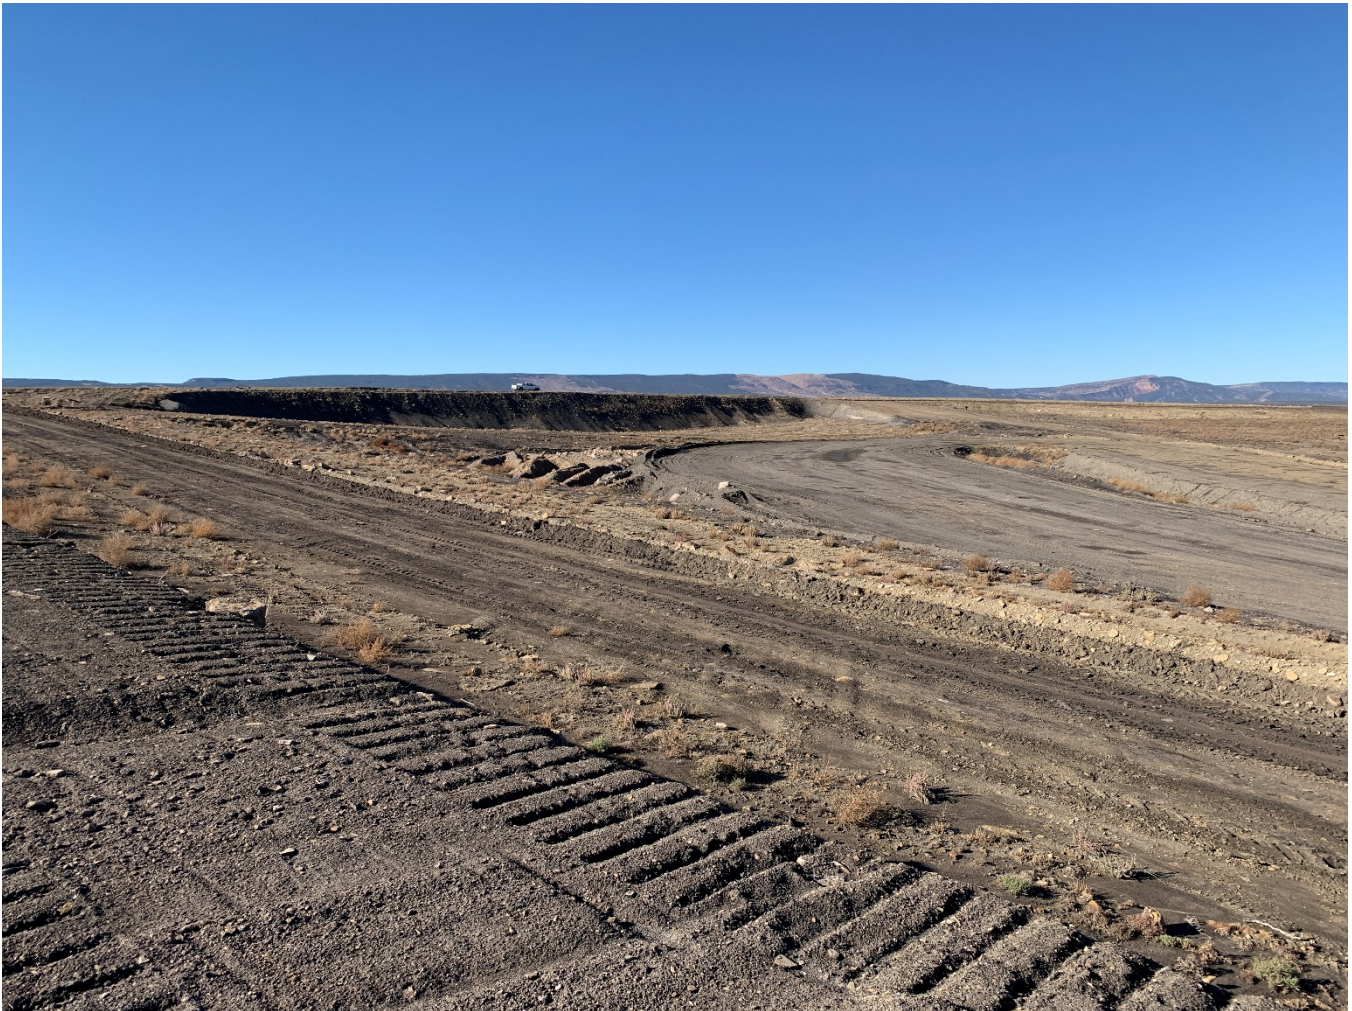
The deposition area was observed to be in good condition (Appendix A indicates the location of the deposition area at the time of the visual observation on October 28, 2021). Signs of ground movement, such as sloughing or sliding, cracking, subsidence, or bulging, were not observed in the deposition area. No deposition was occurring at the time of the visual observation. The deposition area was appropriately graded so that ash contact water would collect and be contained within the deposition area. A small amount of ponded water resulting from a recent rain event was observed within the deposition area (Appendix A indicates the location of the ponded water at the time of the visual observation). A berm that was several feet in height was in place around the perimeter of the deposition area to prevent migration of ash contact water out of the deposition area. Fugitive dust was not observed in the deposition area. The typical condition of the deposition area is depicted in Photograph 1.

**Photograph 1: Typical Deposition Area Condition**

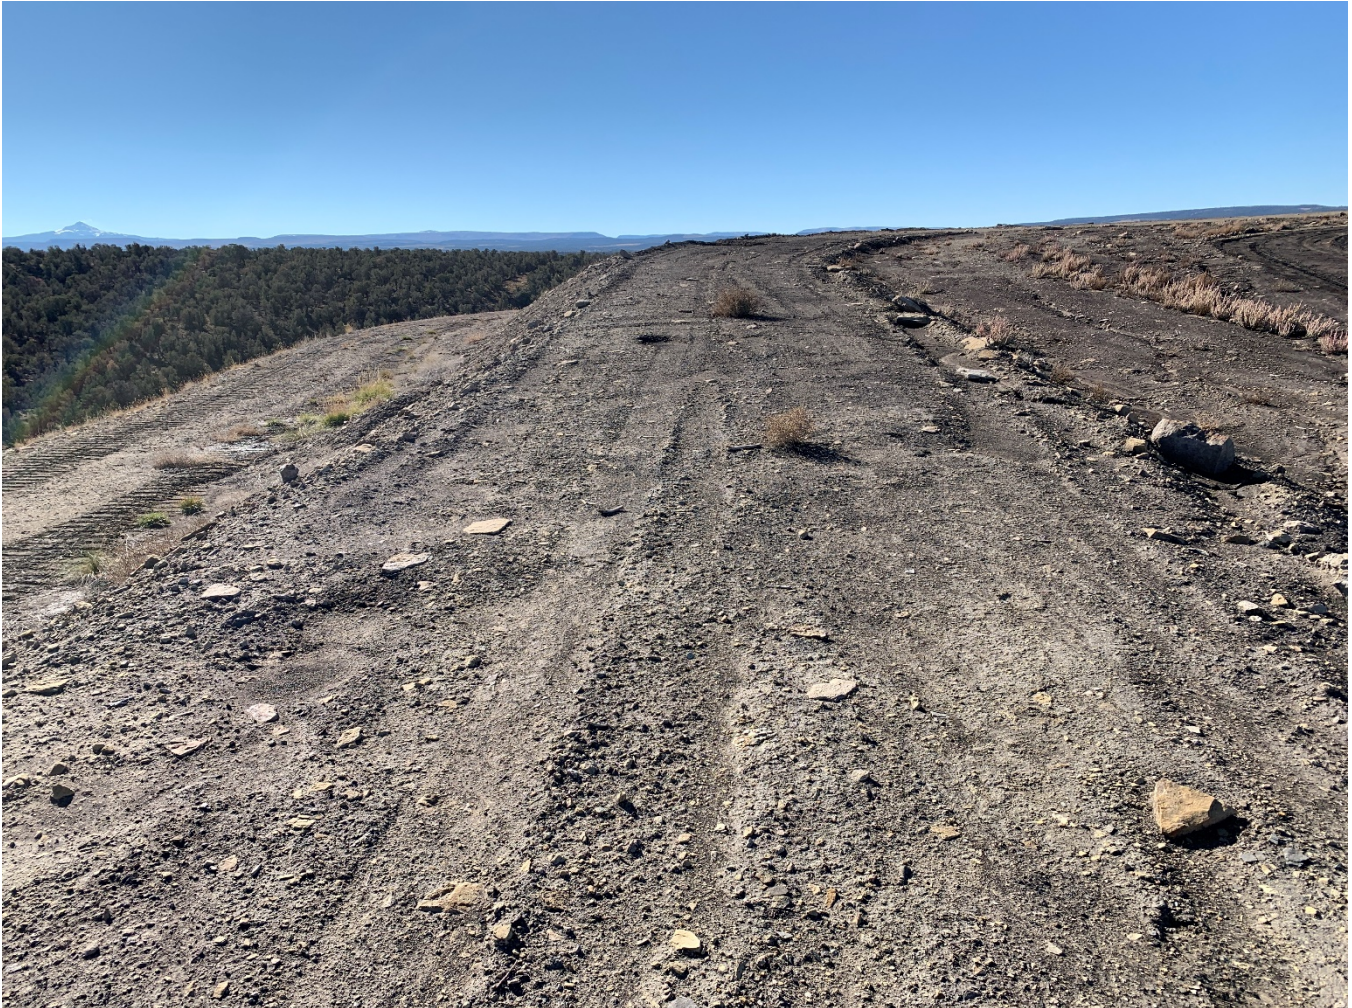
The embankment crest was observed to be in good condition. Cracking that would be indicative of ground movement was not observed along the embankment crest. Low areas that would be indicative of differential

**Photograph 2: Typical Embankment Crest Condition**

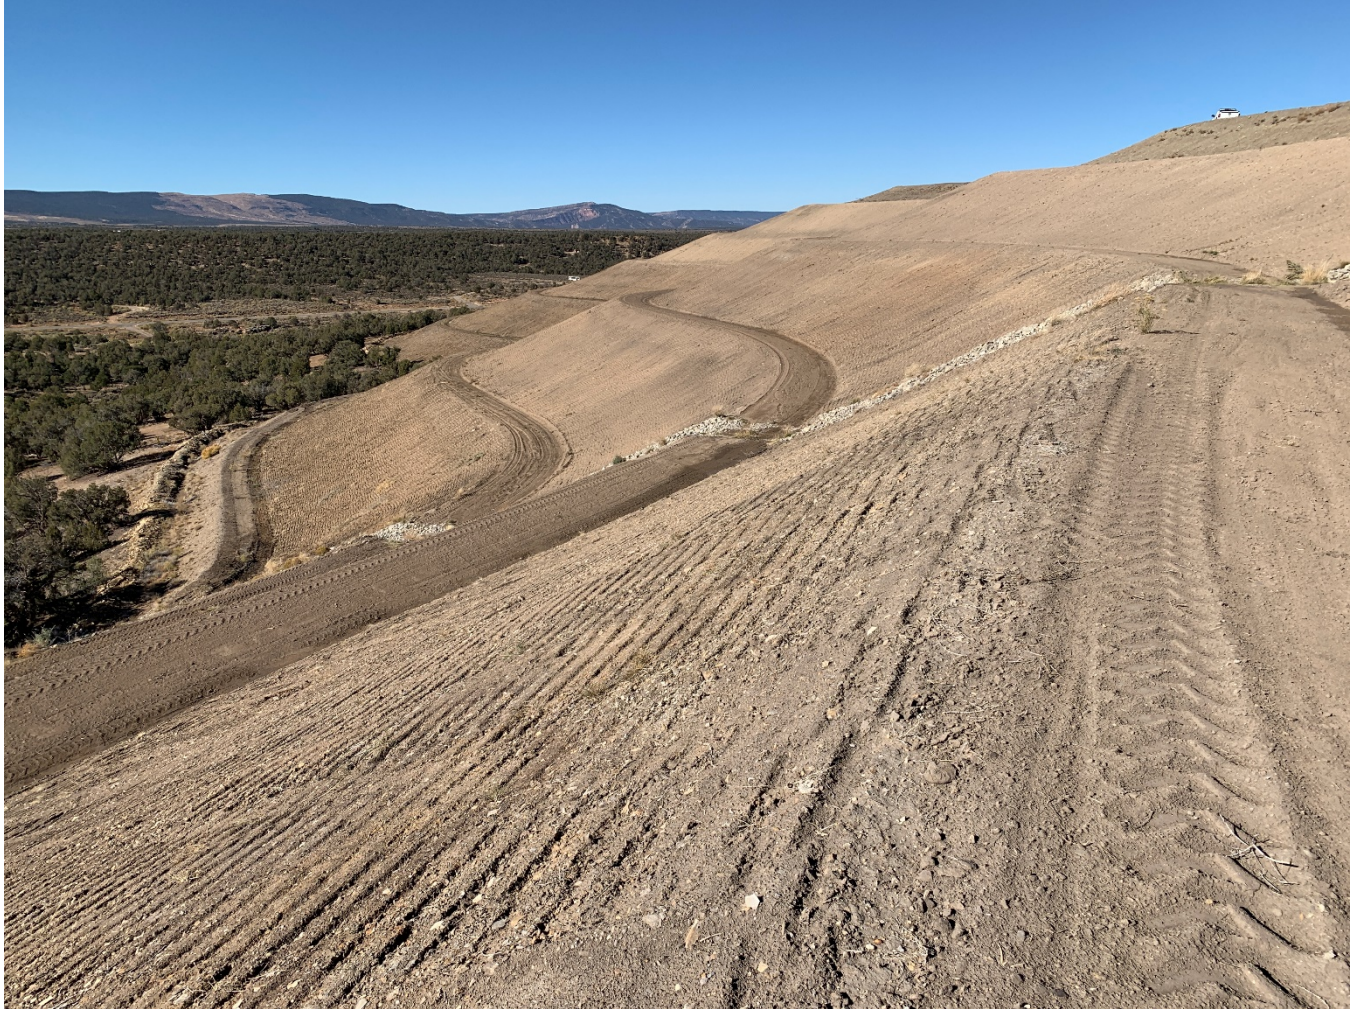
**Photograph 3: Typical Embankment Slope Condition (South Embankment Slopes)**

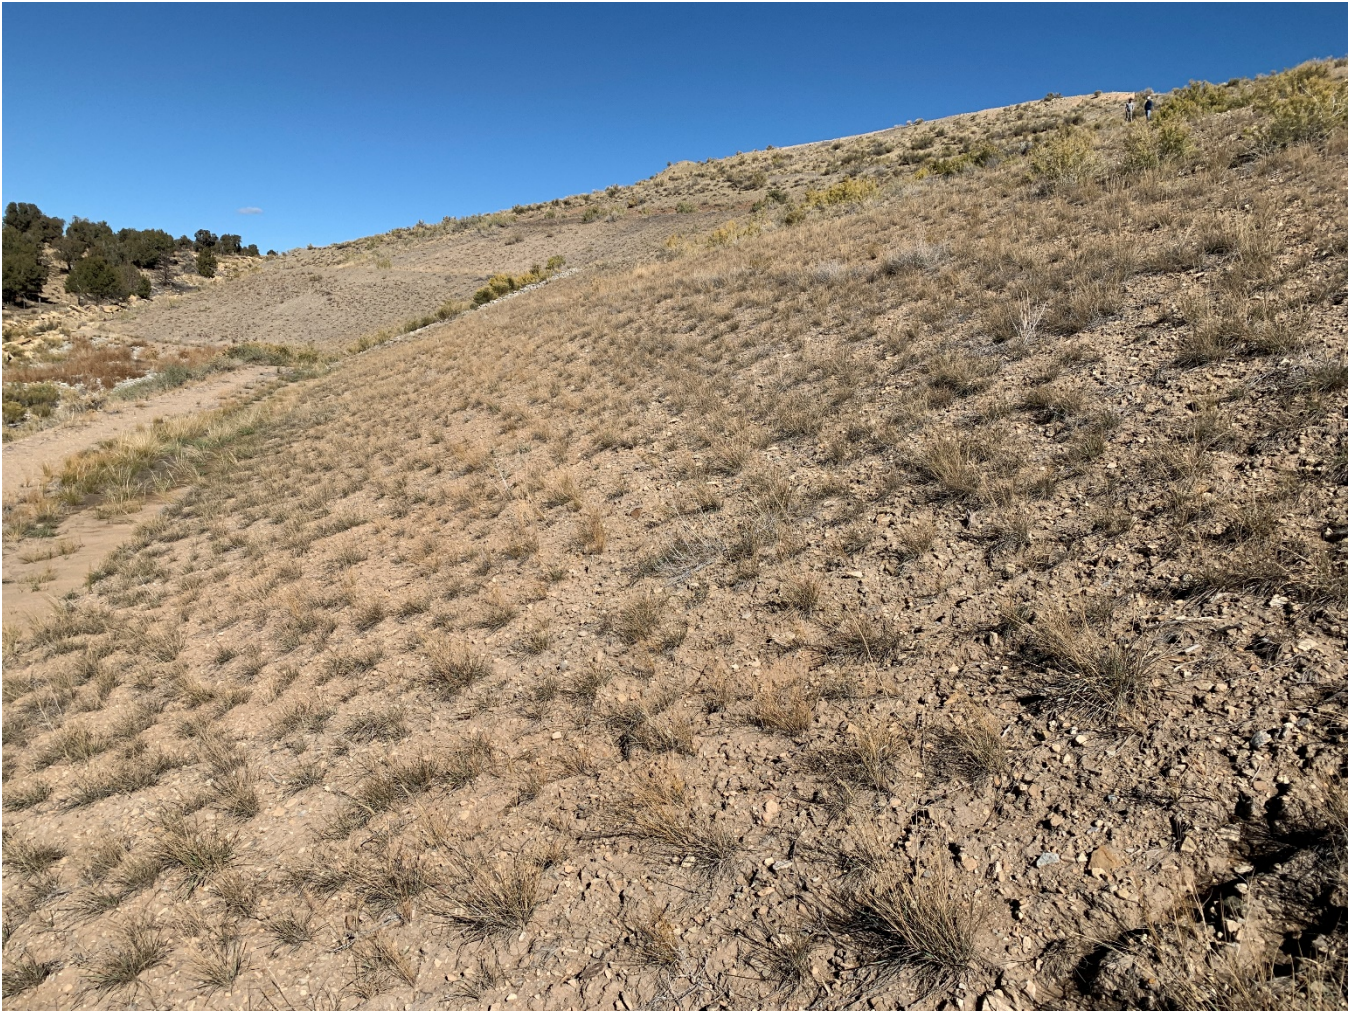
**Photograph 4: Typical Embankment Slope Condition (West, North, and East Embankment Slopes)**

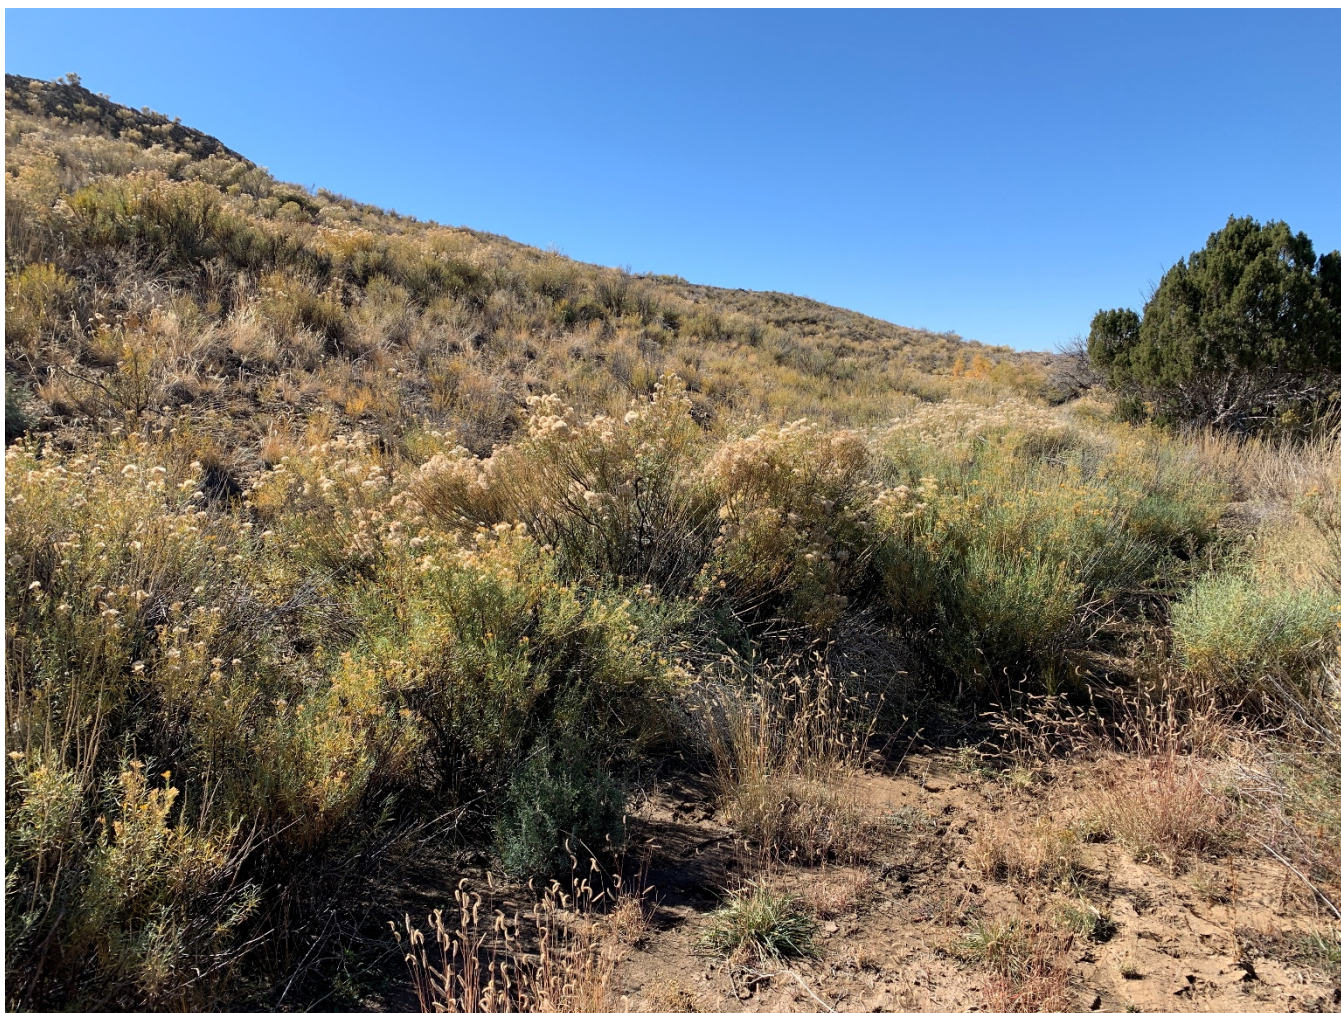
The embankment toe was observed to be in good condition. Signs of seepage, such as springs or boggy areas, were not observed along the embankment toe. The typical condition of the embankment toe is depicted in Photograph 5.

**Photograph 5: Typical Embankment Toe Condition**

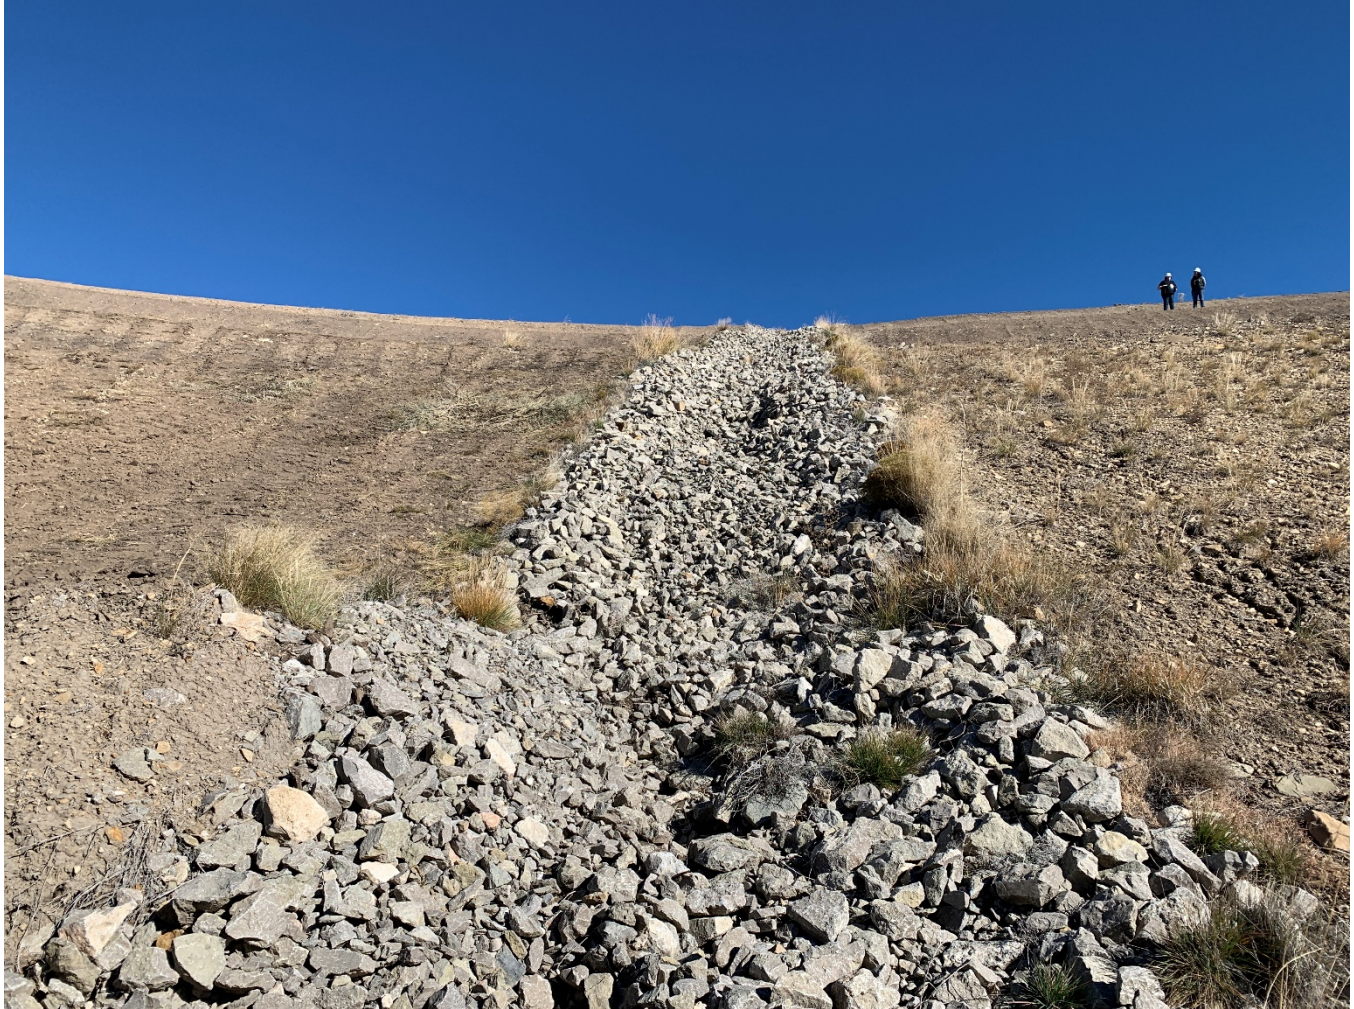
**Photograph 6: Typical Downchute Channel Condition**

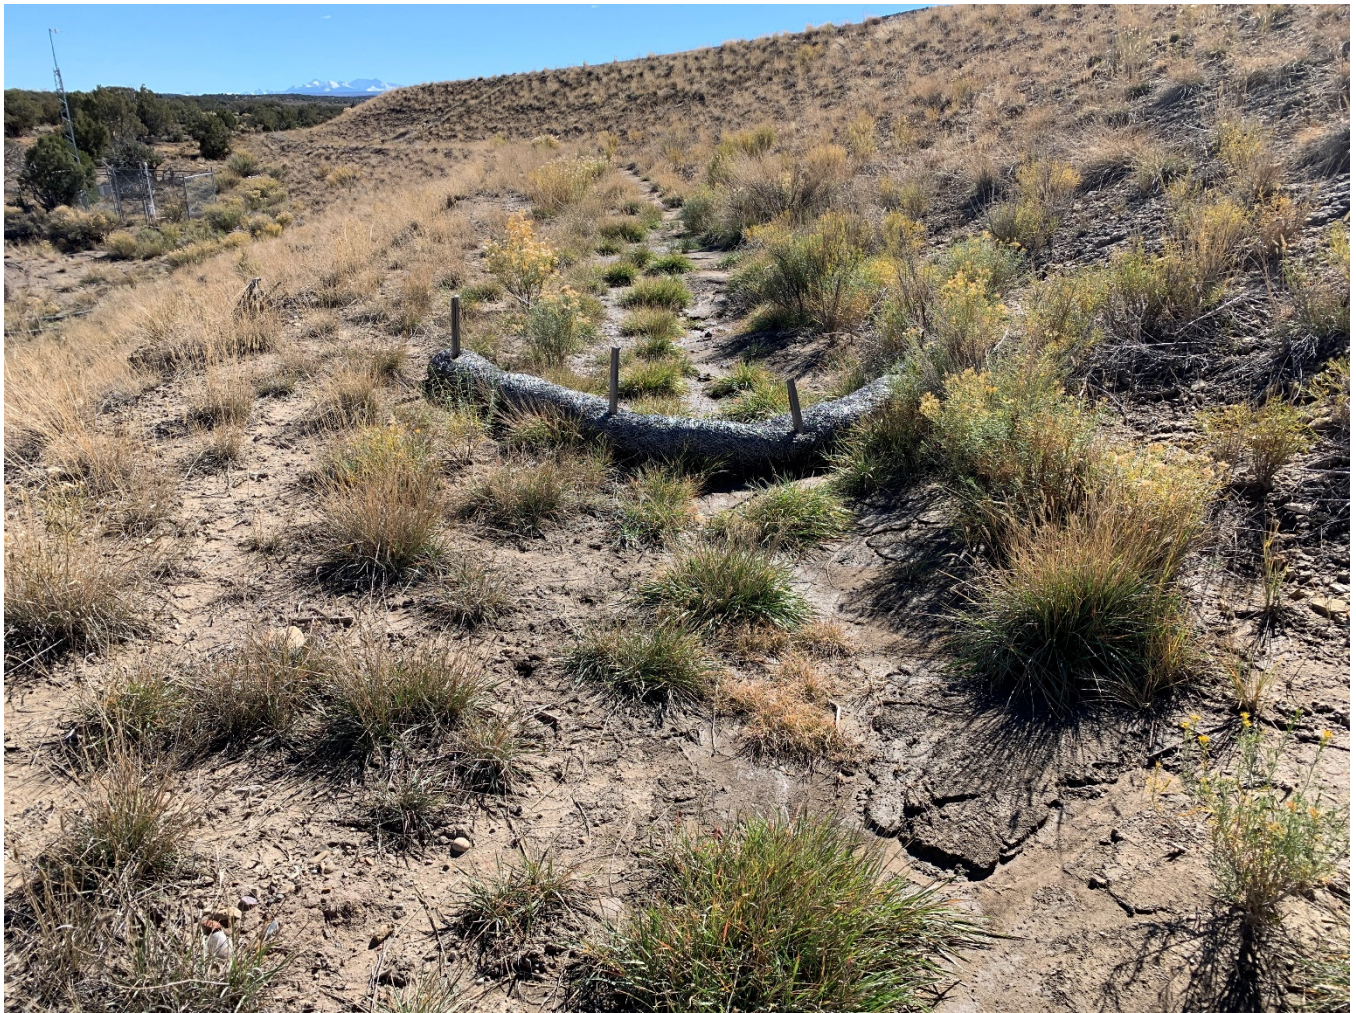
**Photograph 7: Typical Terrace Channel Condition**

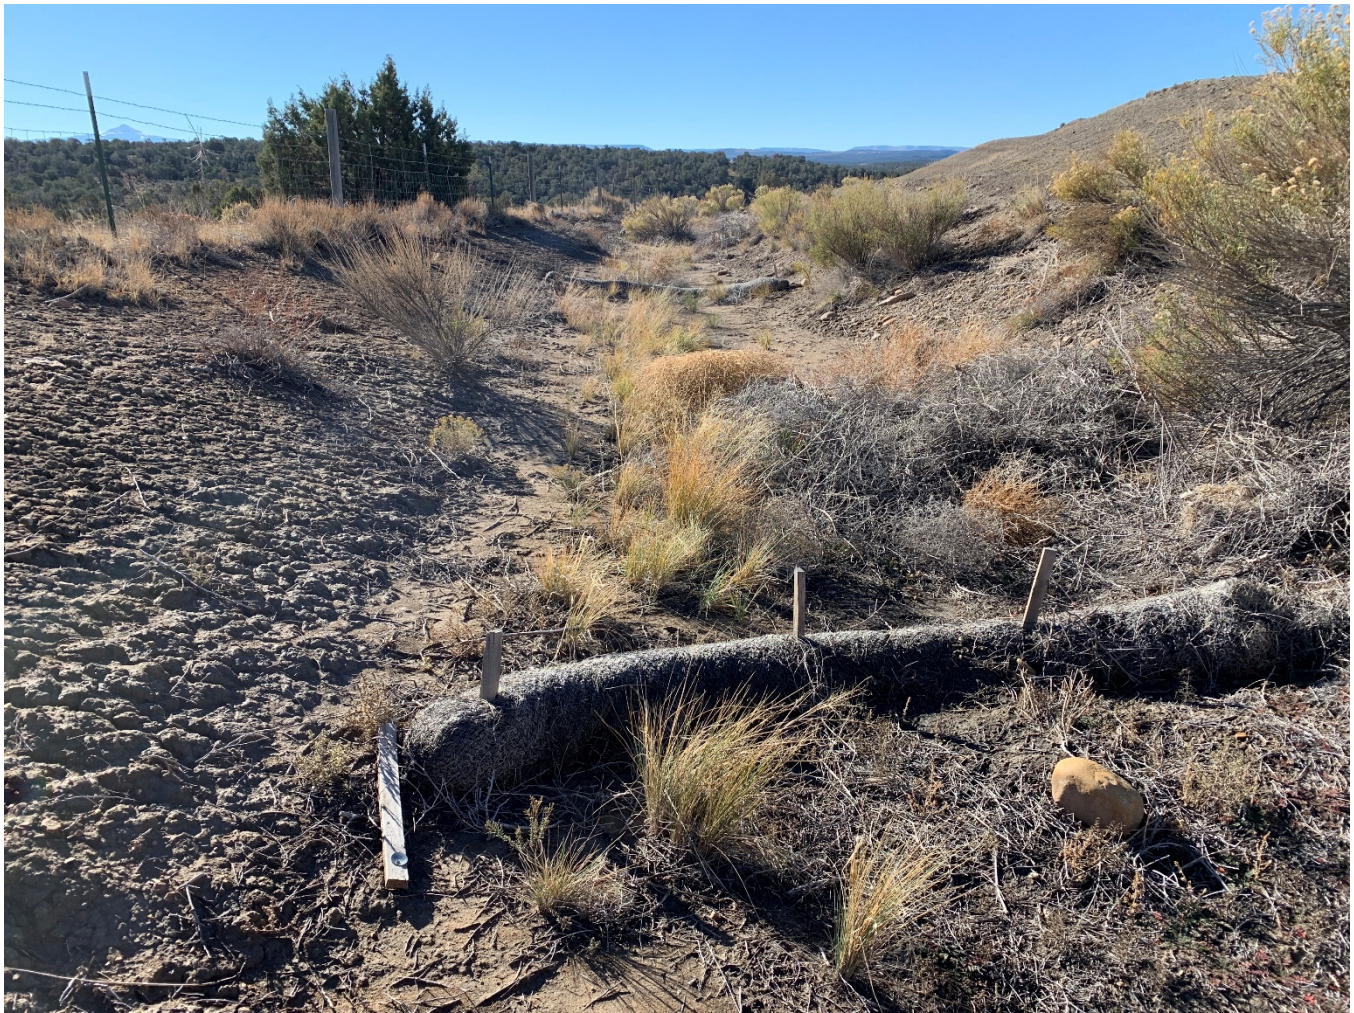
**Photograph 8: Typical Perimeter Channel Condition**

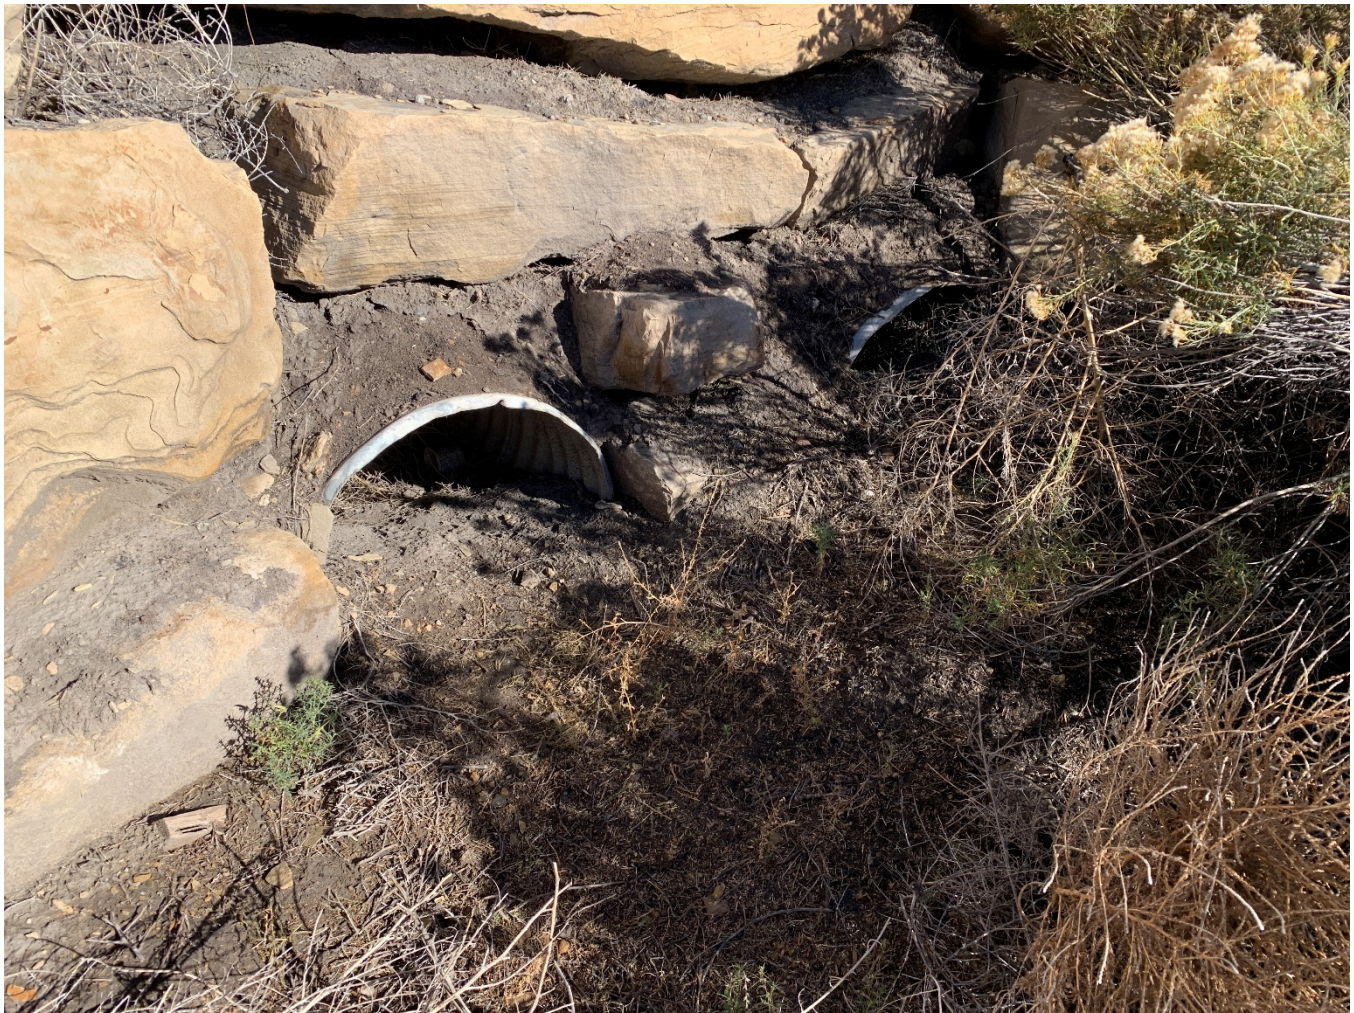
as shown in Photograph 9 (Appendix A indicates the location of the sediment buildup). Debris buildup was observed at the same location during the annual inspection in 2020 and was removed in May 2021, according to Tri-State's records. During the visual observation on October 28, 2021, Golder recommended that Tri-State remove the recently accumulated sediment and consider improvements to the perimeter channel downstream of the culverts to ensure that the elevations and slope of the channel invert are adequate to maintain positive drainage and limit sedimentation. The sediment does not pose a threat to structural stability and did not impact Golder's ability to inspect the facility.

**Photograph 9: Sediment Buildup in the East Perimeter Channel at the Downstream Ends of the Culverts**

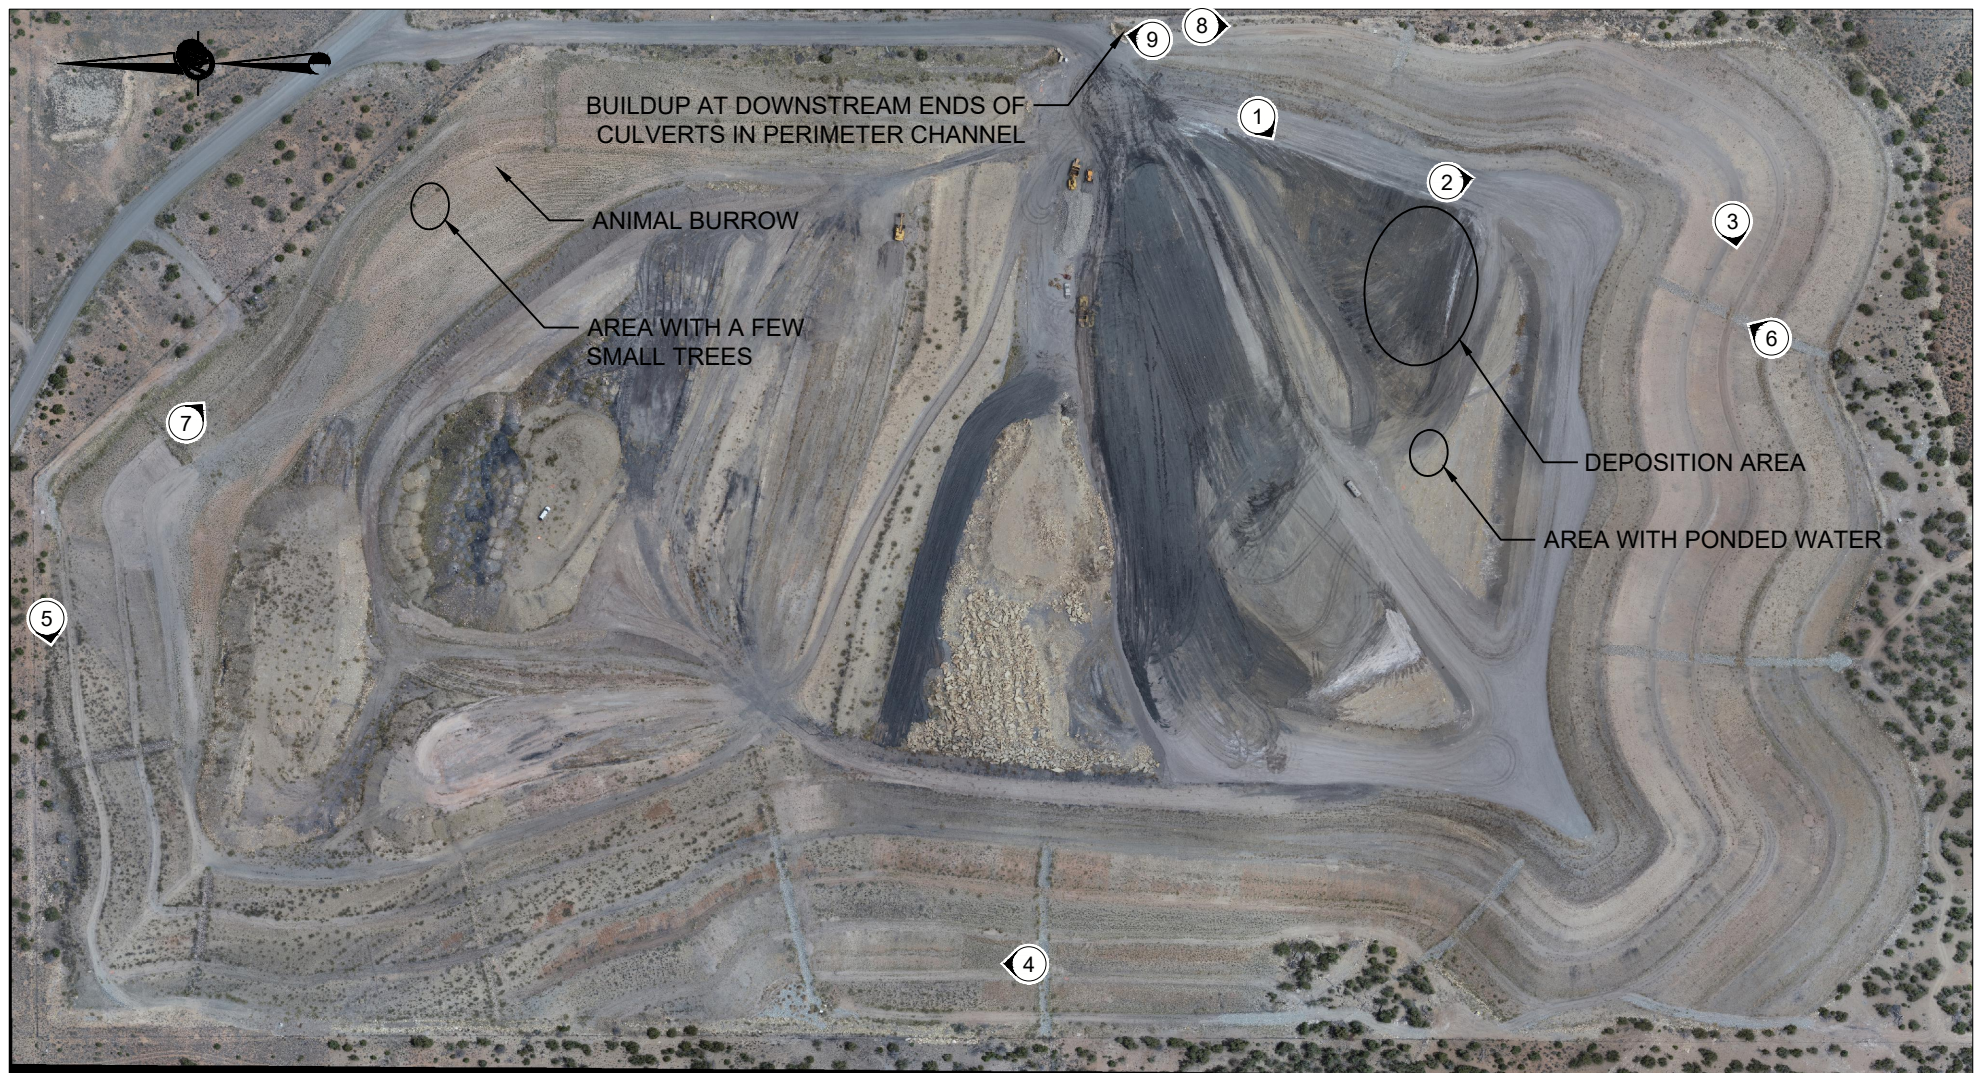
## **ANNUAL INSPECTION FORM** **TRI-STATE GENERATION AND TRANSMISSION ASSOCIATION** **NUCLA STATION ASH DISPOSAL FACILITY**

a.    Sediment buildup at downstream ends of culverts under site entrance road						
b.						
c.						
d.						
e.						
<b>J. Elaboration</b>						
<i>Identify the specific item number (for instance, F.2.) and elaborate on each deficiency or issue identified during the annual inspection. Attach documentation (photographs or sketches) if practical.</i>						
H.3. Sediment has accumulated again at the downstream ends of the culverts in the location shown on page 3. The sediment does not pose a stability concern but could reduce the hydraulic capacity of the culverts. Golder recommended removing the sediment and considering improvements to the perimeter channel downstream of the culverts to ensure that the elevations and slope of the channel invert are adequate to maintain positive drainage and limit sedimentation.						
F.4. A few small trees were observed at the location shown on page 3. Golder recommended removing the trees. The trees do not currently pose a stability concern.

F.5. One animal burrow was observed at the location shown on page 3. There was no evidence of recent burrowing activity. The burrow does not currently pose a stability concern and does not require action at this time.
