Active Coal Combustion Residuals Disposal Facility 2022 Annual Inspection

Escalante Station

21453425.002-001-RPT-0

January 13, 2023

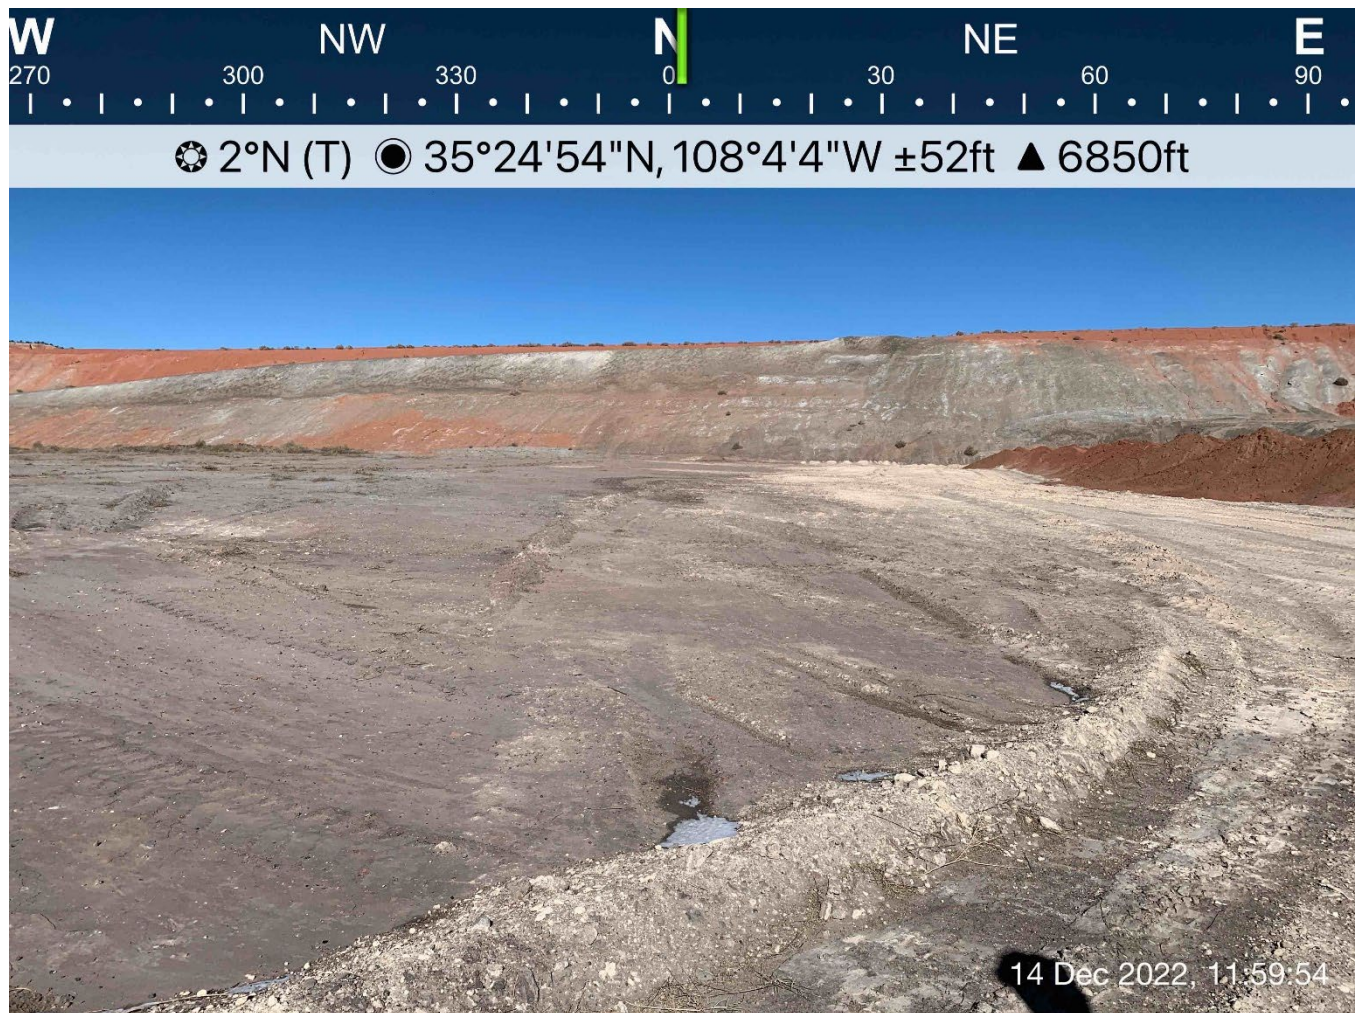
Photograph 1: Typical Condition of Deposition Area

The deposition area was observed to be in good condition. Appendix A shows the deposition area location at the time of the visual observation. Signs of ground movement, such as sloughing or sliding, cracking, subsidence, or bulging, were not observed in the deposition area. Appropriate grading had been established to collect CCR contact water within the deposition area. A berm that was several feet in height was in place around the perimeter of the deposition area to prevent migration of CCR contact water out of the deposition area. Fugitive dust was not observed at the time of the visual observation. The typical condition of the deposition area is depicted in Photograph 1.

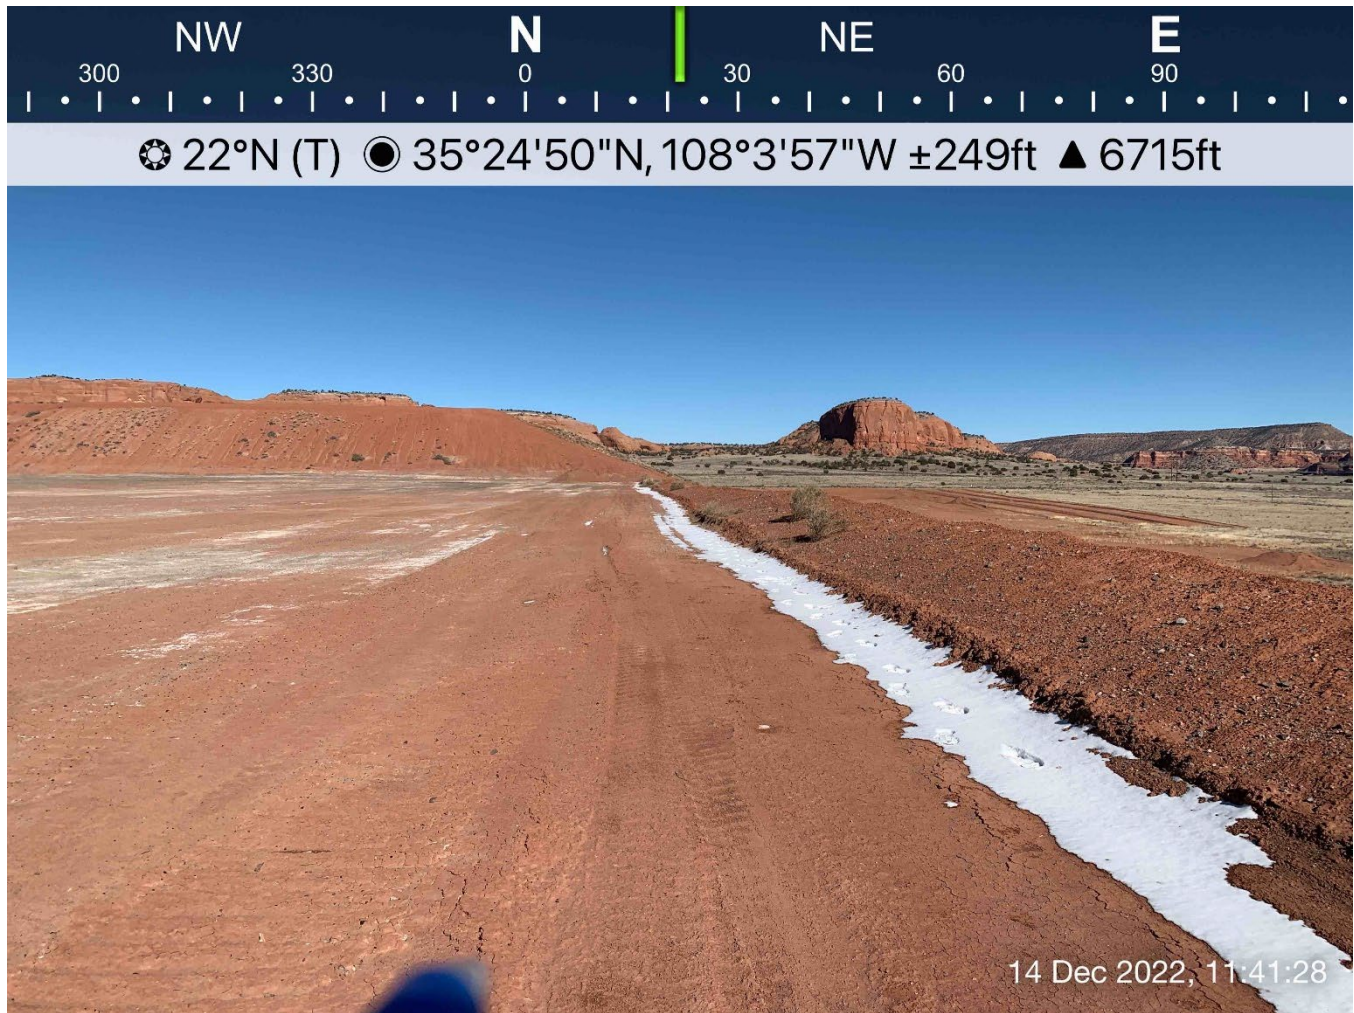
Photograph 2: Typical Condition of Embankment Crest

The embankment crest was observed to be in good condition. Cracking that would be indicative of ground movement was not observed along the embankment crest. Low areas that would be indicative of differential settlement were not observed along the embankment crest. The typical condition of the embankment crest is depicted in Photograph 2.

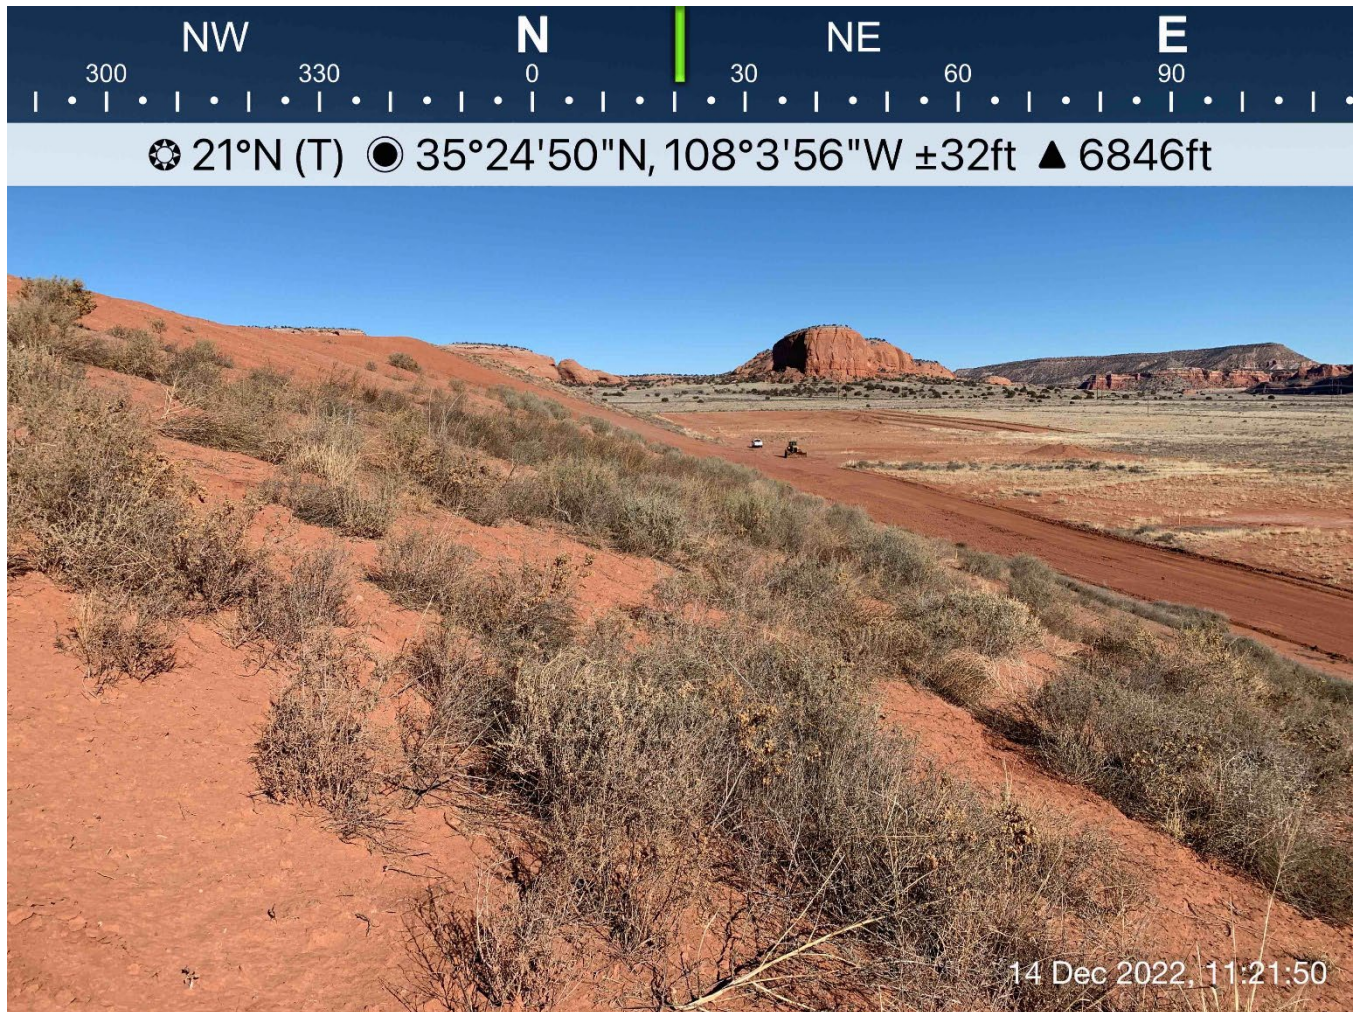
The embankment slopes were observed to be in fair condition. Signs of ground movement, such as sloughing or sliding, subsidence, or bulging, were not observed on the embankment slopes. One area with longitudinal cracking was noted near the crest of the south embankment, where shown in Appendix A. The cracking was believed to be caused by regrading activities immediately north of the location of the cracking (inside the embankment crest), which resulted in a change in stress conditions and some minor displacement. The cracking is not indicative of a threat to structural stability and is not disrupting the operation or safety of the facility. Evidence of wind-deposited CCR particles was observed on the northern segment of the east embankment slope. At the time of the site visit, Tri-State had recently recontoured CCRs on the top surface immediately west of this area and installed an earthen mound to block the wind in an effort to reduce migration of windblown CCR particles. The wind-deposited CCRs are not disrupting the operation or safety of the facility, but the effectiveness of the mitigation measures should be monitored and the issue should be further addressed if needed. Minor rilling was also observed on the embankment slopes, with more significant rills near the western end of the south embankment slope. The severity of the rilling was observed to be about the same as in October 2021. The rilling does not currently pose a threat to structural stability and is not disrupting the operation or safety of the facility, but

Native vegetation was observed on the embankment slopes, except on the northern segment of the east embankment slope where Tri-State had recently used a bulldozer to remove wind-deposited CCRs. This area will need to be seeded to re-establish native vegetation. Establishment of a mature vegetative community continues to be challenging given the climatic conditions at the site. Unusually poor or thriving vegetative growth was not observed on the embankment slopes, but there was generally less vegetative coverage on the south embankment slope than on the east embankment slope due to the southern aspect. No trees were observed on the embankment slopes. Active animal burrows were not observed on the embankment slopes. The typical condition of the embankment slopes is depicted in Photograph 3.

it should be monitored and addressed if it becomes excessive. While localized repairs may become necessary for rills that become excessively deep or wide, WSP recommends that broad-scale rill repair efforts be deferred until the rills become more severe or a reseeding attempt is planned, as repair efforts would disturb the vegetation and the crust remaining from the most recent hydraulic mulch application.

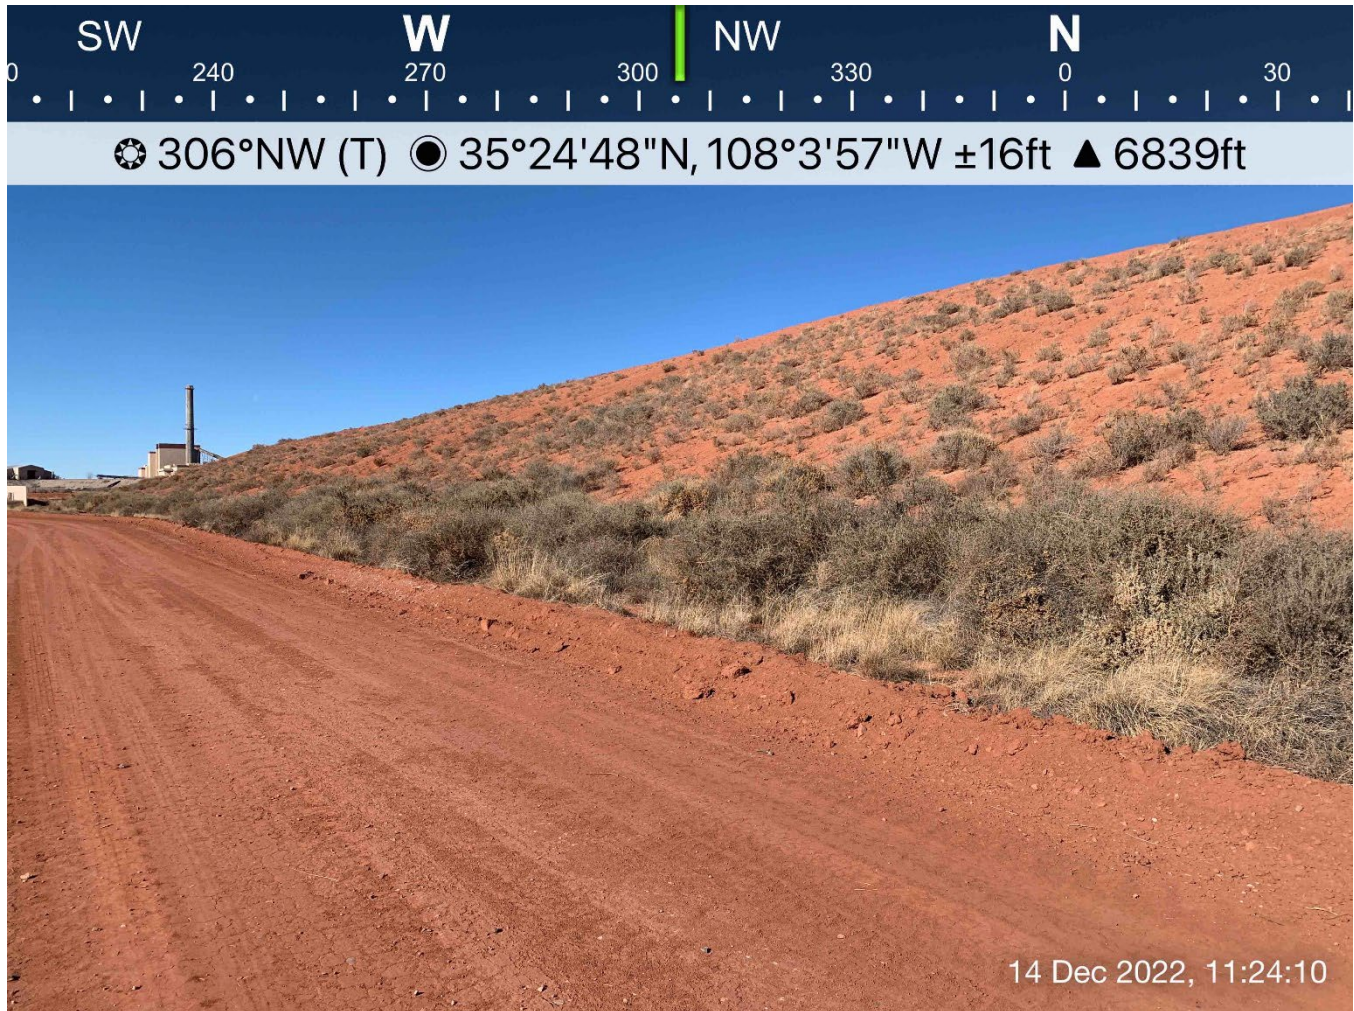
Photograph 4: Typical Condition of Embankment Toe

The embankment toe was observed to be in good condition. Signs of seepage, such as springs or boggy areas, were not observed along the embankment toe. The typical condition of the embankment toe is depicted in Photograph 4.

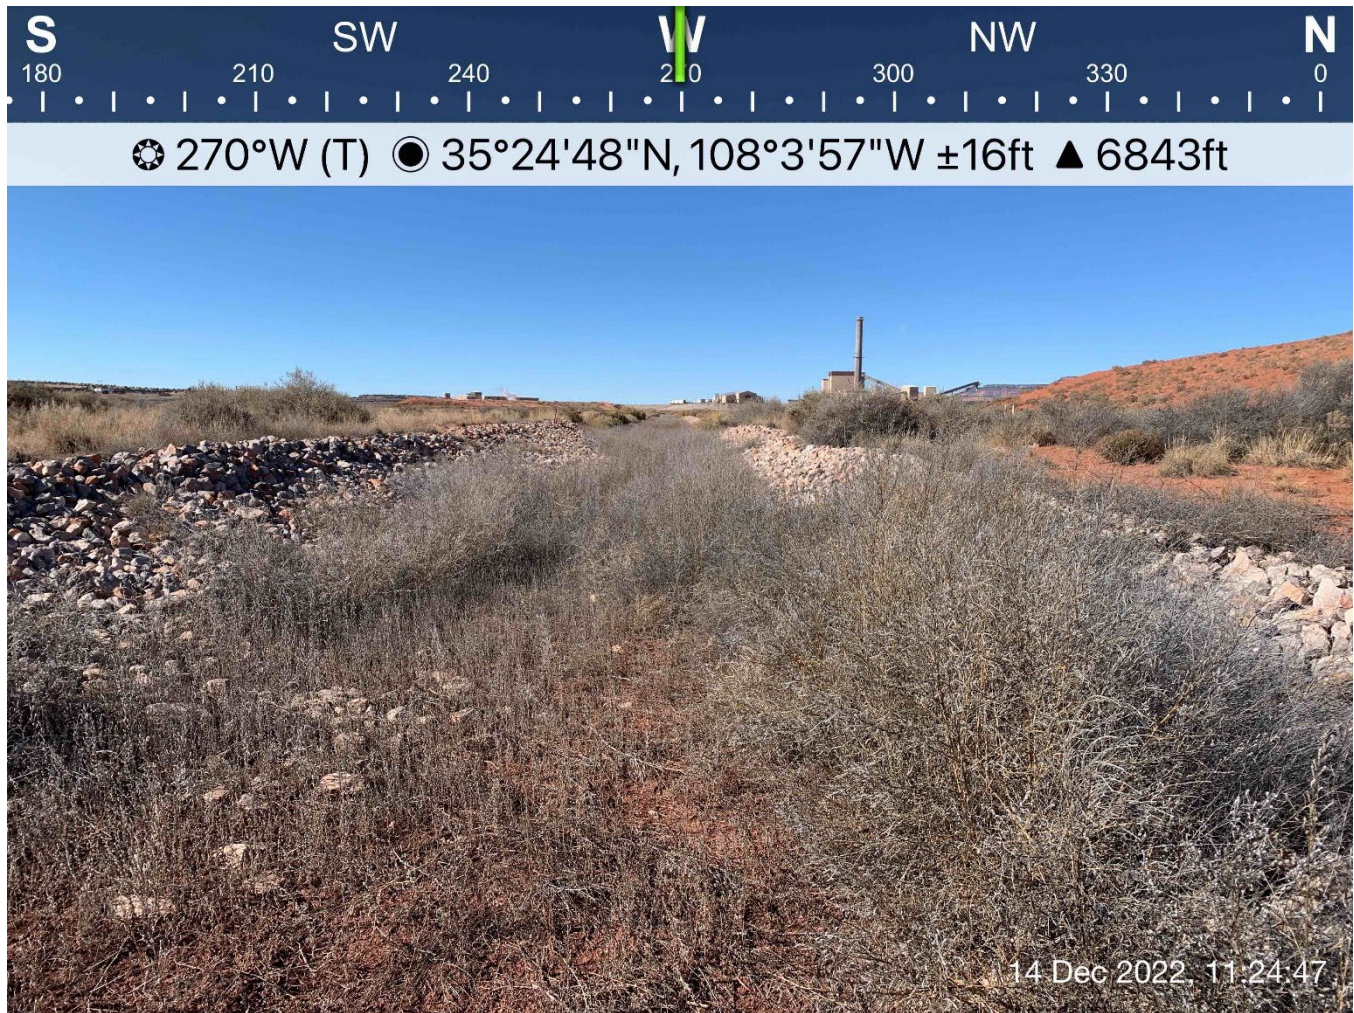
Photograph 5: Typical Condition of Run-on Control Channel

The stormwater control features at the facility were observed to be in fair condition. At the time of the visual observation, the only permanent stormwater control feature at the facility was a run-on control channel that is designed to convey stormwater from west to east outside the southern limit of the facility. The run-on control channel is armored with riprap. Relatively large shrubs were observed to be growing in the flow path. The shrubs are not disrupting the operation or safety of the facility, but they should be removed periodically to help maintain the channel’s flow capacity. The typical condition of the run-on control channel is depicted in Photograph 5.

WSP completed an annual inspection of the active CCR disposal facility at Escalante Station to address the requirements of 40 CFR 257.84(b)(1). Signs of distress or malfunction of the facility were not observed, and appearances of actual or potential structural weakness of the facility were not identified. Facility maintenance activities that should be carried out as the need is indicated by weekly inspections conducted in accordance with 40 CFR 257.84(a) include control of burrowing animals, repair of significant erosion damage on embankment slopes, revegetation of embankment slopes, control and containment of CCR contact water, and periodic removal of shrubs from the run-on control channel.

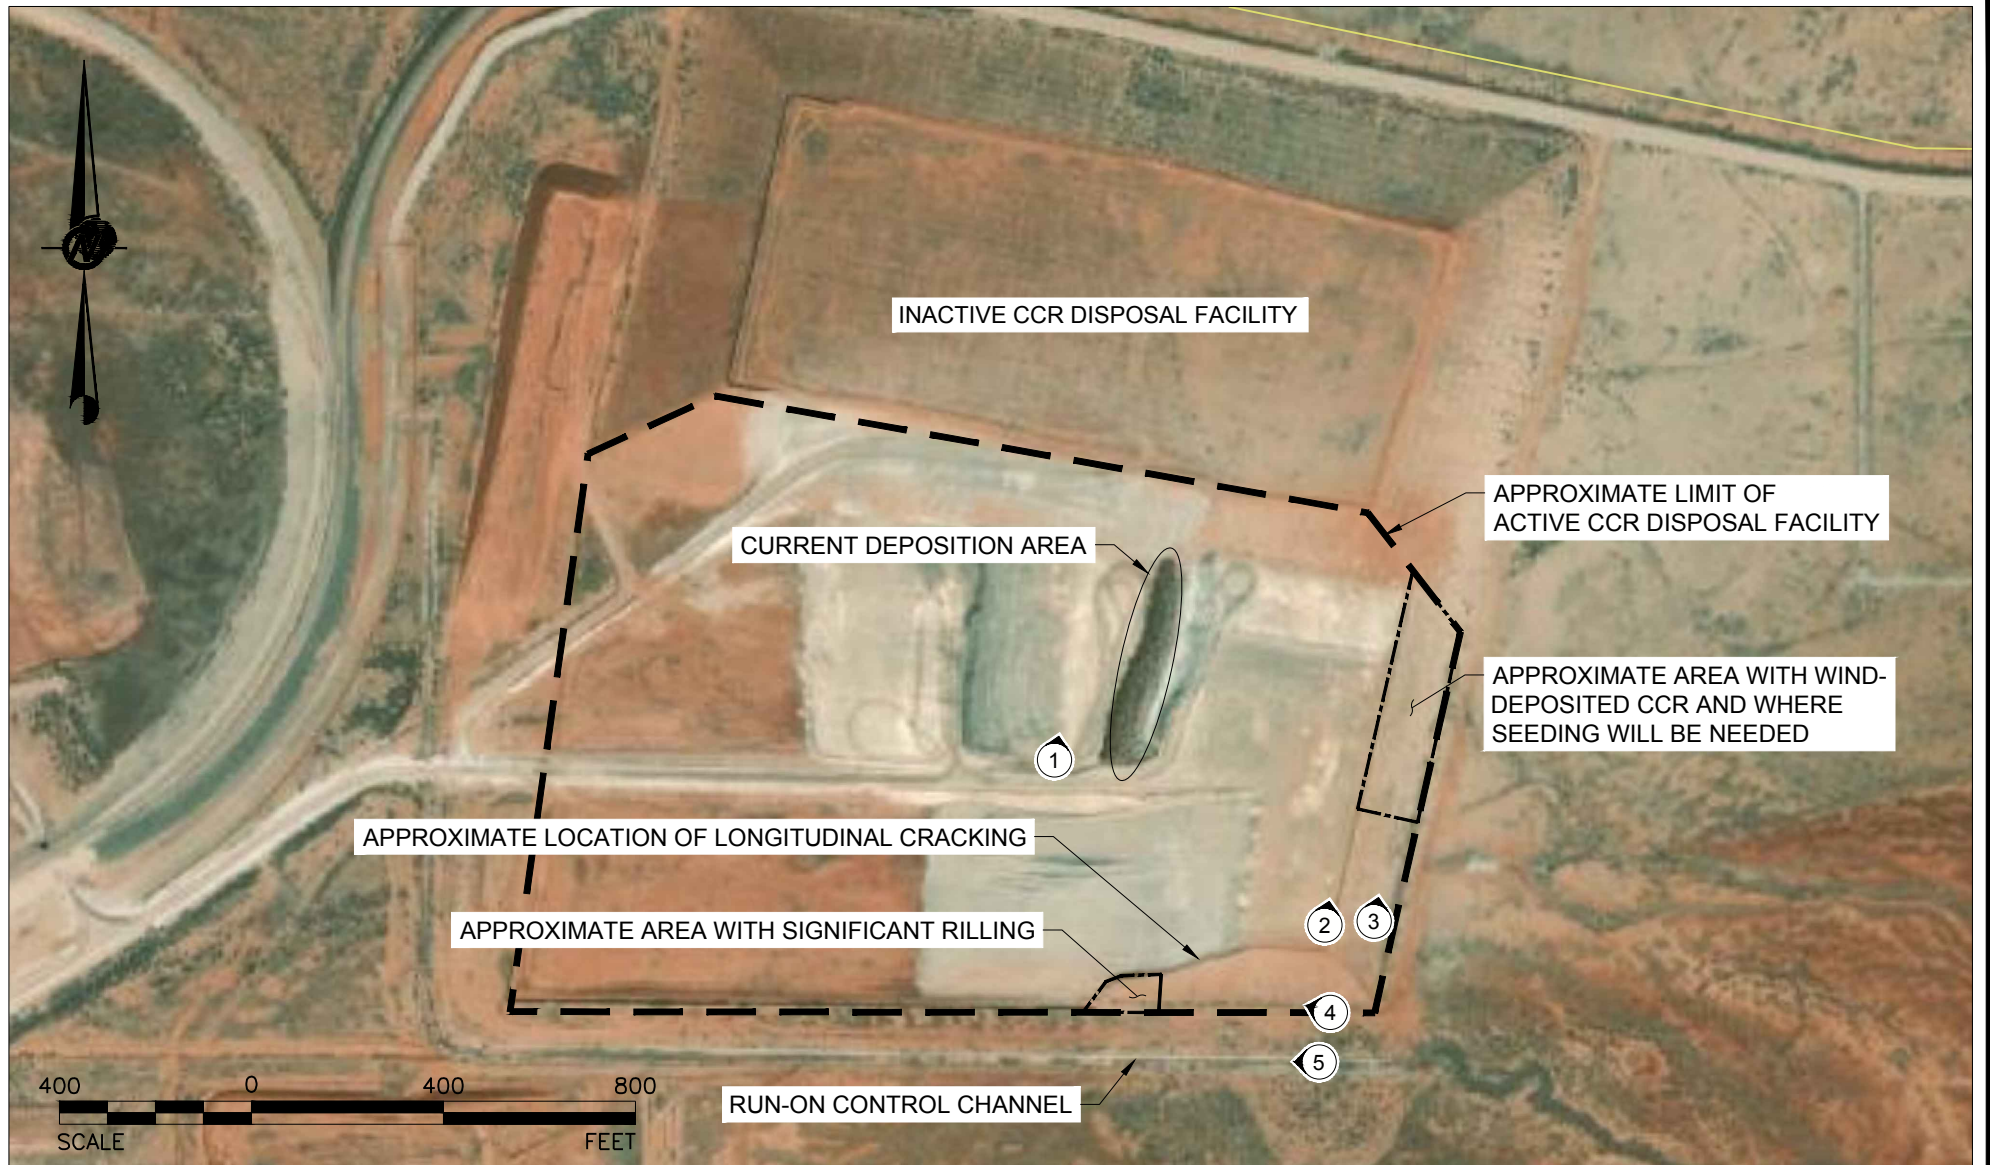
ANNUAL INSPECTION FORM
TRI-STATE GENERATION AND TRANSMISSION ASSOCIATION
ESCALANTE GENERATING STATION ACTIVE CCR DISPOSAL FACILITY

a. The northern segment of the east embankment slope will need to be seeded to re-establish native vegetation.						
b.						
c.						
d.						
e.						
J. Elaboration						
Identify the specific item number (for instance, F.2.) and elaborate on each deficiency or issue identified during the annual inspection. Attach documentation (photographs or sketches) if practical.						
D.4. Wind-deposited CCRs were observed on the northern segment of the east embankment slope (see page 3 for the approximate location). Tri-State has recently implemented mitigation measures and should monitor their effectiveness. Immediate action is not required, but further action may be needed if the mitigation measures are found to be ineffective.						
E.1. An area with longitudinal cracking was noted near the crest of the south embankment (see page 3 for the approximate location). The cracking was believed to be caused by regrading activities immediately north of the location of the cracking (inside the embankment crest), which resulted in a change in stress conditions and some minor displacement. The cracking is not indicative of a threat to structural stability and is not disrupting the operation or safety of the facility, so no action is required.

F.3. Significant rilling was observed on the western segment of the south embankment slope (see page 3 for the approximate location). The severity of the rilling was observed to be about the same as during the previous annual inspection. The rilling does not currently pose a threat to structural stability and is not disrupting the operation or safety of the facility, so immediate repair is not required. The rilling should be monitored and addressed if it becomes excessive.						
F.4. Tri-State recently used a bulldozer to remove wind-deposited CCRs across the northern segment of the east embankment slope (see page 3 for the approximate location), and the existing vegetation was damaged in the process. This area will need to be seeded to re-establish native vegetation.
