Active Coal Combustion Residuals Disposal Facility 2021 Annual Inspection

Escalante Generating Station

21453429-1-R-0

January 14, 2022

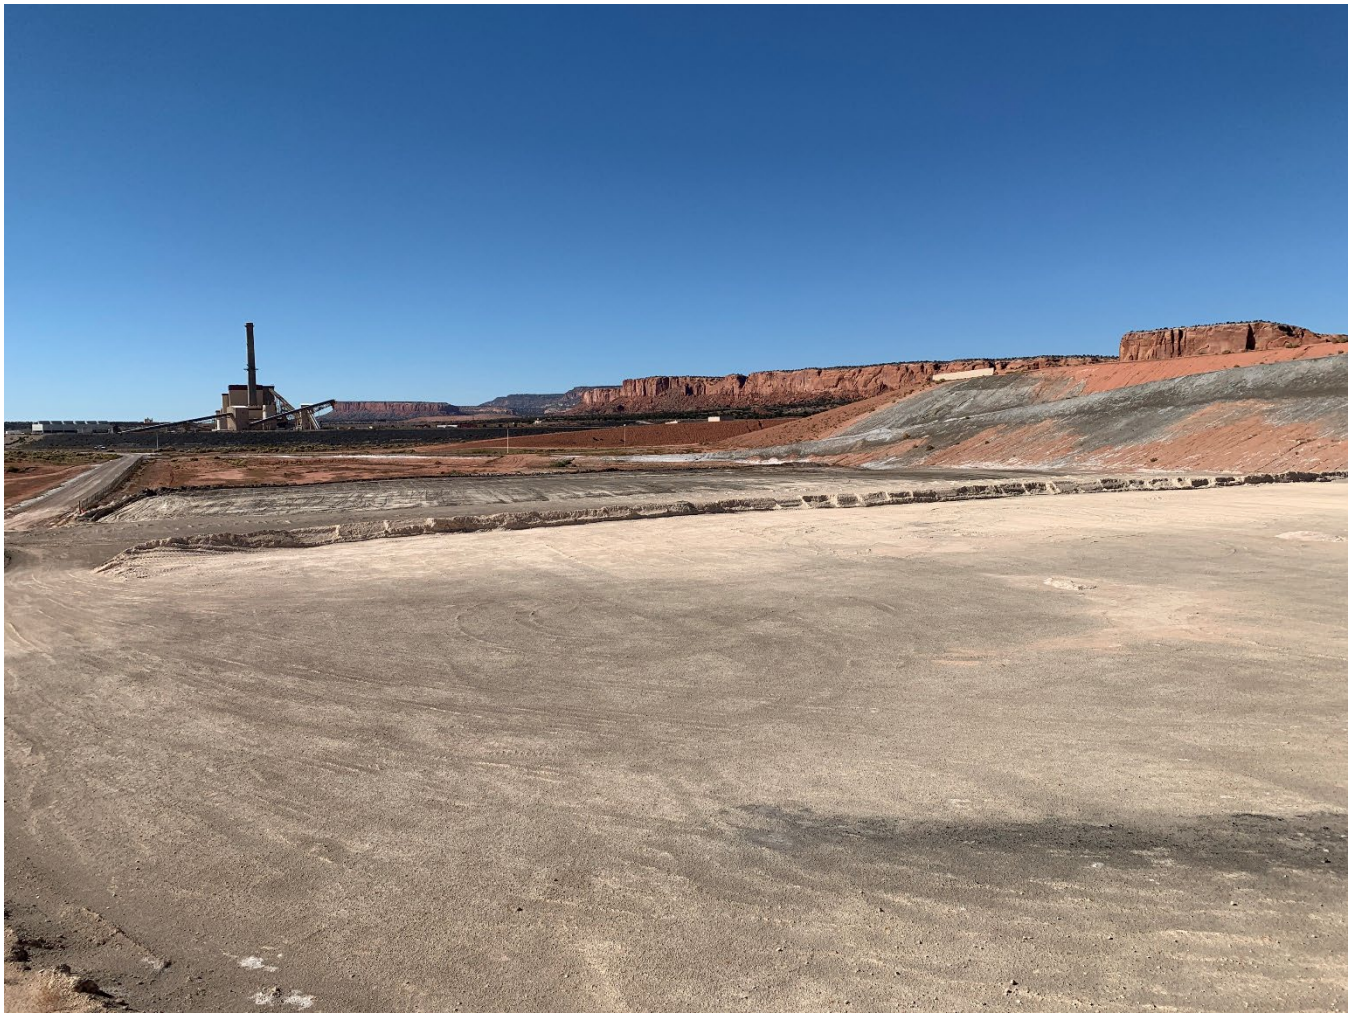
The deposition area was observed to be in good condition. Appendix A shows the deposition area location at the time of the visual observation. Signs of ground movement, such as sloughing or sliding, cracking, subsidence, or bulging, were not observed in the deposition area. Appropriate grading had been established to collect CCR contact water within the deposition area. A berm that was several feet in height was in place around the perimeter of the deposition area to prevent migration of CCR contact water off of the deposition area. Fugitive dust was not observed at the time of the visual observation. The typical condition of the deposition area is depicted in Photograph 1.

Photograph 1: Typical Deposition Area Condition

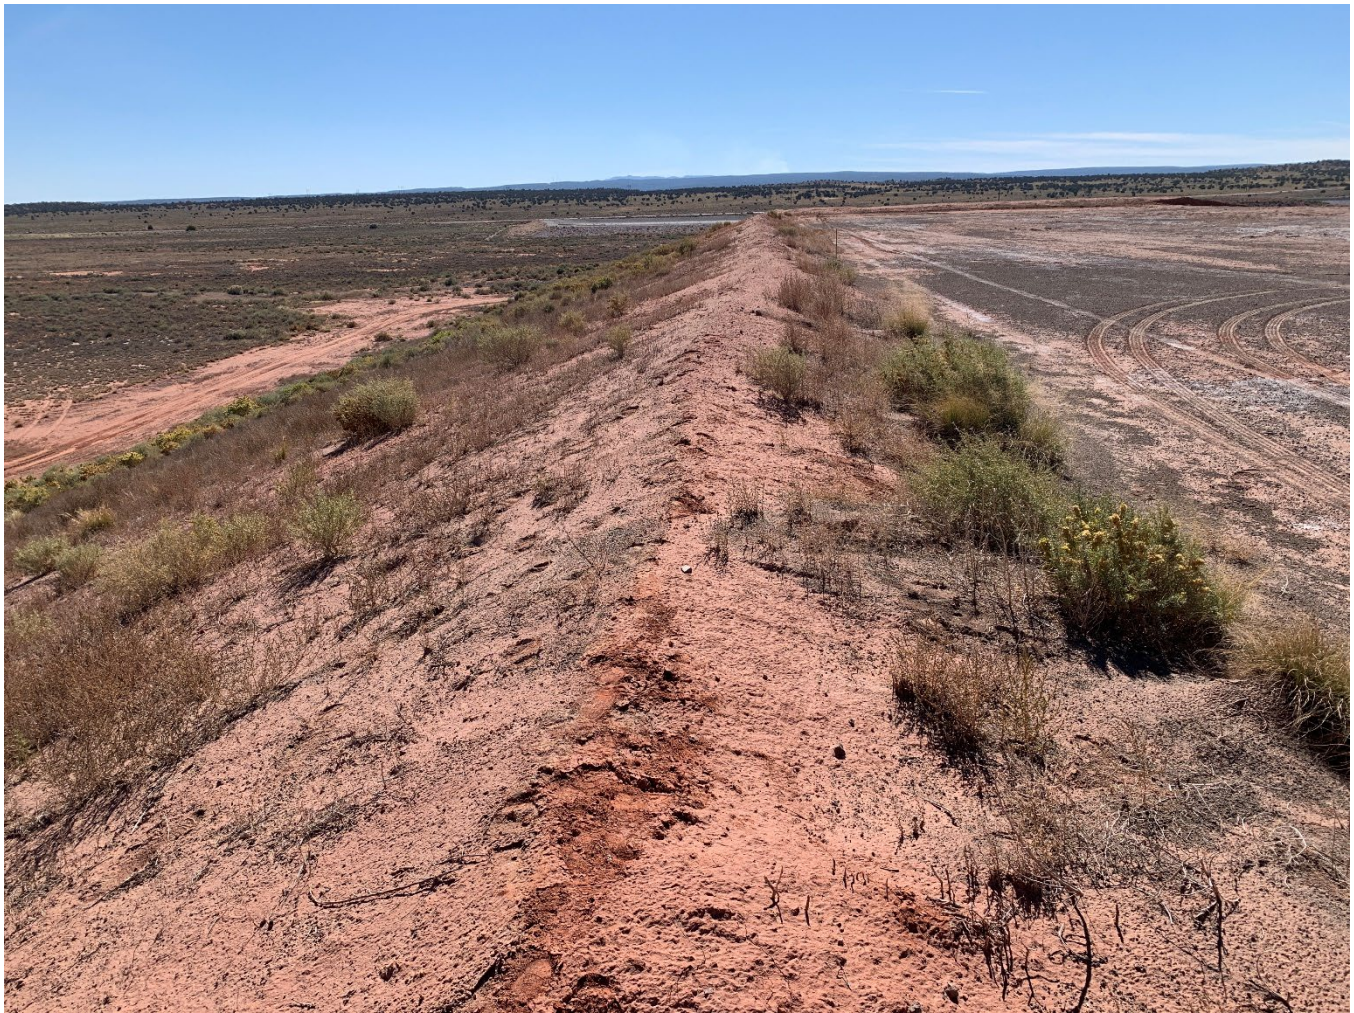
The embankment crest was observed to be in good condition. Cracking that would be indicative of ground movement was not observed along the embankment crest. Low areas that would be indicative of differential settlement were not observed along the embankment crest. The typical condition of the embankment crest is depicted in Photograph 2.

Photograph 2: Typical Embankment Crest Condition

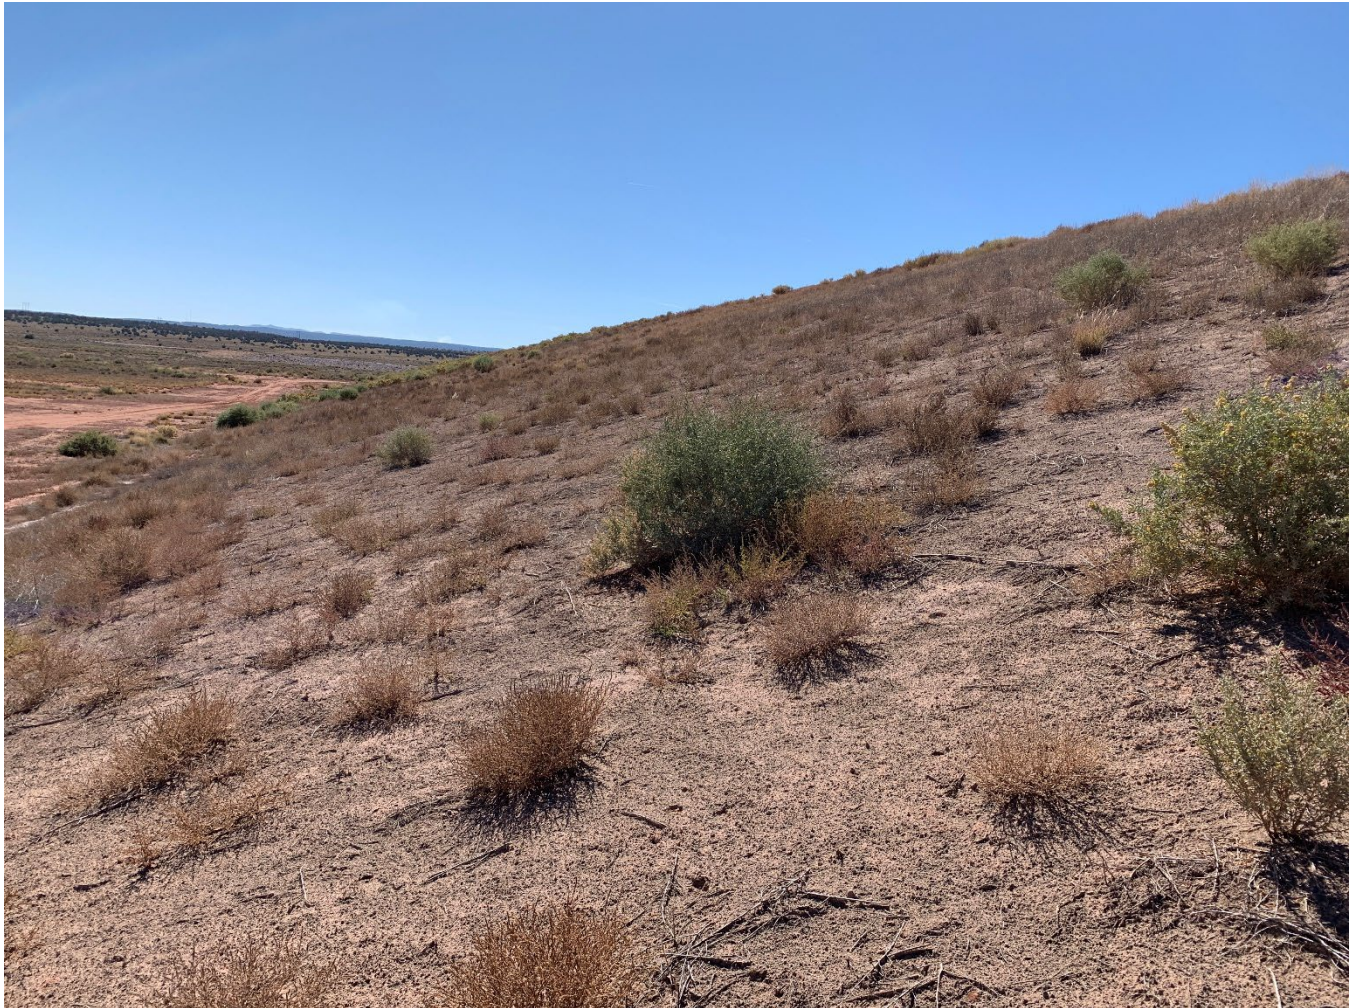
The embankment slopes were observed to be in fair condition. Signs of ground movement, such as sloughing or sliding, cracking, subsidence, or bulging, were not observed on the embankment slopes. Evidence of significant wind and water erosion was observed on the embankment slopes near the northeast corner of the facility. Appendix A shows the approximate area exhibiting significant wind and water erosion at the time of the visual observation. Evidence of significant wind and water erosion included reduced cover soil thickness on the embankment slope, wind-deposited soil and CCR particles on the embankment slope, and accumulation of cover soil near the toe of the embankment slope in the indicated area. The wind and water erosion does not currently pose a threat to structural stability, but it should be addressed as part of facility closure, including verification of adequate cover soil thickness. Minor rilling was also observed on the embankment slopes, with the largest rills near the west end of the south embankment slope. The rilling does not currently pose a threat to structural stability, but it should be monitored and addressed if it becomes significant or excessive. Golder recommends that rill repair efforts be deferred until the rills become more severe or a reseeding attempt is planned, as repair efforts would disturb the vegetation and the crust remaining from the most recent hydraulic mulch application.

Native vegetation is present on the embankment slopes, but establishment of a mature vegetative community is challenging given the climatic conditions at the site. Unusually poor or thriving vegetative growth was not observed on the embankment slopes, but there was generally less vegetative coverage on the south embankment slope than on the east embankment slope due to the southern aspect. No trees were observed on the embankment slopes. Active animal burrows were not observed on the embankment slopes. The typical condition of the embankment slopes is depicted in Photograph 3.

Photograph 3: Typical Embankment Slope Condition

a.						
b.						
c.						
d.						
e.						
J. Elaboration						
<p><i>Identify the specific item number (for instance, F.2.) and elaborate on each deficiency or issue identified during the annual inspection. Attach documentation (photographs or sketches) if practical.</i></p> <p>F.3. Evidence of significant wind and water erosion was observed on the embankment slopes near the northeast corner of the facility. The approximate area exhibiting significant wind and water erosion at the time of the visual observation is shown on page 3. Evidence of significant wind and water erosion included reduced cover soil thickness on the embankment slope, wind-deposited CCR on the embankment slope, and accumulation of cover soil near the toe of the embankment slope in the indicated area. The wind and water erosion does not currently pose a threat to structural stability, but it should be addressed as part of facility closure, including verification of adequate cover soil thickness.</p>

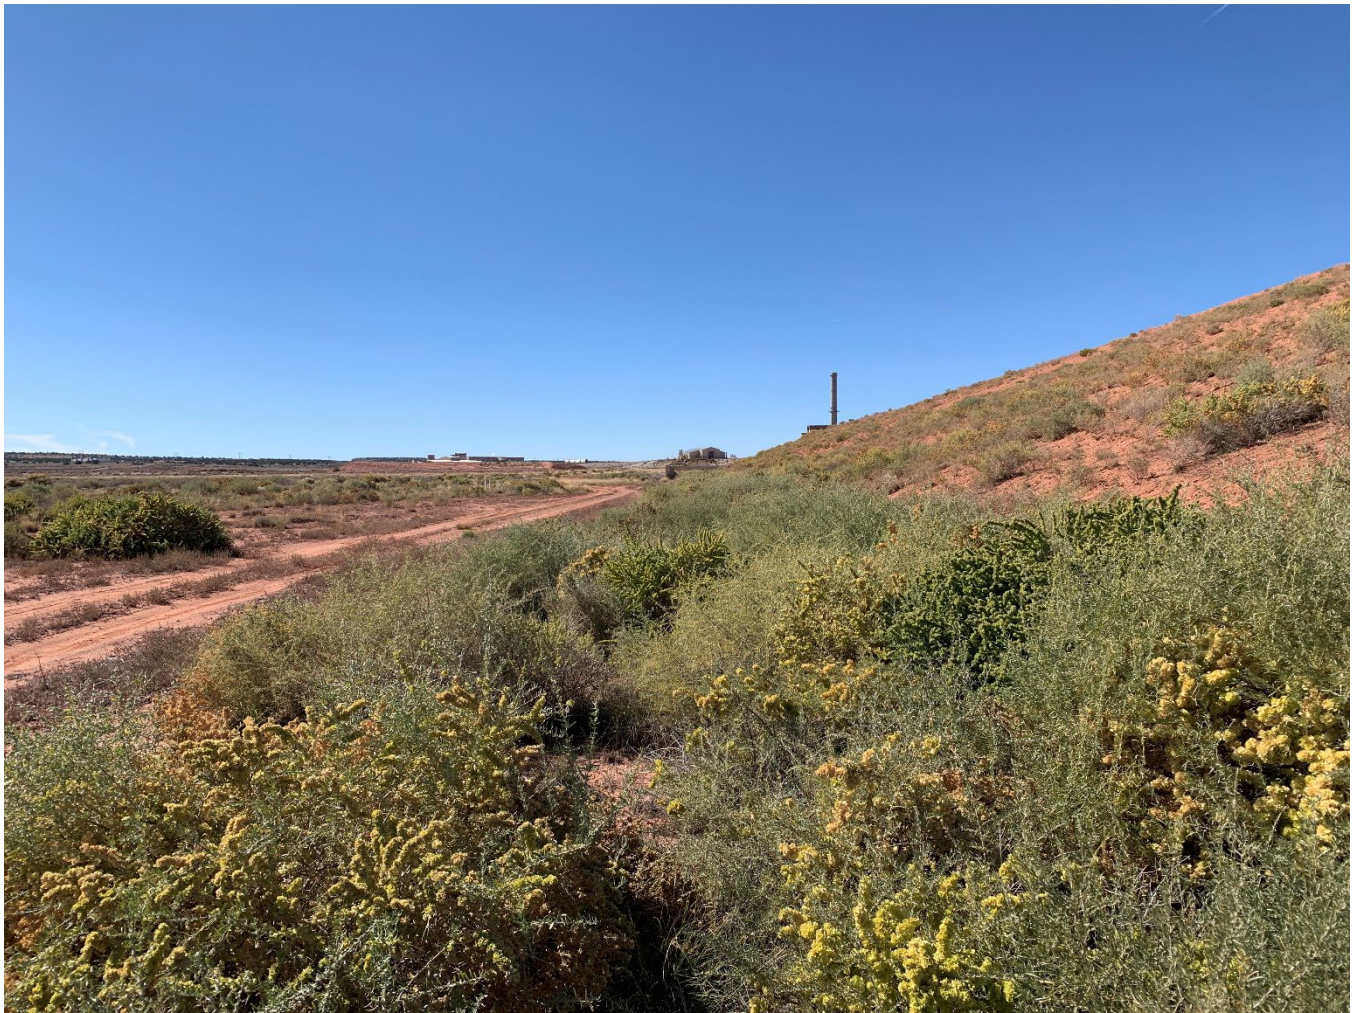
The embankment toe was observed to be in good condition. Signs of seepage, such as springs or boggy areas, were not observed along the embankment toe. The typical condition of the embankment toe is depicted in Photograph 4.

Photograph 4: Typical Embankment Toe Condition

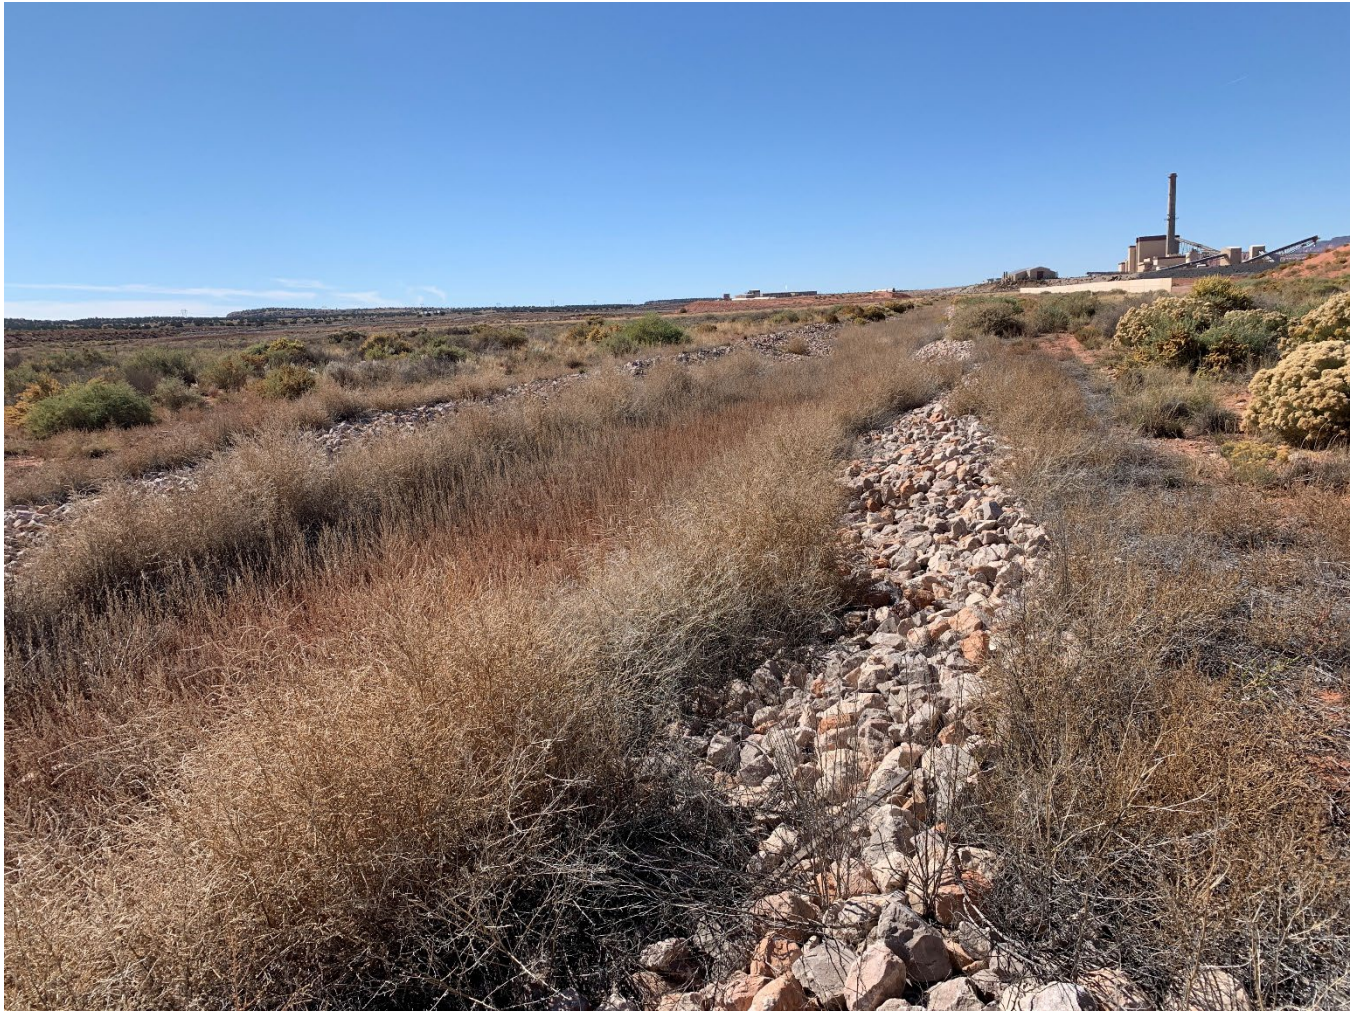
The stormwater control features at the facility were observed to be in fair condition. At the time of the visual observation, the only permanent stormwater control feature at the facility was a run-on control channel that is designed to convey stormwater from west to east outside the southern limit of the facility. The run-on control channel is armored with riprap. Relatively large shrubs were observed to be growing in the flow path. The shrubs do not pose a threat to structural stability, but they should be removed periodically to help maintain the channel's flow capacity. The typical condition of the run-on control channel is depicted in Photograph 5.

Photograph 5: Typical Storm Water Channel Condition

Golder completed an annual inspection of the active CCR disposal facility at Escalante Generating Station to address the requirements of 40 CFR 257.84. Signs of distress or malfunction of the facility were not observed, and appearances of actual or potential structural weakness of the facility were not identified. Facility maintenance activities that should be carried out as the need is indicated by weekly inspections conducted in accordance with 40 CFR 257.84(a) include control of burrowing animals, repair of significant erosion damage on embankment slopes, establishment of suitable vegetation on embankment slopes, control and containment of CCR contact water, periodic removal of shrubs from the run-on control channel, and promotion of positive stormwater drainage away from the facility.

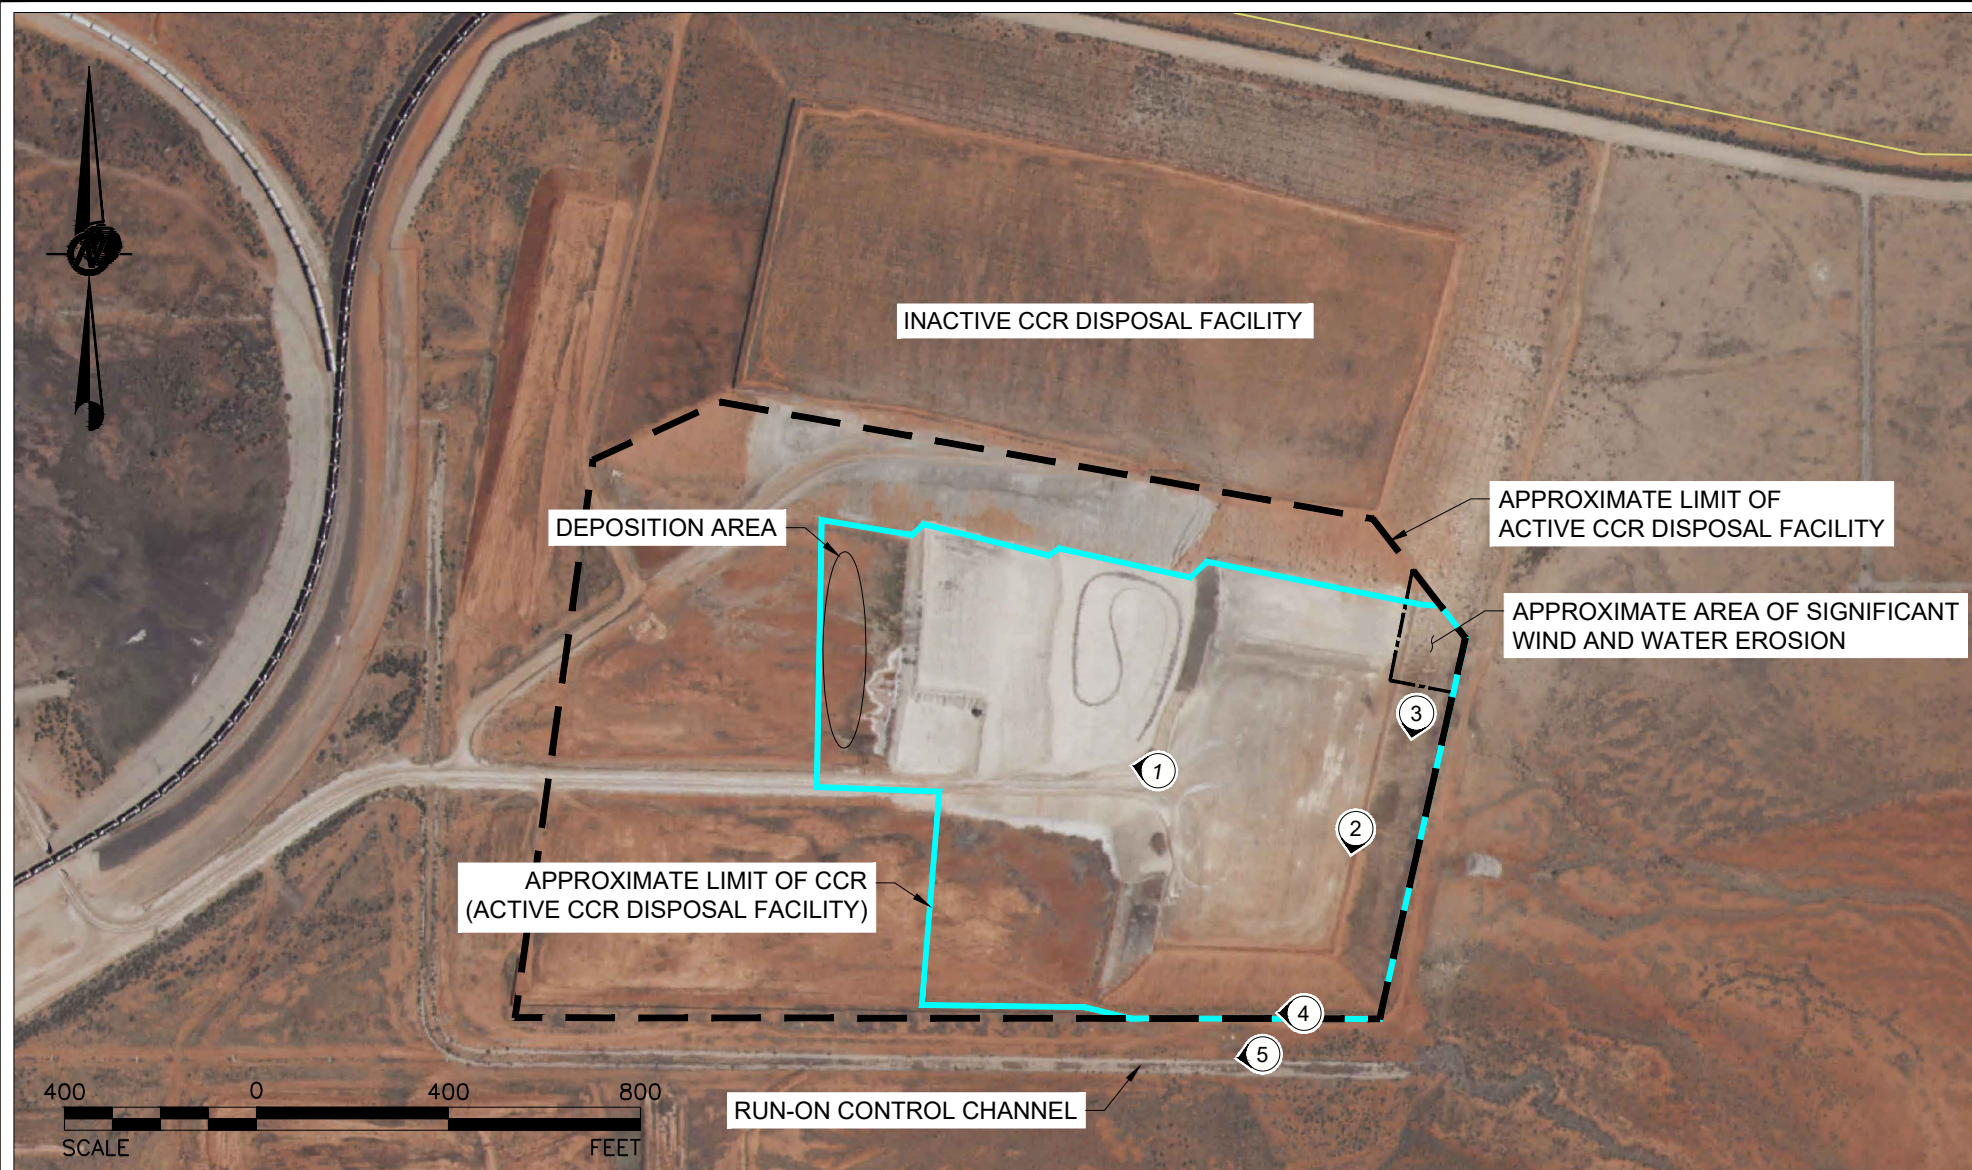
ANNUAL INSPECTION FORM

1. Where are CCRs and/or other materials currently being deposited (indicate on the plan view on page 3 or write N/A)? See page 3
