Coal Combustion Residuals Landfill Annual Inspection

Nucla Station Ash Disposal Facility

31403149-1-R-0

December 16, 2022

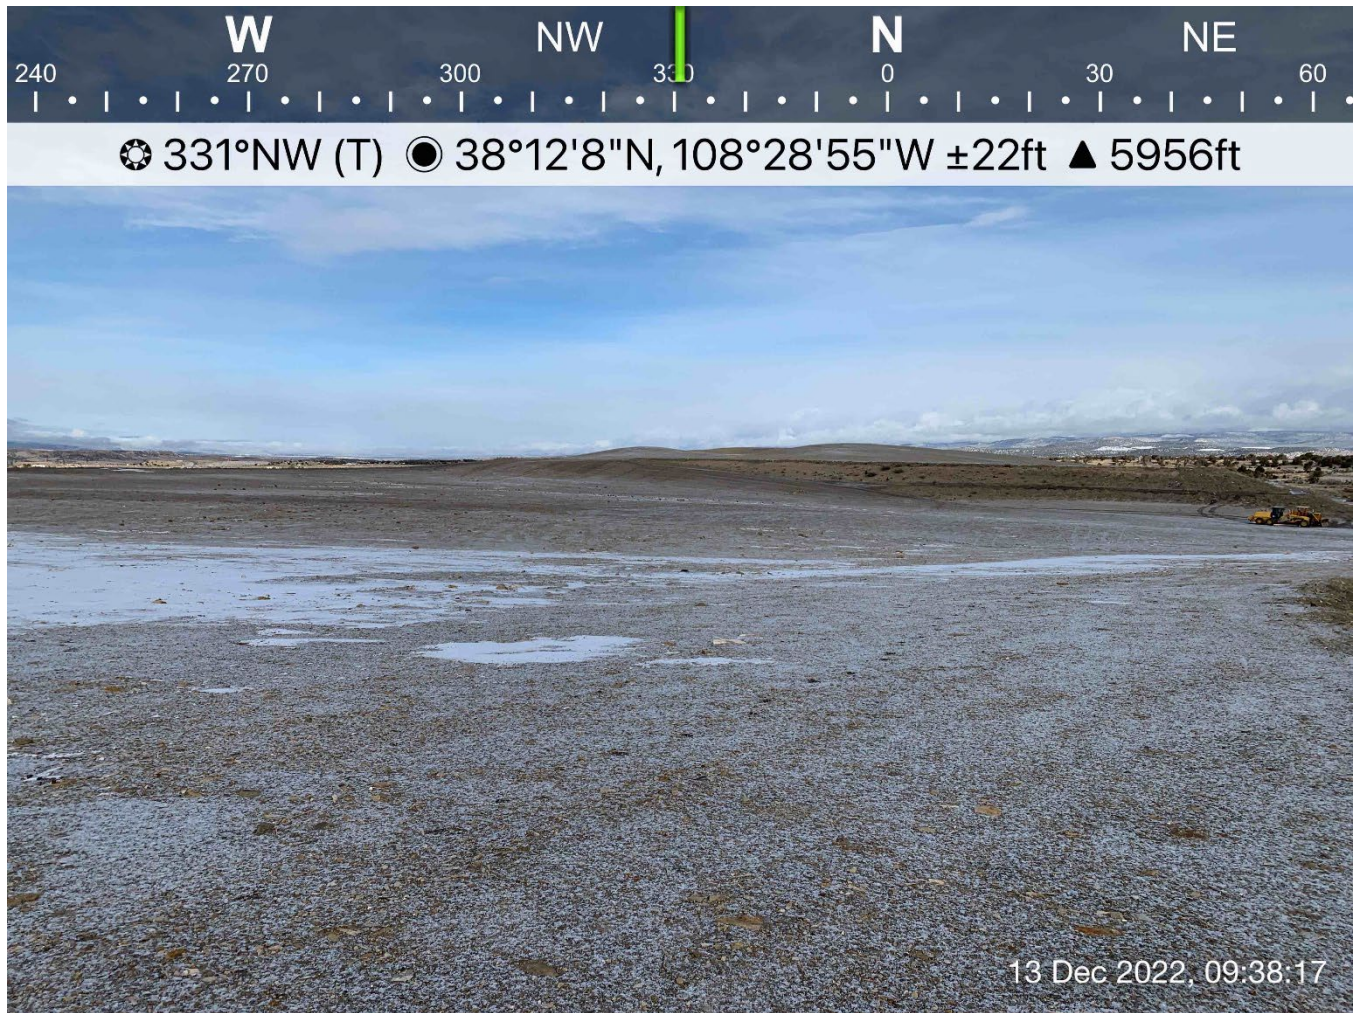
The top surface was observed to be in good condition. Signs of ground movement, such as sloughing or sliding, cracking, subsidence, or bulging, were not observed across the top surface. The top surface was appropriately graded so that stormwater will be routed away from the facility to the designated locations. Minor erosion rills were observed at one location, where indicated in Appendix A. The erosion rills do not currently pose a threat to structural stability and did not hinder Golder's ability to inspect the facility. The typical condition of the top surface is depicted in Photograph 1.

Photograph 1: Typical Condition of the Top Surface

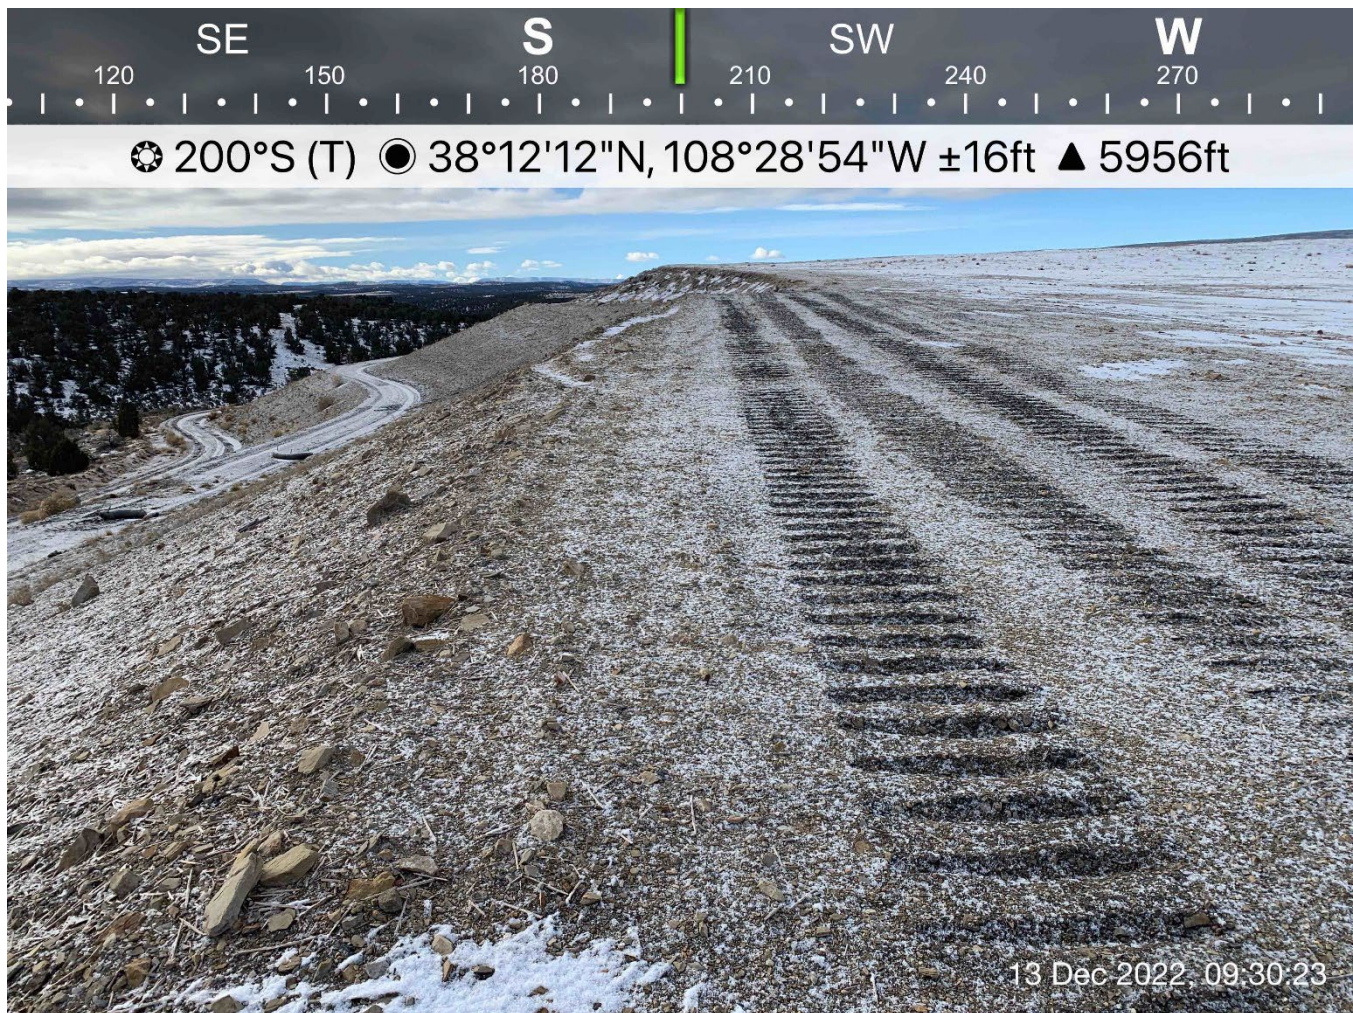
The embankment crests were observed to be in good condition. Cracking that would be indicative of ground movement was not observed along the embankment crests. Low areas that would be indicative of differential settlement were not observed along the embankment crests. The typical condition of the embankment crests is depicted in Photograph 2.

Photograph 2: Typical Condition of Embankment Crests

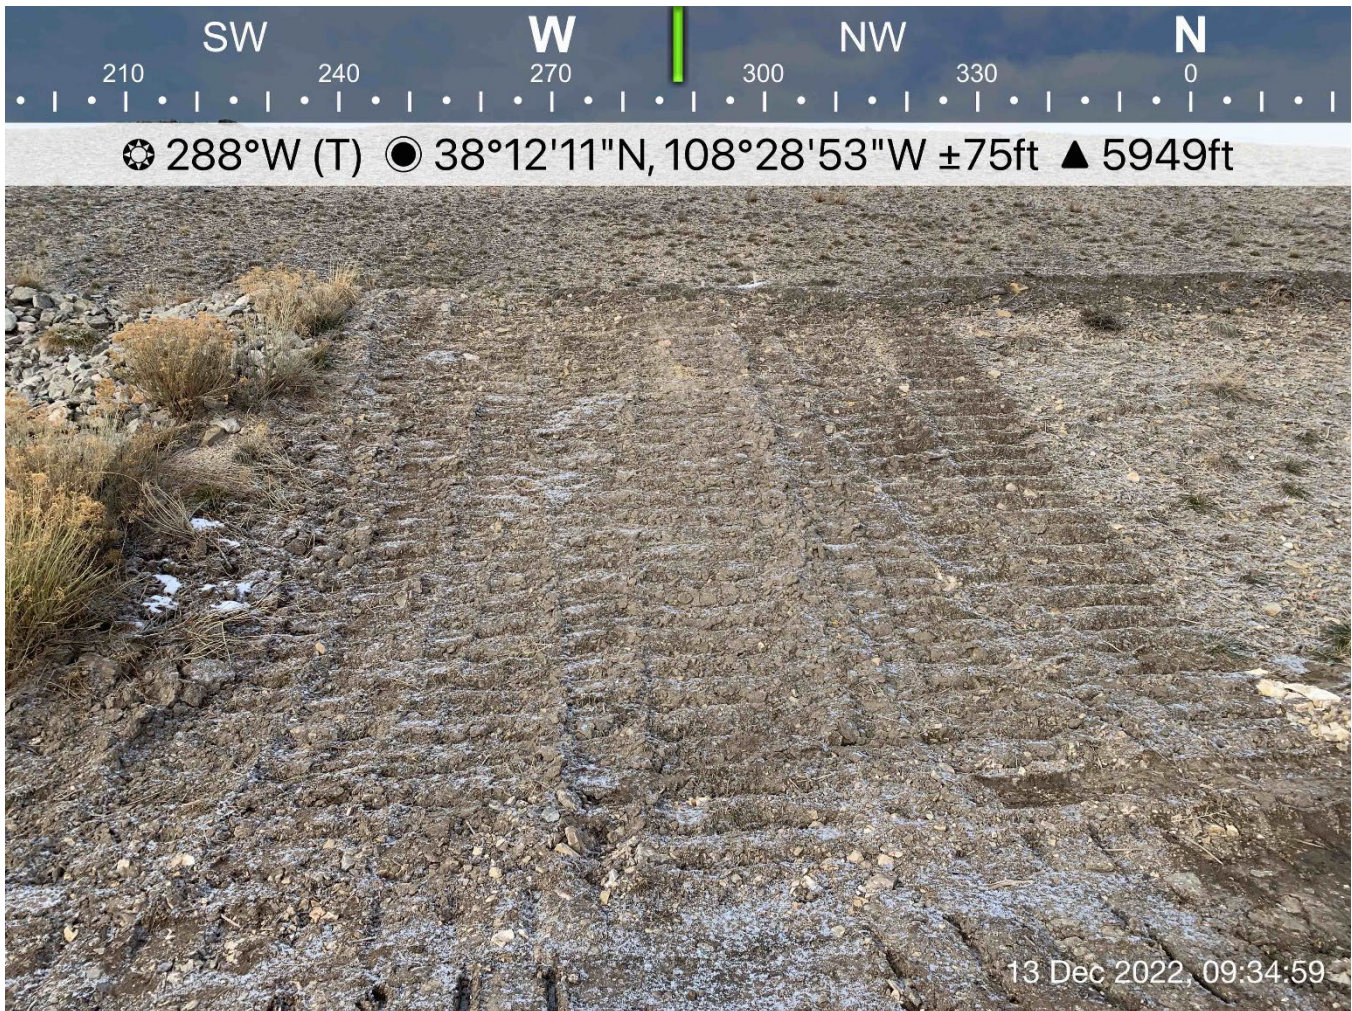
Photograph 3: Typical Condition of Erosion Rill Repair Areas

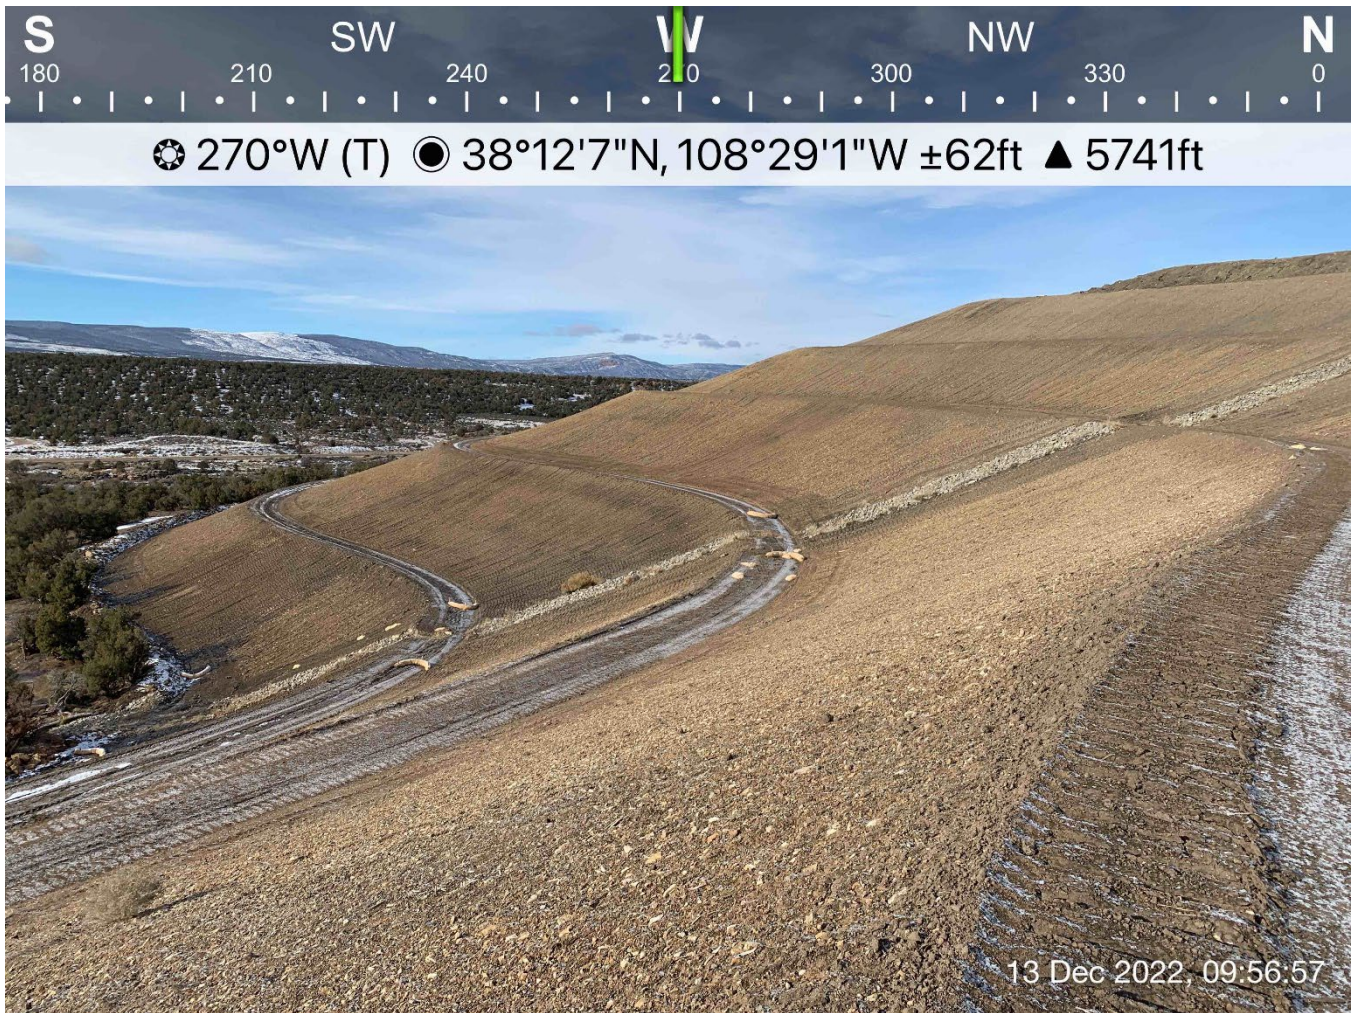
The embankment slopes were observed to be in good condition. Signs of ground movement, such as sloughing or sliding, cracking, subsidence, or bulging, were not observed on the embankment slopes. Evidence of excessive erosion or slope deterioration was not observed on the embankment slopes. At the time of the visual observation, repair work had recently been completed to address erosion rills on the embankment slopes in several locations. A typical erosion rill repair is shown in Photograph 3. The weekly inspection forms indicate that the erosion rills were primarily caused by major storm events in late September and early October 2022. The repair work appeared to be adequate to address the erosion damage. Native vegetation has been established on the embankment slopes. The west, north, and east embankment slopes generally had adequate vegetative coverage at the time of the visual observation. Vegetation on the south embankment slopes has yet to reestablish after major repair work in the fall of 2021. Reseeding should be carried out during the appropriate season in areas where work has been performed to address erosion rills. Unusually poor or thriving vegetative growth was not observed on the embankment slopes. A few animal burrows were observed on the embankment slopes, where indicated in Appendix A. The animal burrows do not currently pose a threat to structural stability and did not

Photograph 4: Typical Condition of the South Embankment Slopes

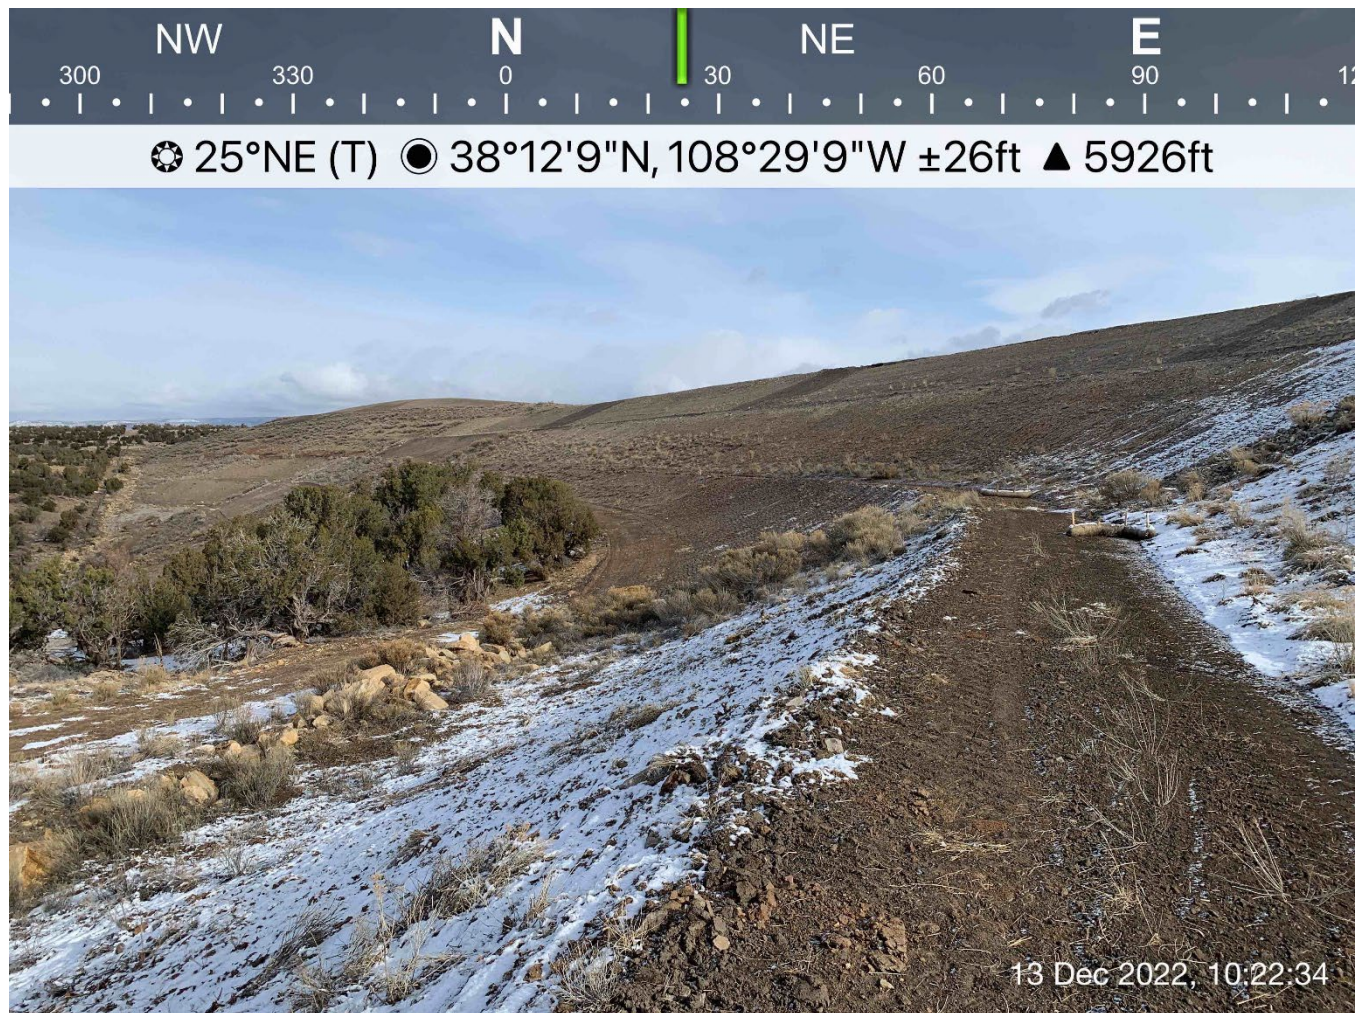
Photograph 5: Typical Condition of the West, North, and East Embankment Slopes

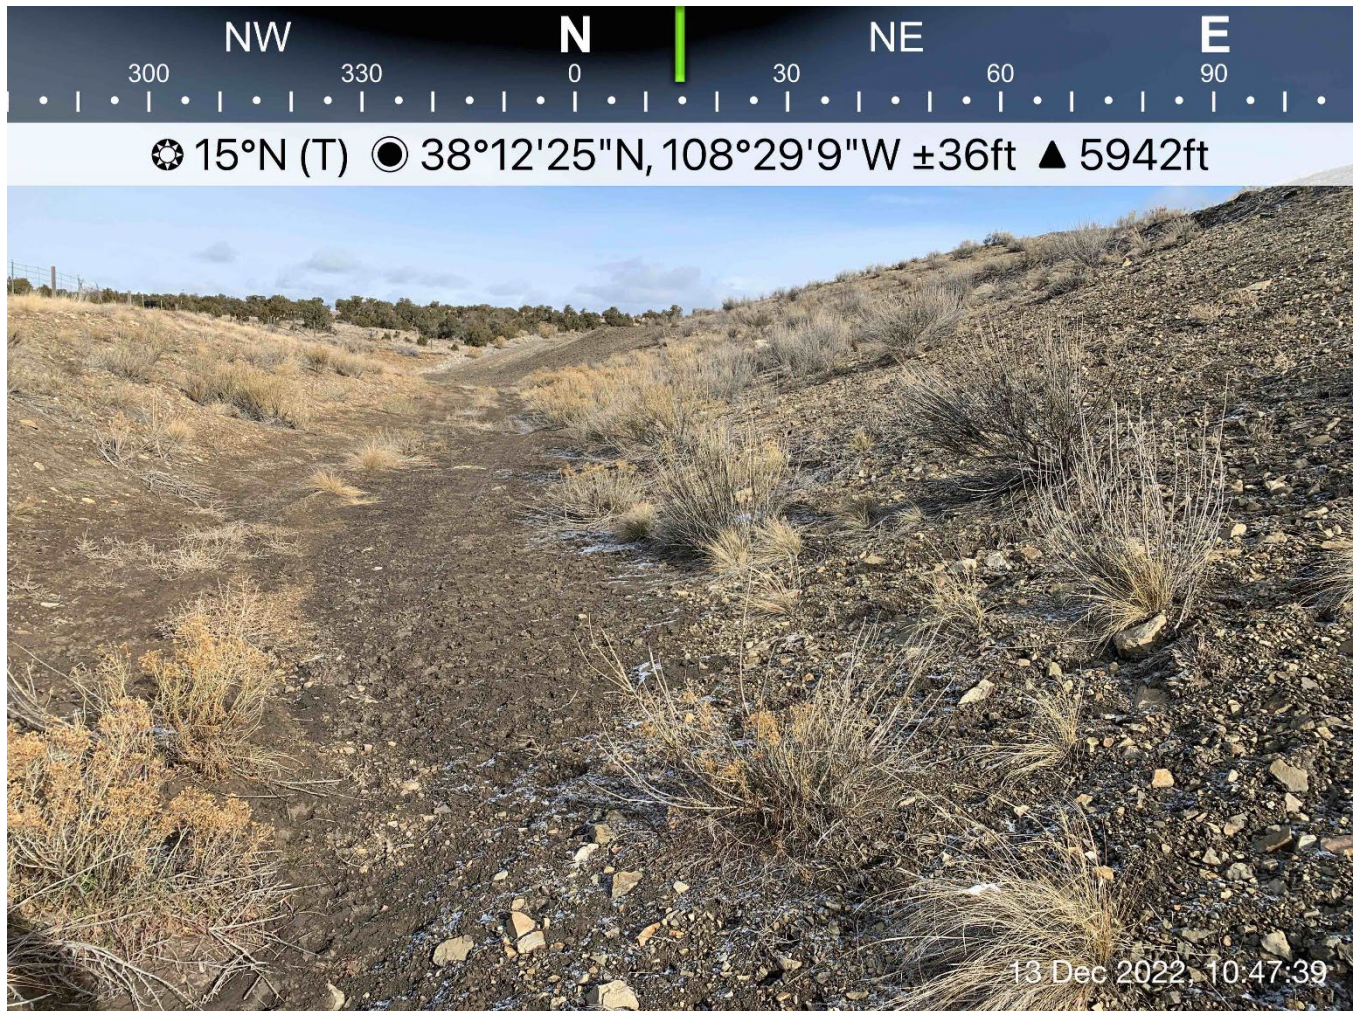
The embankment toes were observed to be in good condition. Signs of seepage, such as springs or boggy areas, were not observed along the embankment toes. The typical condition of the embankment toes is depicted in Photograph 6.

Photograph 6: Typical Condition of Embankment Toes

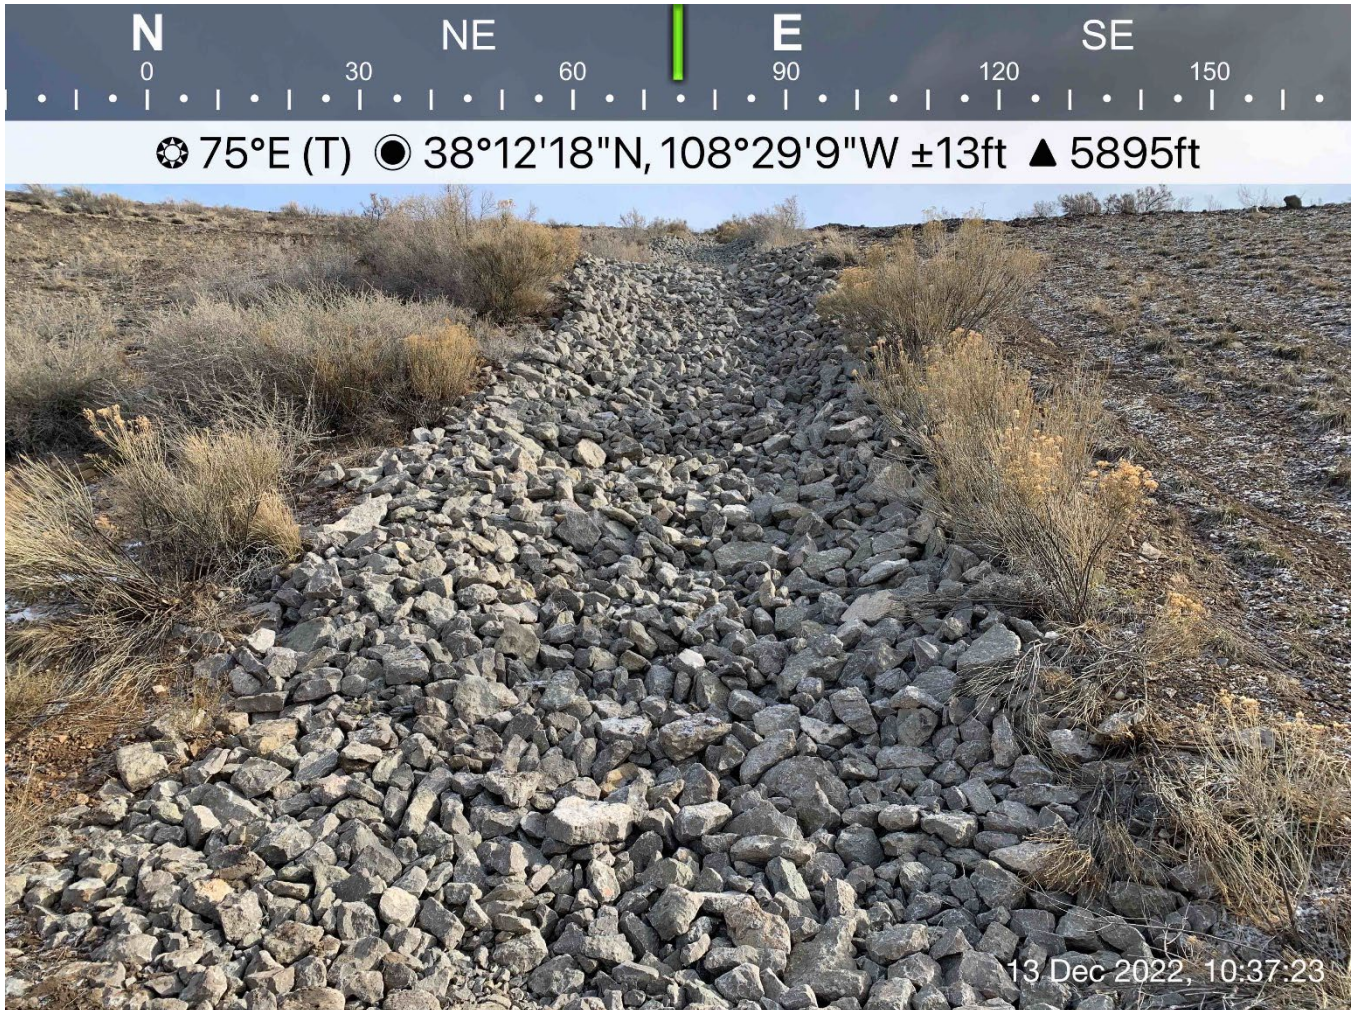
Photograph 7: Typical Condition of Downchute Channels

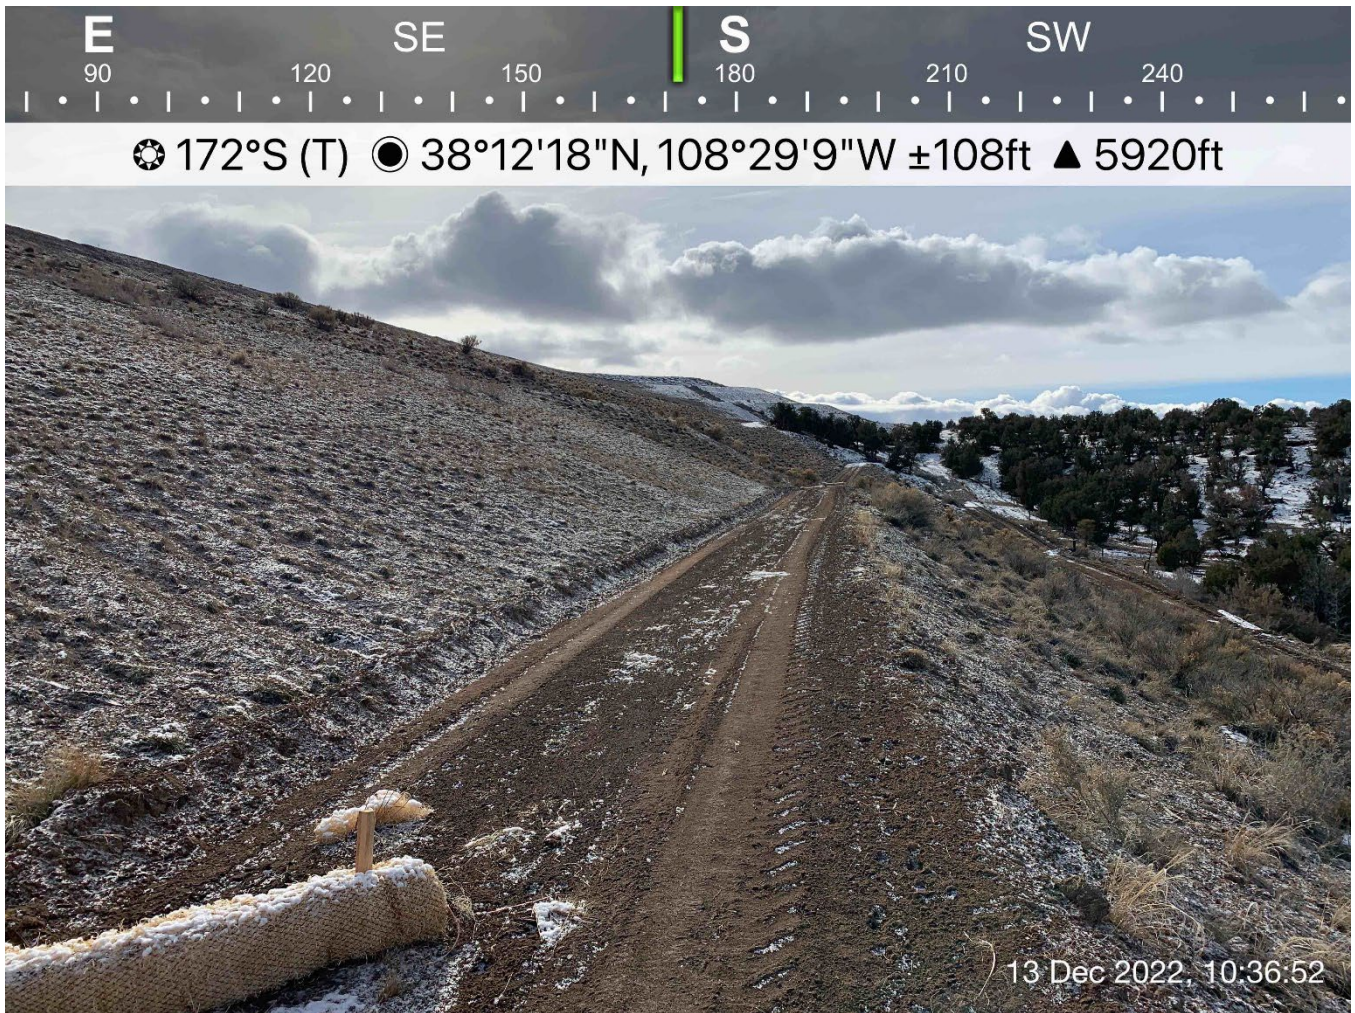
Photograph 8: Typical Condition of Terrace Channels

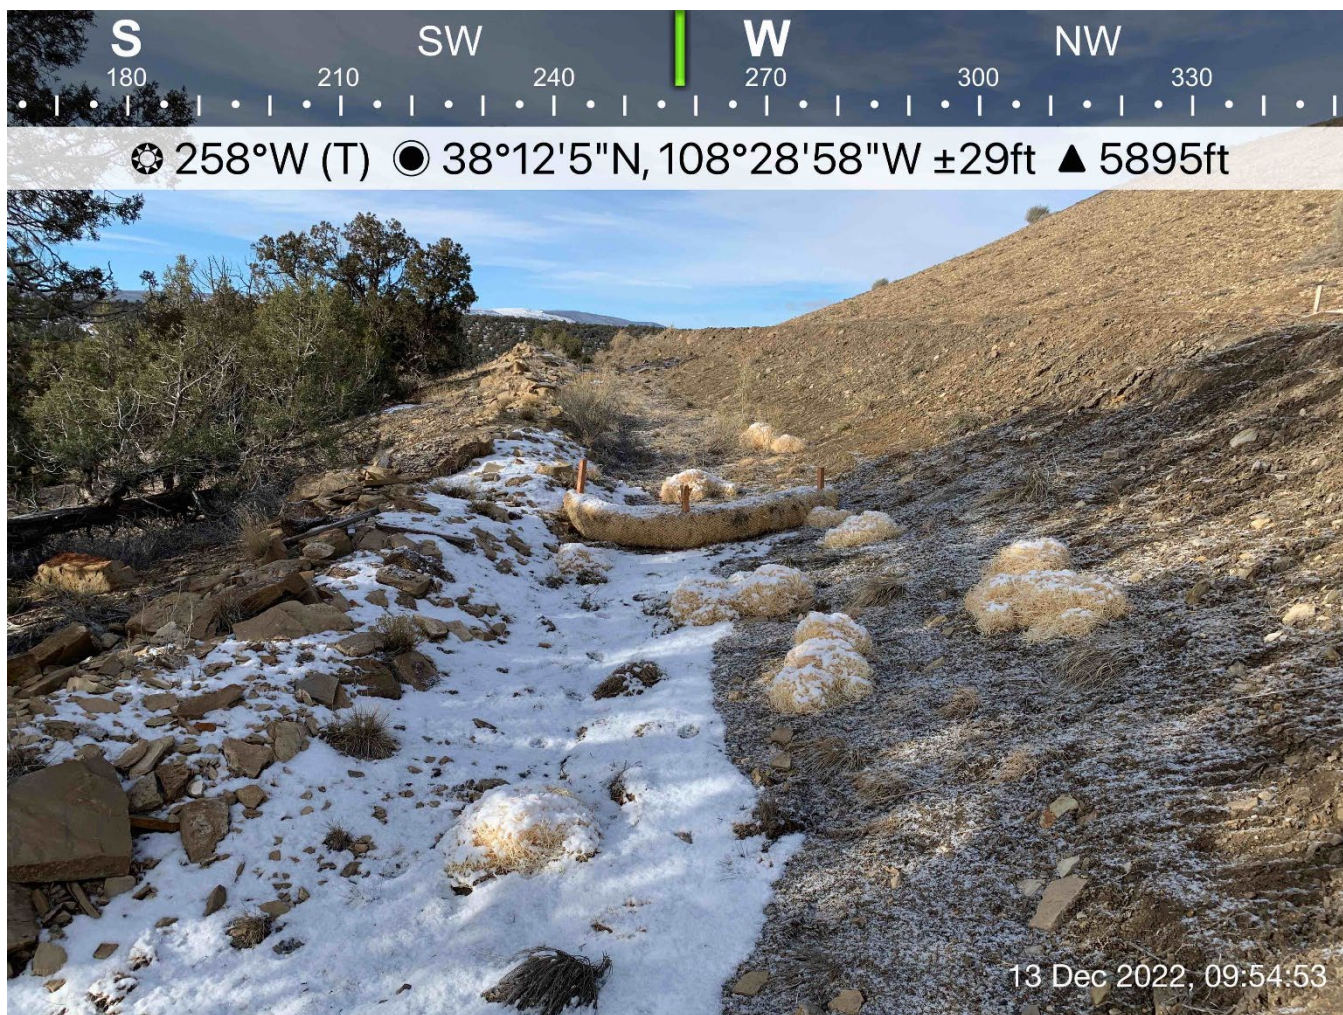
Photograph 9: Typical Condition of Perimeter Channels

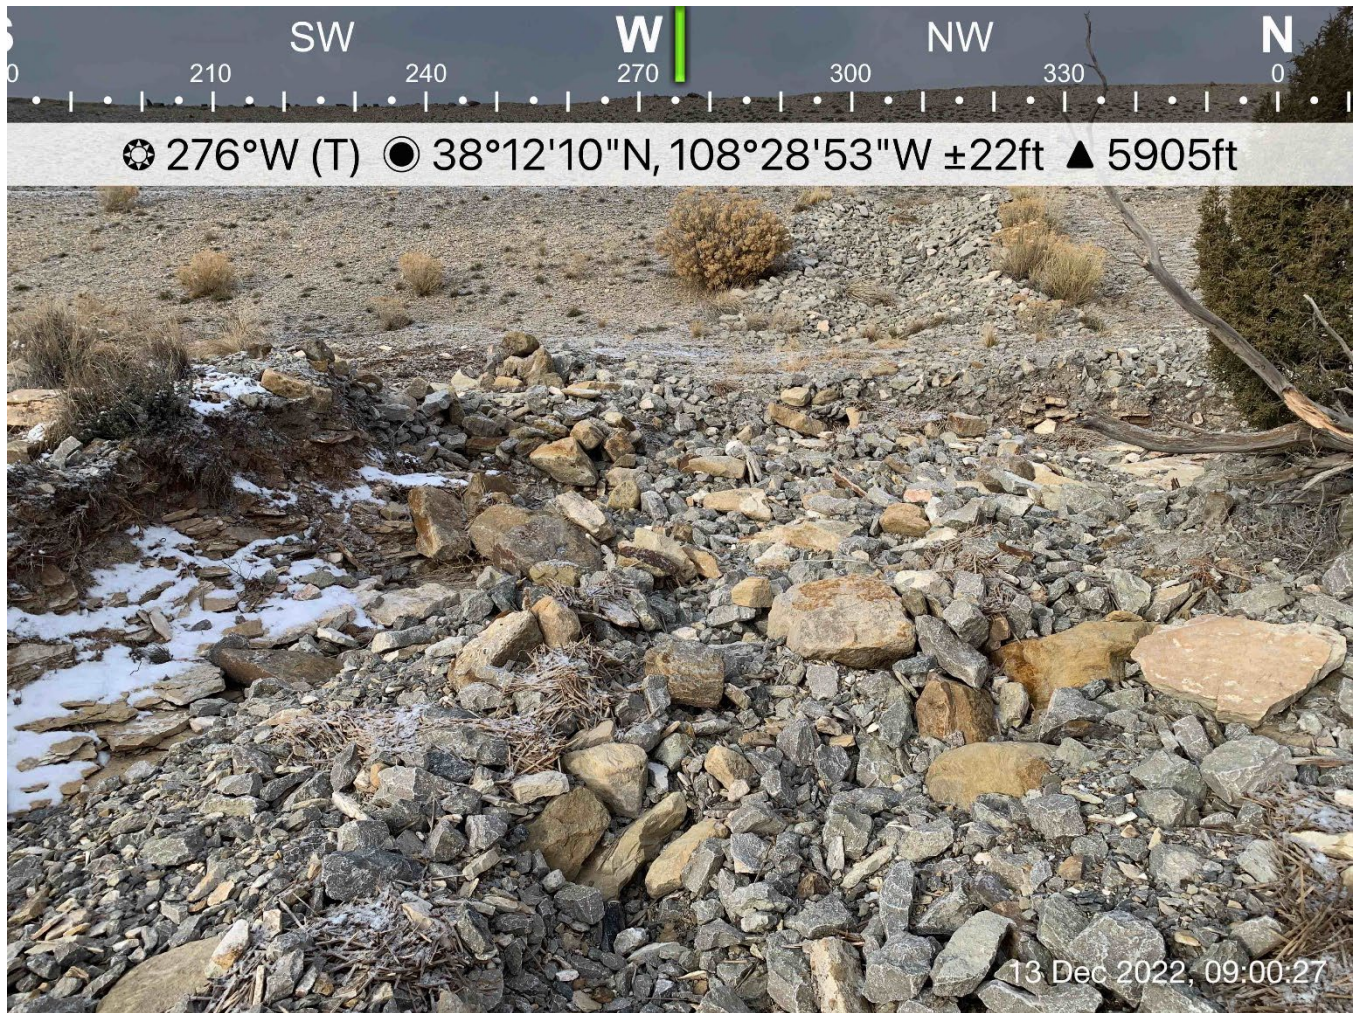
The stormwater control features at the facility were observed to be in good condition. Downchute channels and energy dissipation basins at the facility are constructed with riprap. At the time of the visual observation, repair work had recently been completed to address erosion damage to several of the downchute channels. The weekly inspection forms indicate that the damage was caused by major storm events in late September and early October 2022. The repair work appeared to be adequate to address the damage. The typical condition of the downchute channels is depicted in Photograph 7. Terrace channels at the facility are provided at approximate 20-foot vertical intervals. Erosion control wattles have been installed to control erosion and capture sediment in the terrace channels at appropriate intervals. The typical condition of the terrace channels is depicted in Photograph 8. Perimeter channels are in place around the facility where they are needed to control stormwater. Perimeter channels at the facility are generally constructed with soil and rock. Erosion control wattles have been installed at appropriate intervals in the perimeter channels to control erosion and capture sediment. The typical condition of the perimeter channels is depicted in Photograph 9. During the visual observation, Golder observed the significant damage to a stormwater outfall that was caused by major storm events in late September and early October 2022, where indicated in Appendix A. The damage is shown in Photograph 10. This damage should be

Photograph 10: Damage to Stormwater Outfall

a. H.4. Repairs are needed at the stormwater outfall on the southern half of the east perimeter due to erosion damage from a major storm event.						
b.

repaired, and Golder is in the process of developing recommendations for repair work to address the damage. The damage does not currently pose a threat to structural stability and did not hinder Golder's ability to inspect the facility.

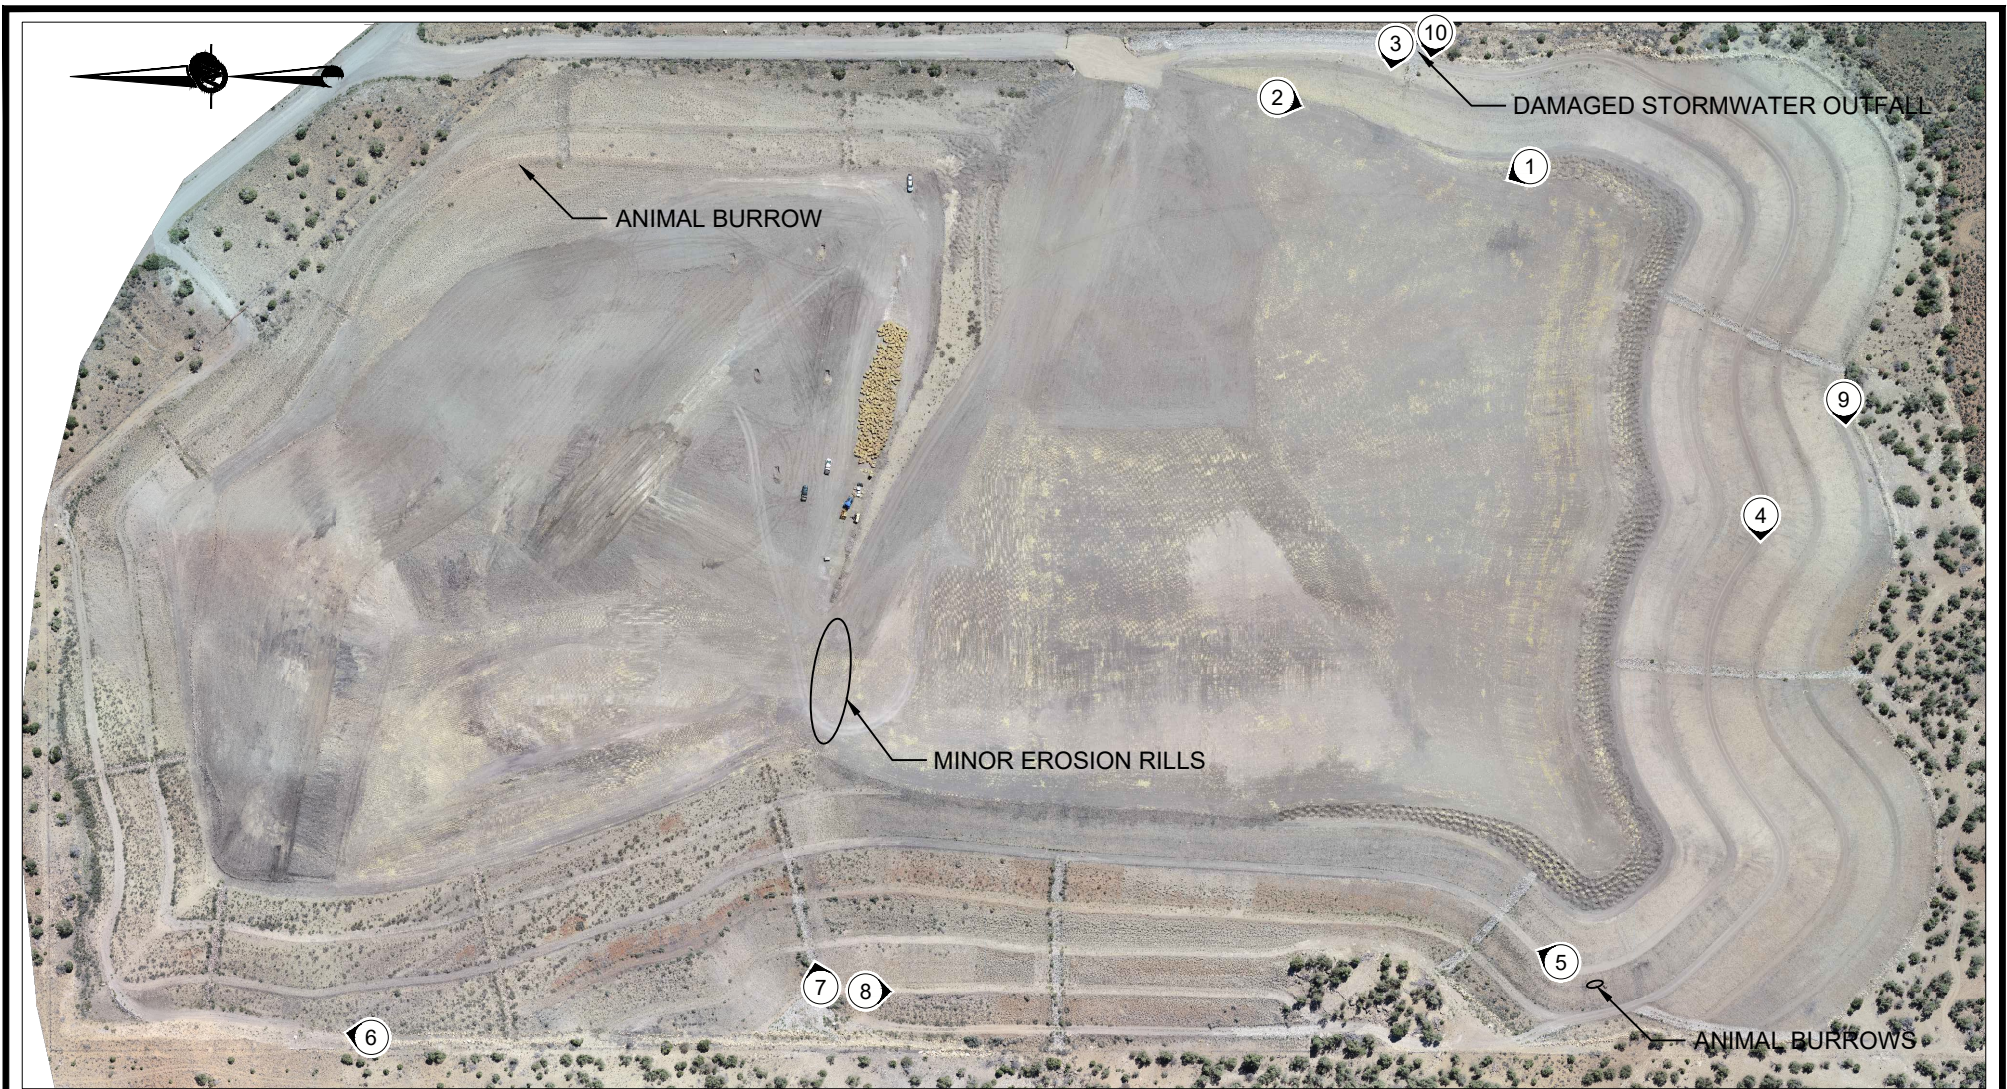
ANNUAL INSPECTION FORM

c.						
d.						
e.						
J. Elaboration						
Identify the specific item number (for instance, F.2.) and elaborate on each deficiency or issue identified during the annual inspection. Attach documentation (photographs or sketches) if practical.						
D.3. Minor erosion rills were observed along the west edge of the top surface, near the crest of the top surface access road (see the map on page 3). Tri-State personnel indicated that erosion rills have been recurring in this location. Tri-State has requested that Golder provide recommendations on armoring in this location.						
D.5. Small animal burrows were observed in one location near the southwest corner of the facility and in another location along the east edge of the facility (see the map on page 3). Tri-State should monitor these areas for continued burrowing activity.						
H.4. Perimeter channels and stormwater outfalls are in good condition, with one exception. The stormwater outfall on the southern half of the east perimeter (see the map on page 3) was damaged by major storm events in late September and early October, according to Tri-State personnel. Repairs should be made. Tri-State has requested that Golder provide recommendations on how to conduct the repair work.
