# COAL COMBUSTION RESIDUALS LANDFILL ANNUAL INSPECTION REPORT

Nucla Station Ash Disposal Site

January 18, 2016

103-81938

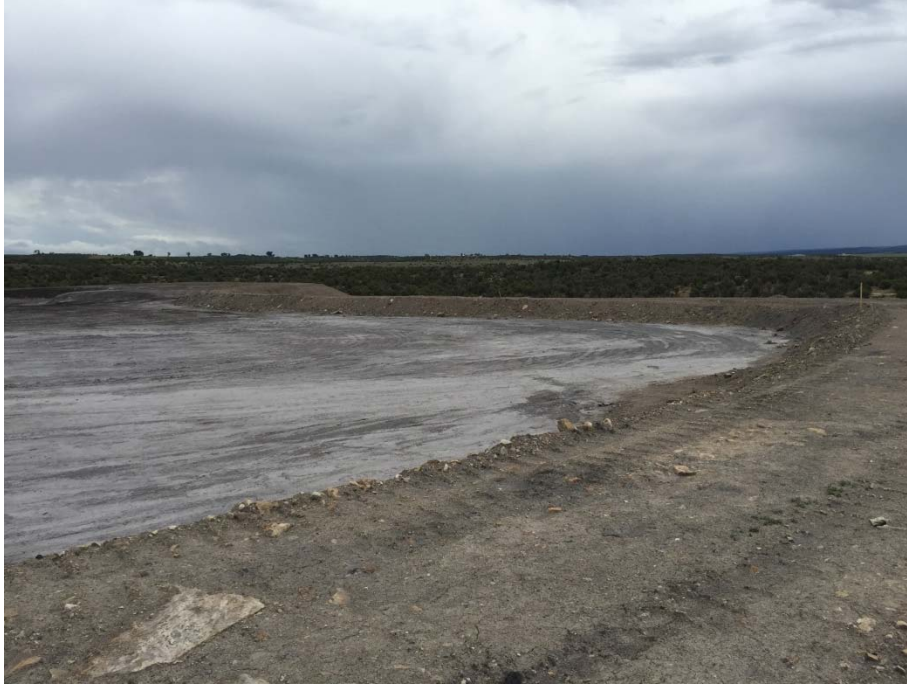
**Figure 1: Typical Ash Deposition Area Condition**

The ash deposition area was observed to be in good condition. No signs of ground movement, such as sloughing or sliding, cracking, subsidence, or bulging, were observed in the ash deposition area. Ash deposition was occurring at the time of the visual observation. The ash deposition methodology appeared to be appropriate. Ash contact water was being collected within the ash deposition area. A berm that was several feet in height was in place around the perimeter of the ash deposition area to prevent

migration of ash contact water out of the ash deposition area. Fugitive dust was being adequately controlled at the time of the visual observation. The typical condition of the ash deposition area is depicted in Figure 1.

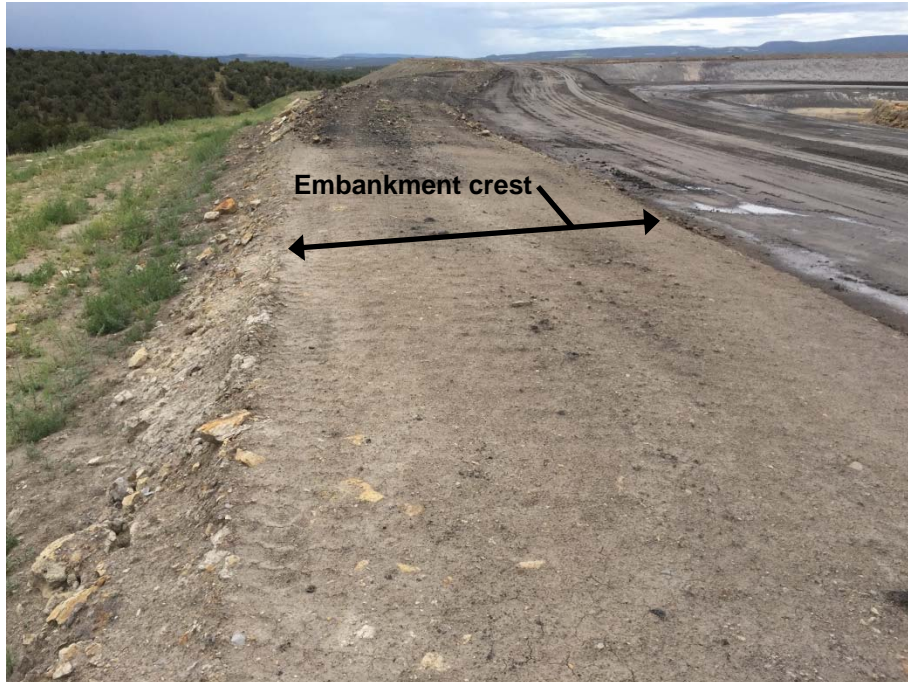
**Figure 2: Typical Embankment Crest Condition**

The embankment crest was observed to be in good condition. No cracking indicative of ground movement was observed along the embankment crest. No low areas indicative of differential settlement were observed along the embankment crest. The typical condition of the embankment crest is depicted in Figure 2.

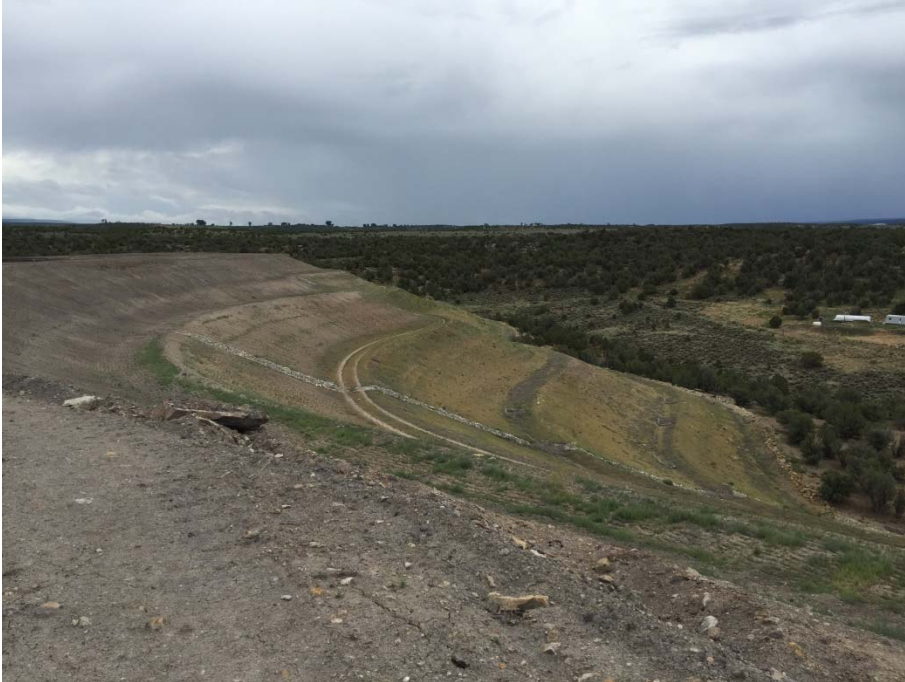
**Figure 3: Typical Embankment Slope Condition**

The embankment slopes were observed to be in fair condition. No signs of ground movement, such as sloughing or sliding, cracking, subsidence, or bulging, were observed on the embankment slopes. No evidence of significant or excessive erosion or slope deterioration was observed on the embankment slopes. Slope stability calculations completed by Golder indicate that the embankment slopes at the facility are expected to remain stable with acceptable factors of safety under anticipated maximum loading conditions (static and seismic). Native vegetation is being established on the embankment slopes as the facility is progressively built higher. Lower portions of embankment slopes have adequate vegetative coverage, while upper portions of embankment slopes have not yet been in place long enough for a mature vegetative community to be established. Repair of erosion rills is being conducted in these areas as needed, and one such repair location was noted. No unusually poor or thriving vegetative growth was observed on the embankment slopes. Some woody shrubs were observed on the embankment slopes. This type of vegetation is typical of the surrounding area, and mitigation is not considered to be necessary. No trees were observed on the embankment slopes. The extent of woody shrubs was minor and does not pose a threat to structural stability. Animal burrows were observed in three areas, as shown on the plan view included in Appendix C. The extent of burrowing was minor and does not pose a threat to structural stability. The typical condition of the embankment slopes is depicted in Figure 3. Animal burrows observed on an embankment slope in the southeast portion of the facility are shown in Figure 4.

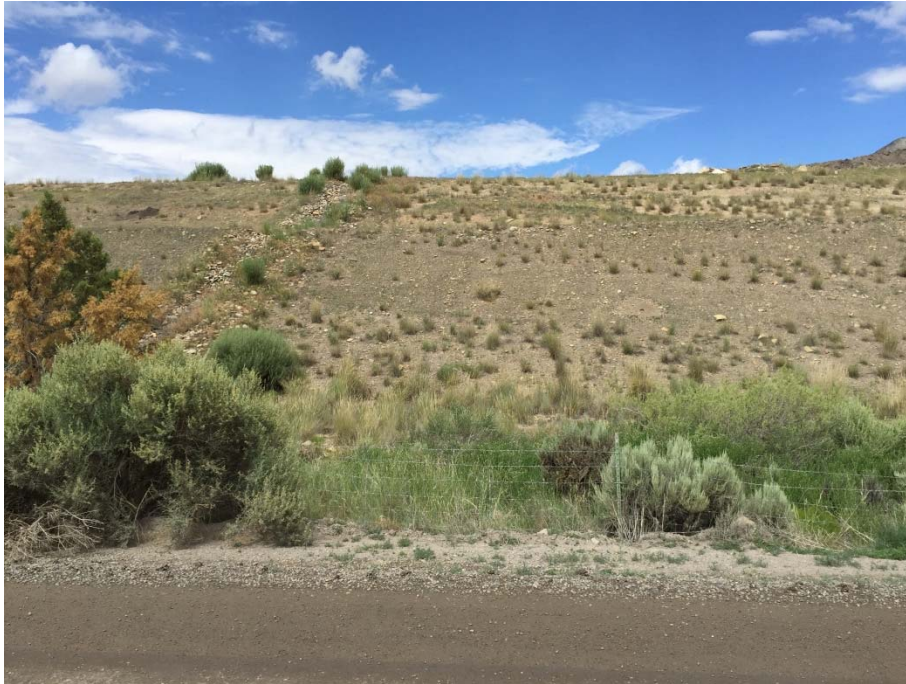
**Figure 5: Typical Embankment Toe Condition**

The embankment toe was observed to be in good condition. No signs of seepage, such as springs or boggy areas, were observed at the embankment toe. Golder observed one area along the embankment toe, shown on the plan view in Appendix C, where vegetation was thriving more than in the surrounding

areas. Upon further inspection, Golder found that surface water was being retained in a shallow pool at this location before draining away from the area. The retained surface water does not pose a threat to structural stability. The typical condition of the embankment toe is depicted in Figure 5.

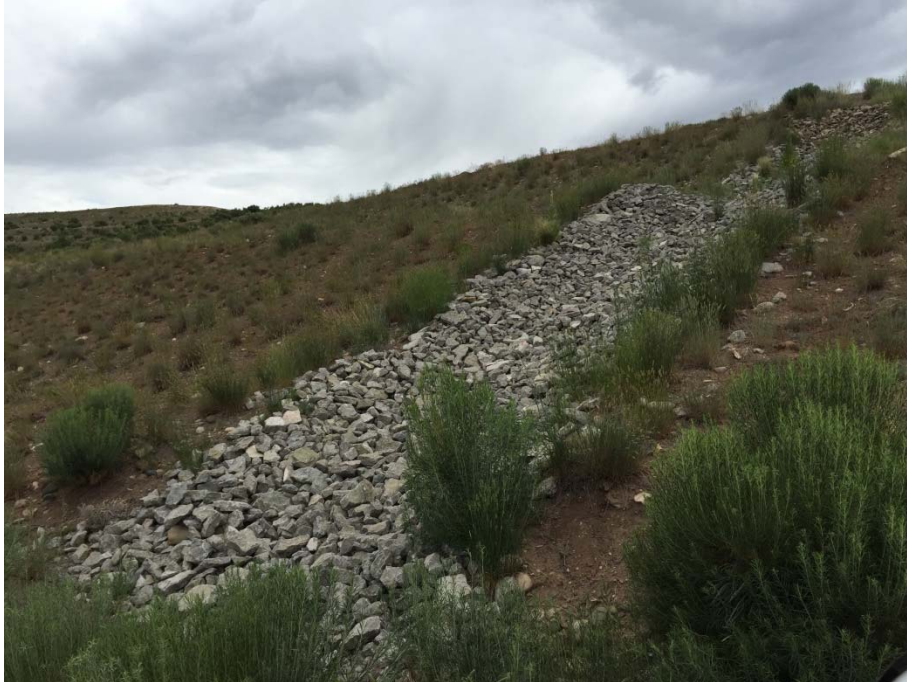
**Figure 6: Typical Downchute Channel Condition**

The storm water control features at the facility were observed to be in fair condition. Downchute channels and energy dissipation basins at the facility are constructed with riprap. Surface water calculations completed by Golder indicate that the downchute channels are located and sized appropriately to convey the 100-year, 24-hour storm event. Some of the downchute channels had relatively large shrubs growing in the flow path, and Golder recommended that these be removed periodically to maintain proper functionality. However, the shrubs do not pose a threat to structural stability and did not impact the ability to inspect the facility. The typical condition of the downchute channels is depicted in Figure 6. Terrace channels at the facility are provided at approximate 20-foot vertical intervals and are grass-lined. Straw wattles have been installed to control erosion and capture sediment in the terrace channels at appropriate intervals. Surface water calculations completed by Golder indicate that the terrace channels are located and sized appropriately to convey the 100-year, 24-hour storm event. The typical condition of the terrace channels is depicted in Figure 7. Perimeter channels at the facility are generally constructed with soil and rock. Straw wattles have been installed to control erosion and capture sediment in the perimeter channels at appropriate intervals. The typical condition of the perimeter channels is depicted in Figure 8.
