COAL COMBUSTION RESIDUALS LANDFILL ANNUAL INSPECTION REPORT

Escalante Generating Station

January 18, 2016

1533418CCR

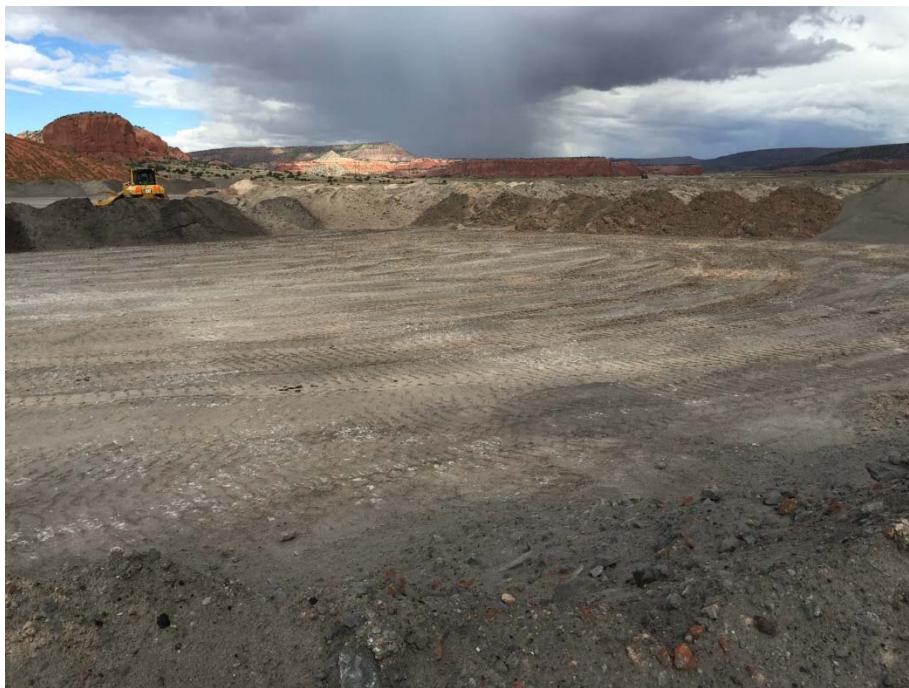
Figure 1: Typical Deposition Area Condition

The deposition area was observed to be in good condition. No signs of ground movement, such as sloughing or sliding, cracking, subsidence, or bulging, were observed in the deposition area. Deposition of CCRs was occurring at the time of the visual observation. The deposition methodology appeared to be appropriate. Contact water was being collected within the deposition area. A berm that was several feet in height was in place around the perimeter of the deposition area to prevent migration of contact water

out of the deposition area. Fugitive dust was being adequately controlled at the time of the visual observation. The typical condition of the deposition area is depicted in Figure 1.

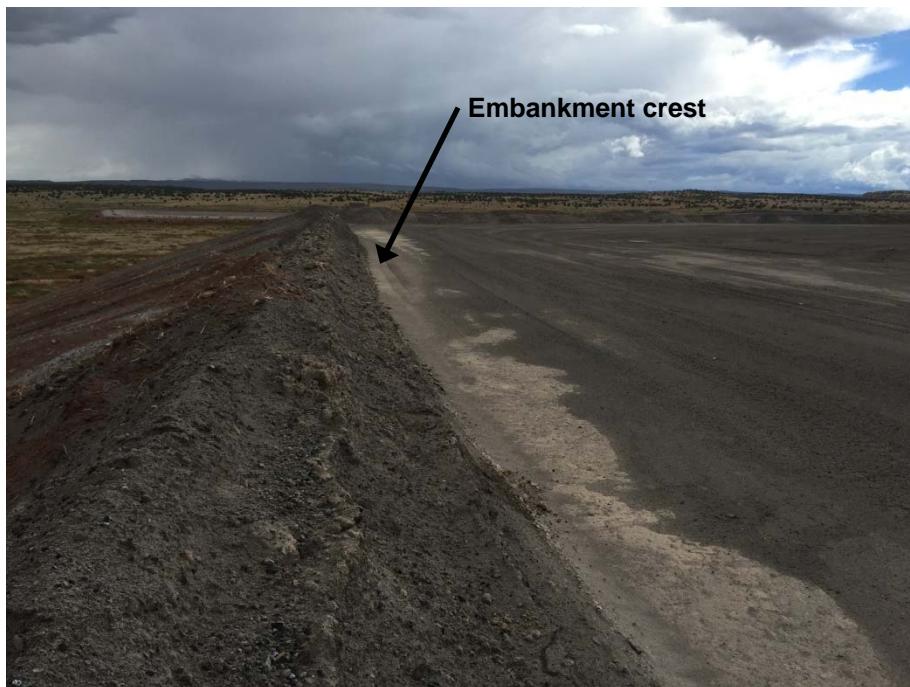
Figure 2: Typical Embankment Crest Condition

The embankment crest was observed to be in good condition. No cracking indicative of ground movement was observed along the embankment crest. No low areas indicative of differential settlement were observed along the embankment crest. The typical condition of the embankment crest is depicted in Figure 2.

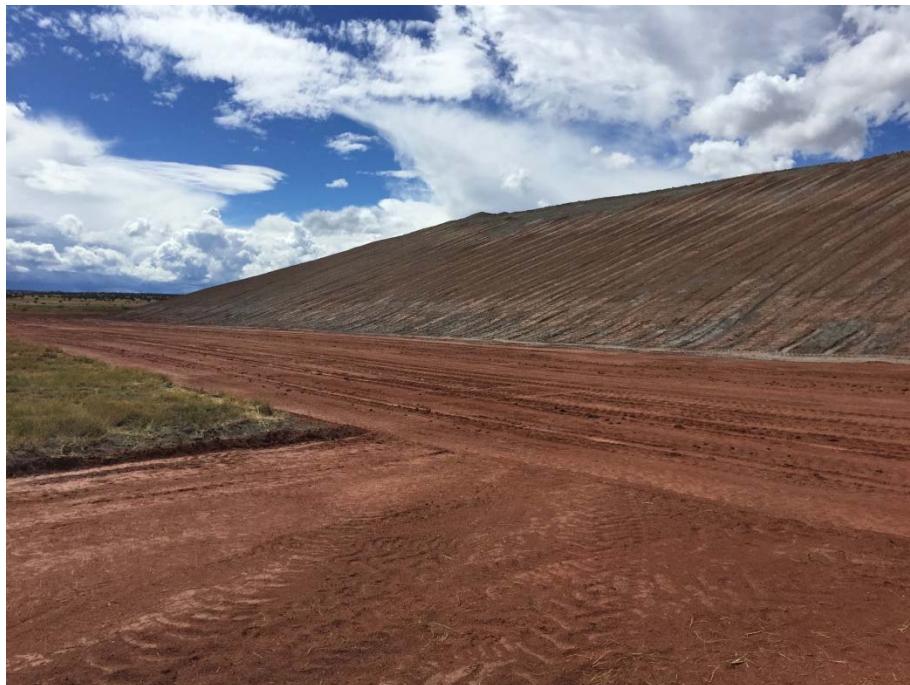
Figure 3: Typical Embankment Slope Condition

The embankment slopes were observed to be in fair condition. No signs of ground movement, such as sloughing or sliding, cracking, subsidence, or bulging, were observed on the embankment slopes. No evidence of significant or excessive erosion or slope deterioration was observed on the embankment slopes. The embankment slopes had not been vegetated at the time of the visual observation, so no unusual vegetative growth or woody vegetation was observed on the embankment slopes. No signs of animal burrowing were observed on the embankment slopes. At the time of the visual observation, soil cover had been placed over the exposed CCRs in some areas of the embankment slopes. However, sufficient soil resources had not yet been placed to fully cover the embankment slopes. Tri-State indicated that additional soil would be obtained for this purpose as part of the ongoing cover soil recovery and conservation process. The typical condition of the embankment slopes is depicted in Figure 3.

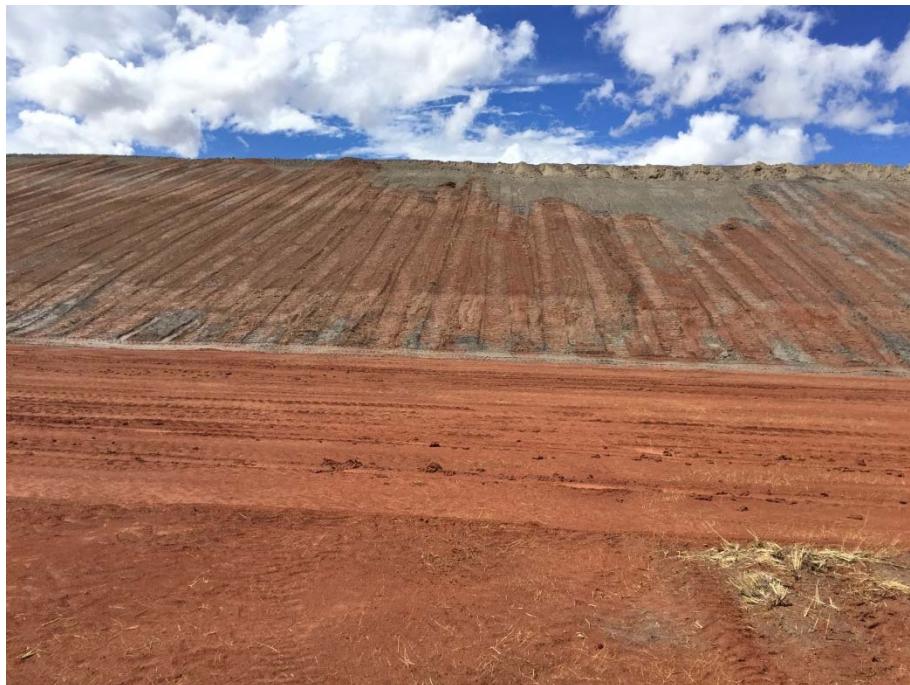
Figure 4: Typical Embankment Toe Condition

The embankment toe was observed to be in good condition. No signs of seepage, such as springs or boggy areas, were observed at the embankment toe. At the time of the visual observation, the embankment toe had been cleared recently to facilitate placement of soil cover on portions of the embankment slopes. The typical condition of the embankment toe is depicted in Figure 4.

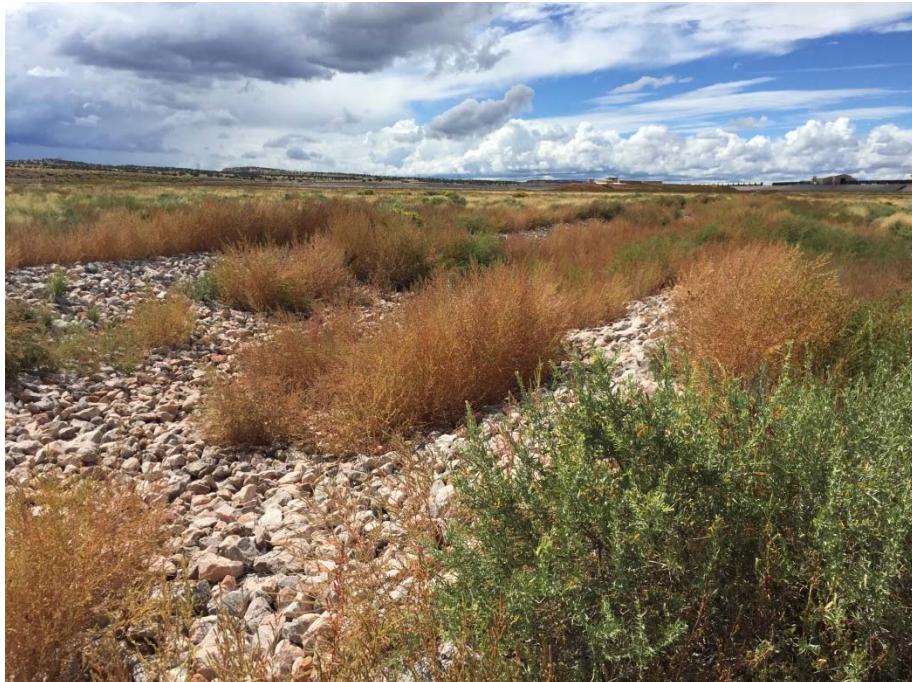
Figure 5: Typical Storm Water Channel Condition

The storm water control features at the facility were observed to be in fair condition. At the time of the visual observation, the only permanent storm water control feature at the facility was a run-on control channel that is designed to convey storm water from west to east along the south end of the facility. The run-on control channel is armored with riprap. It had relatively large shrubs growing in the flow path, and periodic shrub removal may be needed to maintain proper functionality. However, the shrubs do not pose a threat to structural stability. The typical condition of the run-on control channel is depicted in Figure 5.
