**Active Coal Combustion Residuals Disposal Facility
2023 Annual Inspection**
Escalante Station

Tri-State Generation and Transmission Association, Inc.

21453429.000-001-RPT-0

January 13, 2024

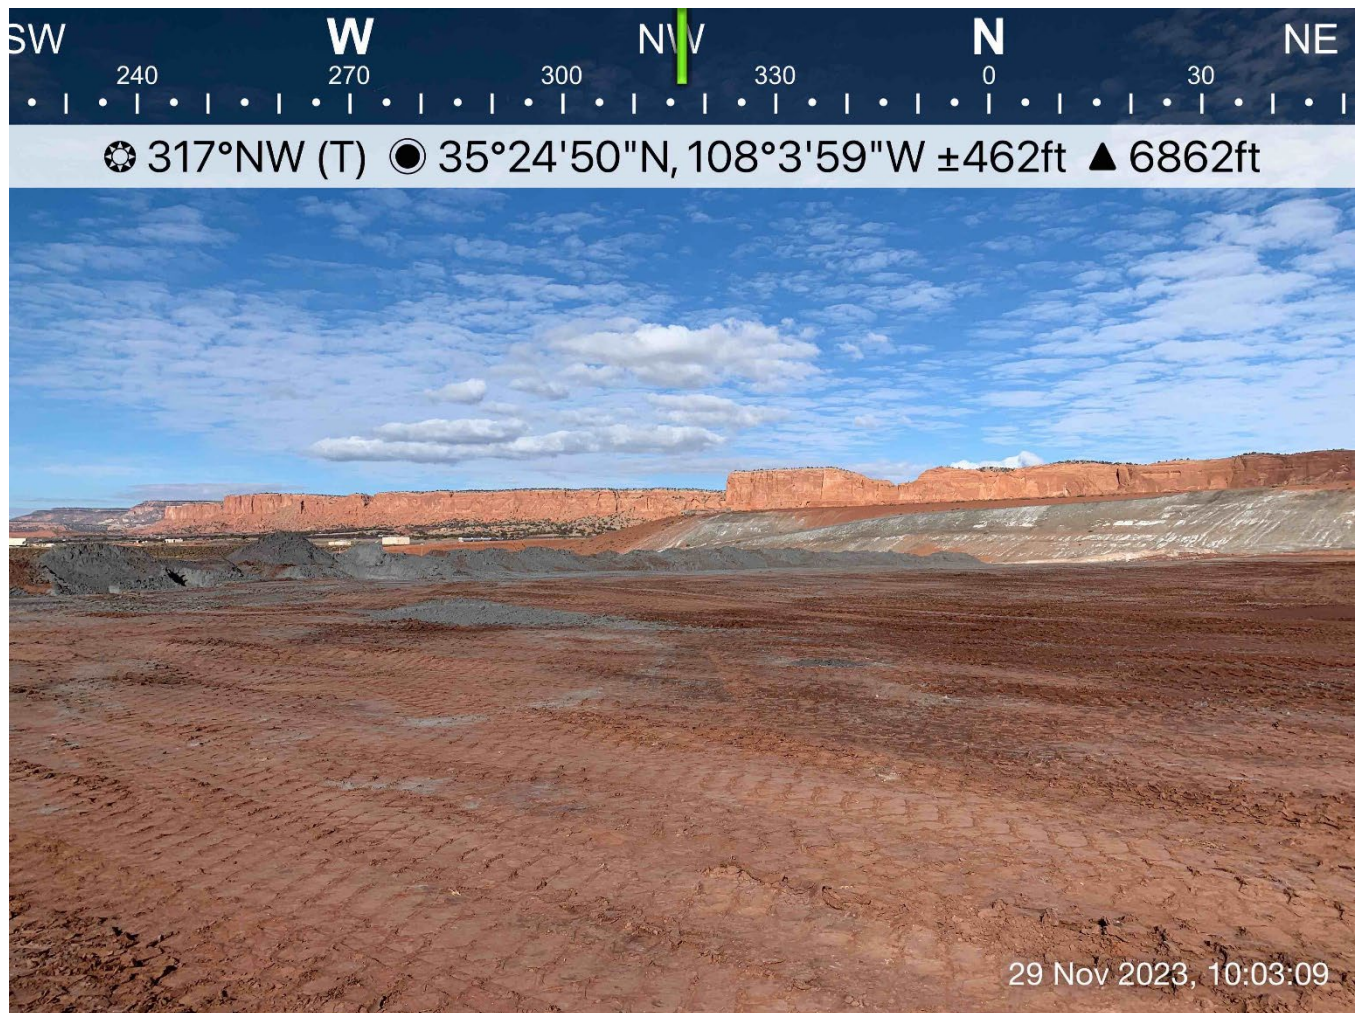
The deposition area was observed to be in good condition. Appendix A shows the deposition area location at the time of the visual observation. Signs of ground movement, such as sloughing or sliding, cracking, subsidence, or bulging, were not observed in the deposition area. Appropriate grading had been established to collect CCR contact water within the facility. Fugitive dust was not observed at the time of the visual observation. The typical condition of the deposition area is depicted in Photograph 1.

Photograph 1: Typical Condition of the Deposition Area

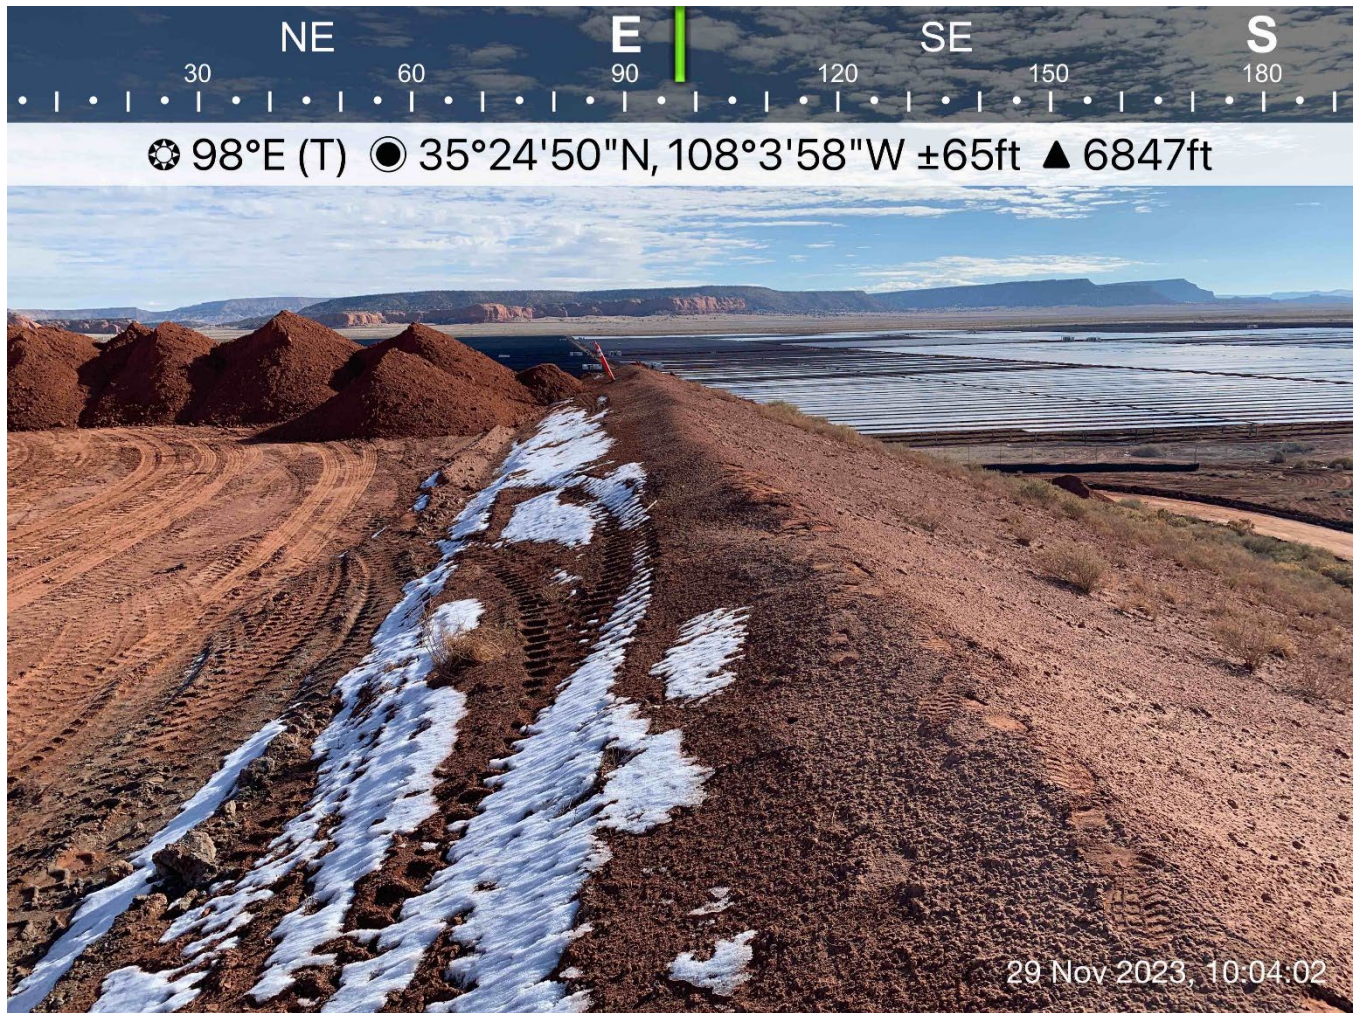
The embankment crest was observed to be in good condition. Cracking that would be indicative of ground movement was not observed along the embankment crest. Low areas that would be indicative of differential settlement were not observed along the embankment crest. The typical condition of the embankment crest is depicted in Photograph 2.

Photograph 2: Typical Condition of the Embankment Crest

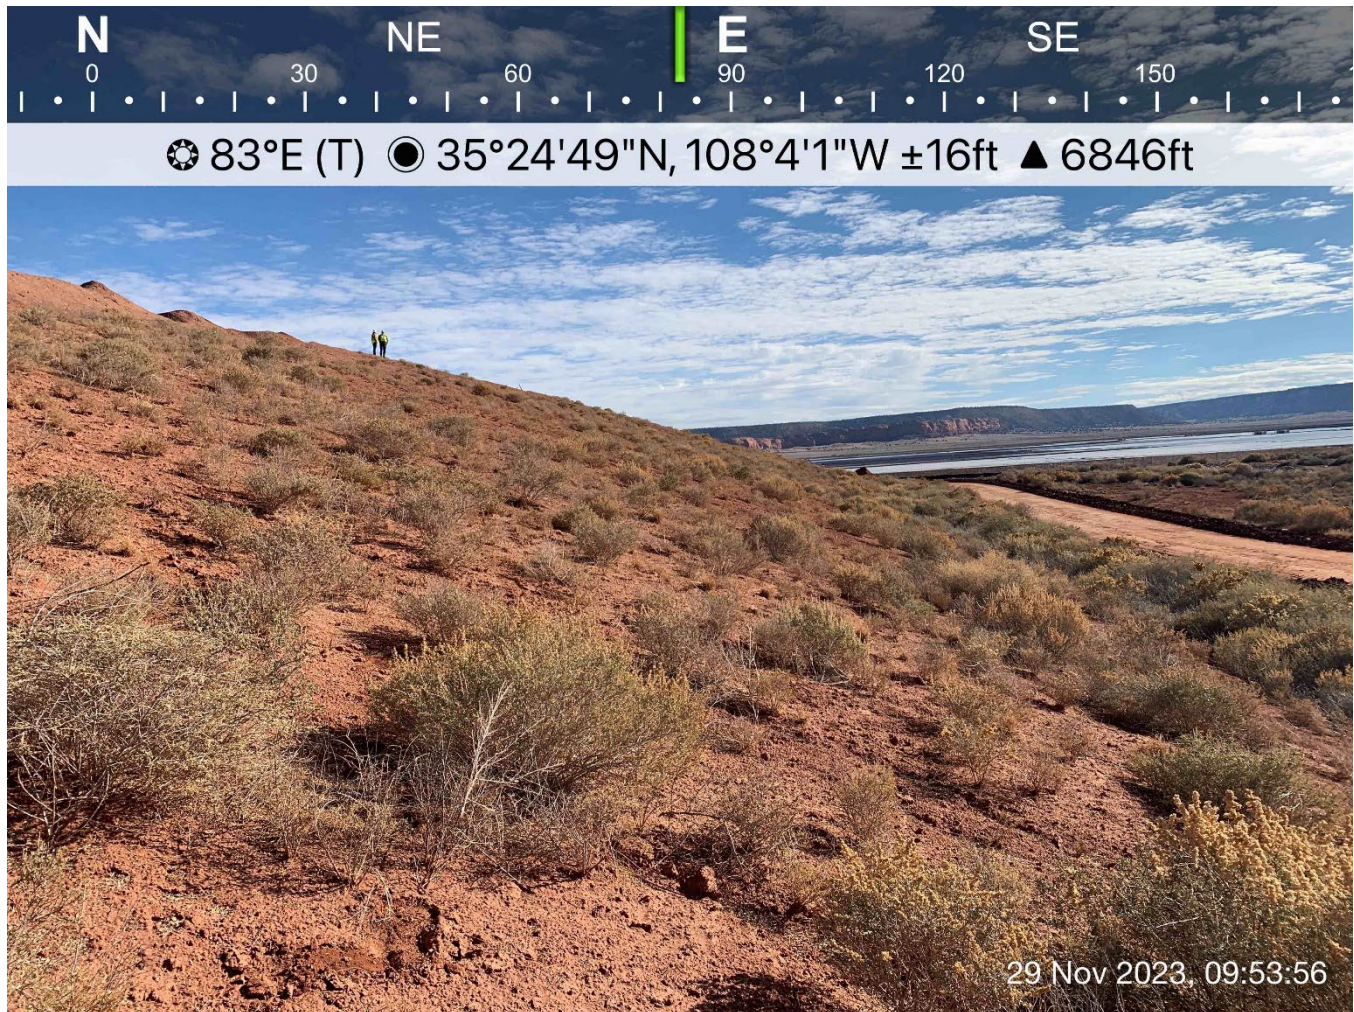
The embankment slopes were observed to be in fair condition. Signs of ground movement, such as sloughing or sliding, subsidence, or bulging, were not observed on the embankment slopes. Evidence of excessive erosion or slope deterioration was not observed on the embankment slopes, but minor rilling was observed on the south embankment slope. The severity of the rilling appeared to be about the same as during previous annual inspections in December 2022 and October 2021 and was similarly observed to increase near the western end of the embankment slope. The rilling does not currently pose a threat to structural stability and is not disrupting the operation or safety of the facility, but it should be monitored and addressed if it becomes excessive. While localized repairs may periodically be needed for rills that become excessively deep or wide, WSP recommends that broad-scale rill repair efforts be deferred until the rills become more severe or a reseeding attempt is planned, as repair efforts would disturb the vegetation and the crust remaining from hydraulic mulch application and may therefore be counterproductive.

Native vegetation was observed on the south embankment slope but not on the east embankment slope due to the ongoing construction work and associated removal of interim cover soil. Unusually poor or thriving vegetative growth was not observed on the south embankment slope, but establishment of a mature vegetative community continues to be challenging given the climatic conditions at the site. No trees were observed on the embankment slopes. Active animal burrows were not observed on the embankment slopes. The typical condition of the south embankment slope is depicted in Photograph 3. The condition of the east embankment slope at the time of the visual observation is depicted in Photograph 4. The east embankment slope will need to be revegetated or armored after the ongoing construction work is complete.

Photograph 3: Typical Condition of the South Embankment Slope

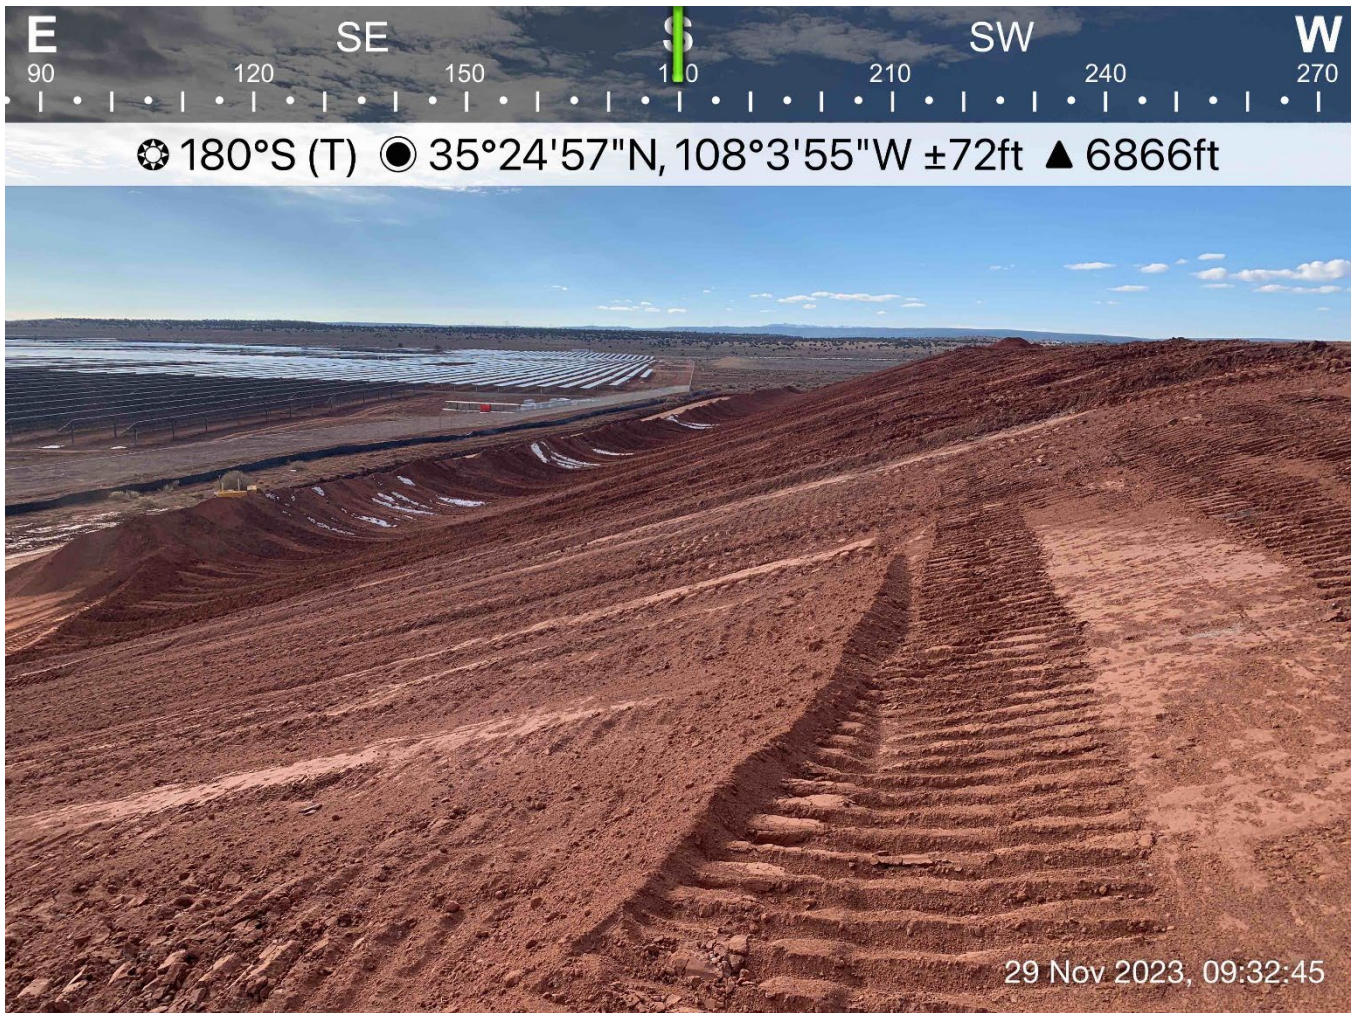
As a noted improvement over conditions observed during the previous annual inspection in December 2022, no wind-deposited CCR particles were observed on the east embankment slope. At the time of the visual observation, Tri-State had recently placed a layer of interim cover soil across the top surface to reduce the

potential for windblown CCR particles. Additionally, Tri-State personnel indicated that the upper zone of interim cover soil on the northern segment of the east embankment slope, where wind-deposited CCR particles were observed during the previous annual inspection in December 2022, had been removed and disposed in the facility.

Photograph 4: Condition of the East Embankment Slope at the Time of the Visual Observation

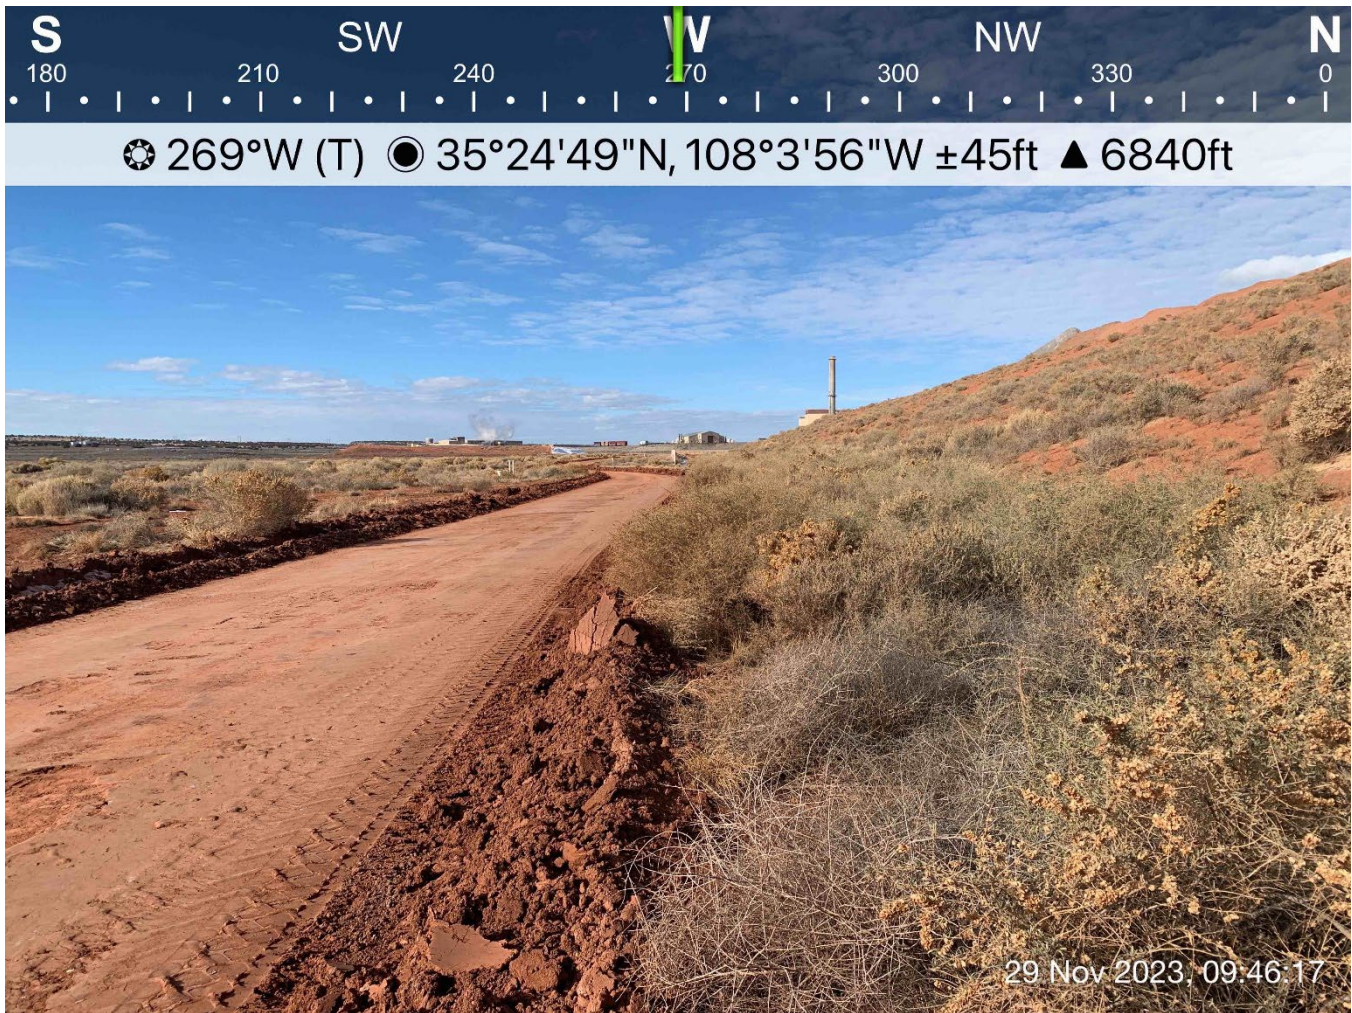
The embankment toe was observed to be in good condition. Signs of seepage, such as springs or boggy areas, were not observed along the embankment toe. The typical condition of the embankment toe is depicted in Photograph 5.

Photograph 5: Typical Condition of the Embankment Toe

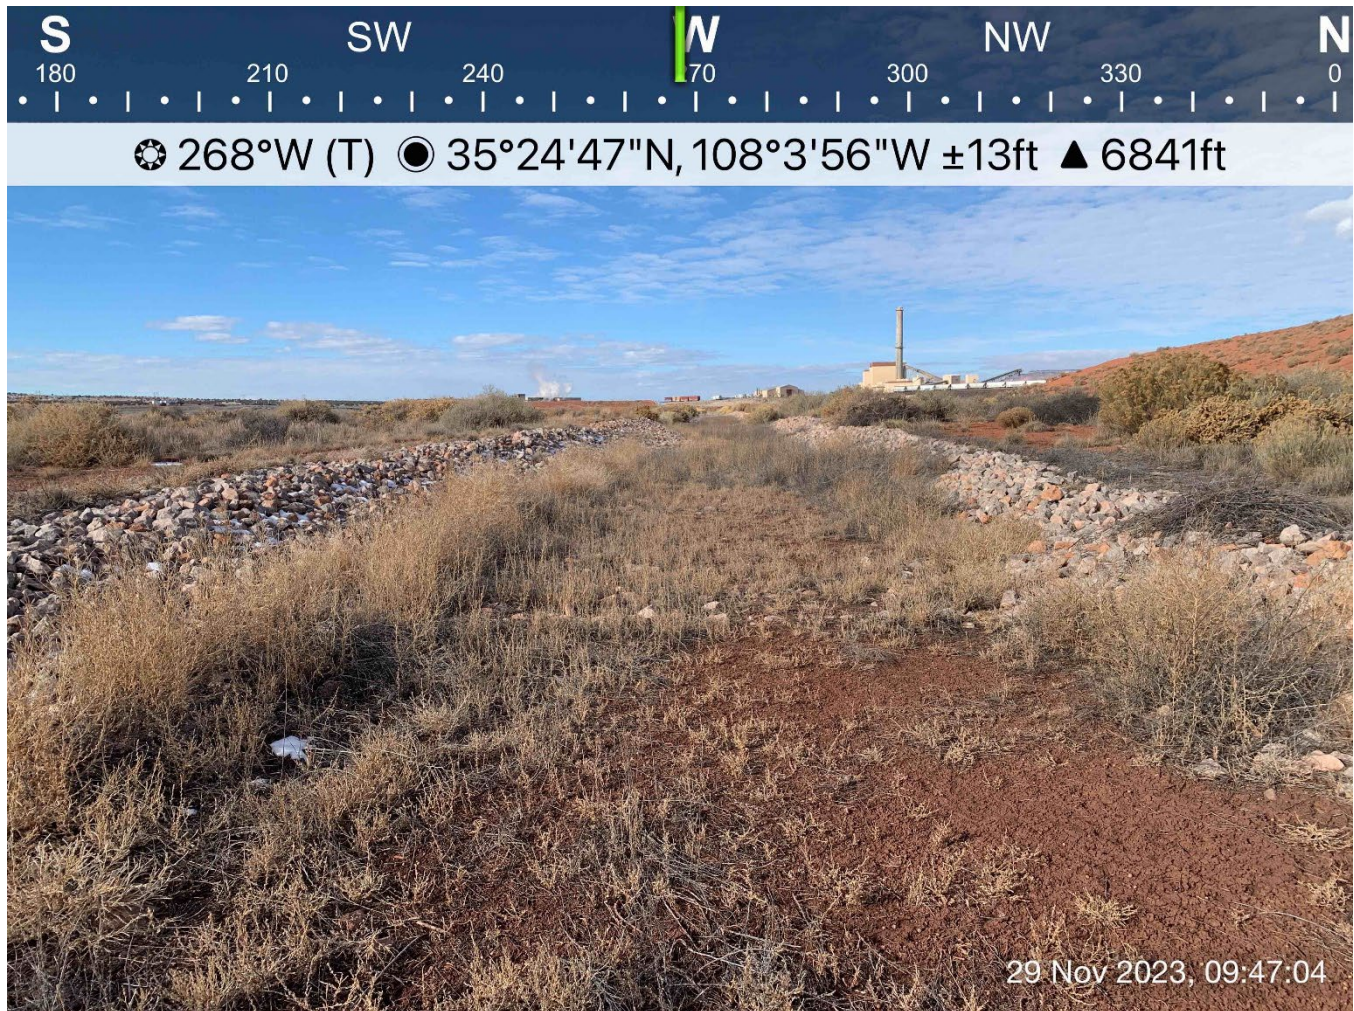
The stormwater control features at the facility were observed to be in fair condition. At the time of the visual observation, the only permanent stormwater control feature at the facility was a run-on control channel that is designed to convey stormwater from west to east outside the southern limit of the facility. The run-on control channel is armored with riprap. Shrubs were observed to be growing in the flow path, and an area of sediment accumulation was observed near the east end of the channel. The shrubs and sediment are not disrupting the operation or safety of the facility, but they should be removed periodically to help maintain the channel’s flow capacity. The typical condition of the run-on control channel is depicted in Photograph 6.

Photograph 6: Typical Condition of the Run-on Control Channel

WSP completed an annual inspection of the active CCR disposal facility at Escalante Station to address the requirements of 40 CFR 257.84(b)(1). Signs of distress or malfunction of the facility were not observed, and appearances of actual or potential structural weakness of the facility were not identified. Facility maintenance activities that should be carried out as the need is indicated by weekly inspections conducted in accordance with 40 CFR 257.84(a) include control of burrowing animals, repair of significant erosion damage on embankment slopes, revegetation of embankment slopes, control and containment of CCR contact water, and periodic removal of shrubs and sediment from the run-on control channel.
