**Active Coal Combustion Residuals Disposal Facility
2024 Annual Inspection**
Escalante Station

Tri-State Generation and Transmission Association, Inc.

31403149.3784-001-RPT-0

January 13, 2025

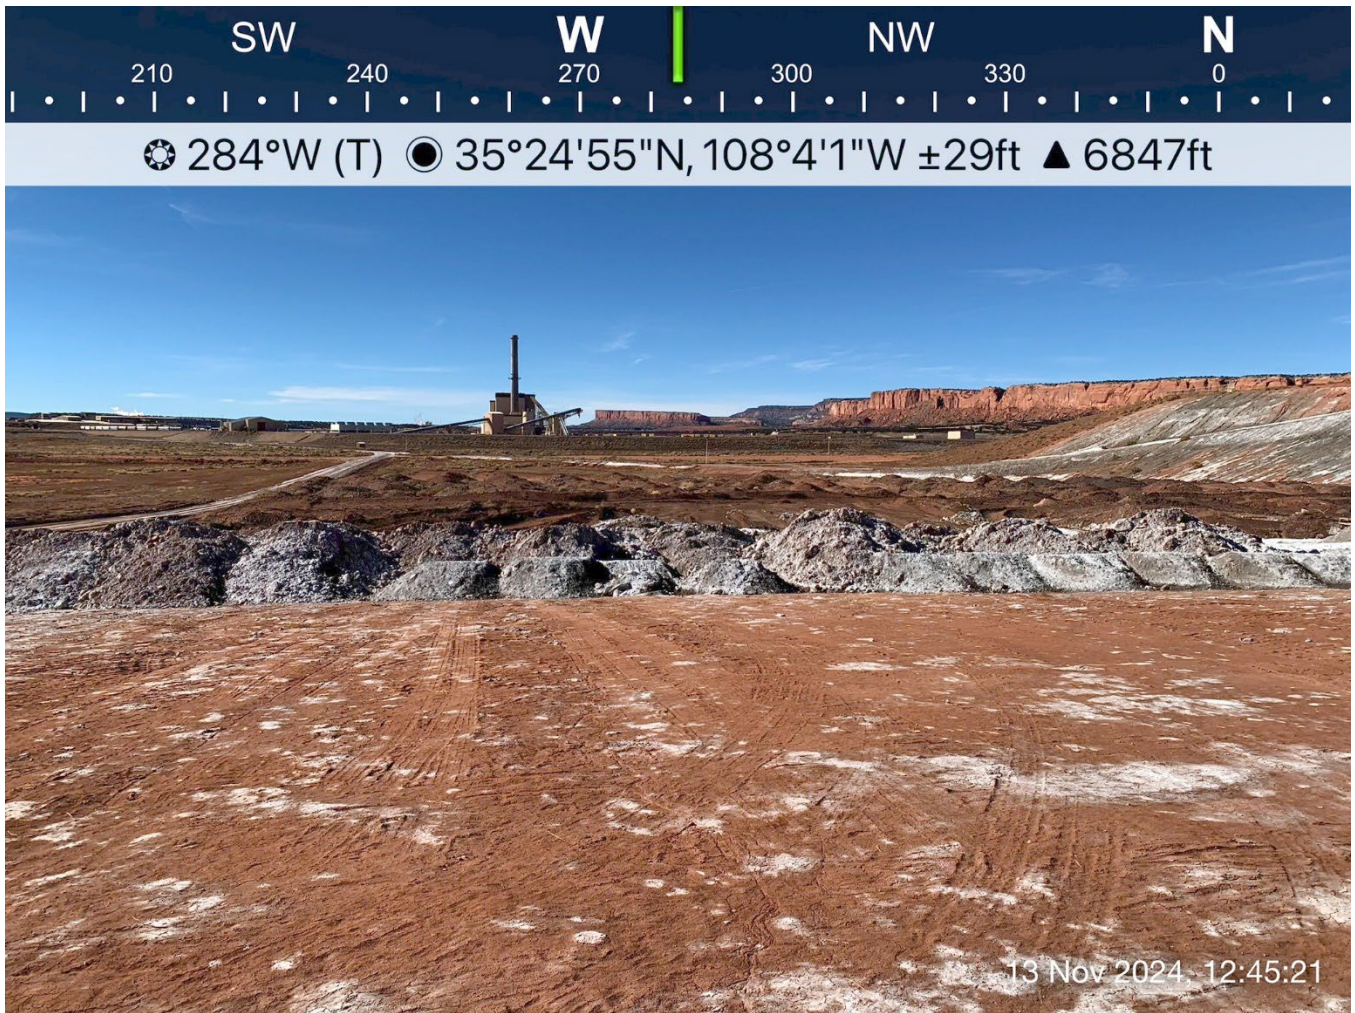
The deposition area was observed to be in fair condition. Appendix A shows the deposition area location at the time of the visual observation. Signs of ground movement, such as sloughing or sliding, cracking, subsidence, or bulging, were not observed in the deposition area. The typical condition of the deposition area is depicted in Photograph 1. Appropriate grading had been established to collect CCR contact water within the facility, except in one location near the southeast corner of the facility where a berm should be installed to eliminate the potential for CCR contact water to accumulate after significant storm events and migrate outside of the facility boundary. This location is shown in Appendix A and depicted in Photograph 2. Fugitive dust was not observed at the time of the visual observation.

Photograph 1: Typical Condition of the Deposition Area

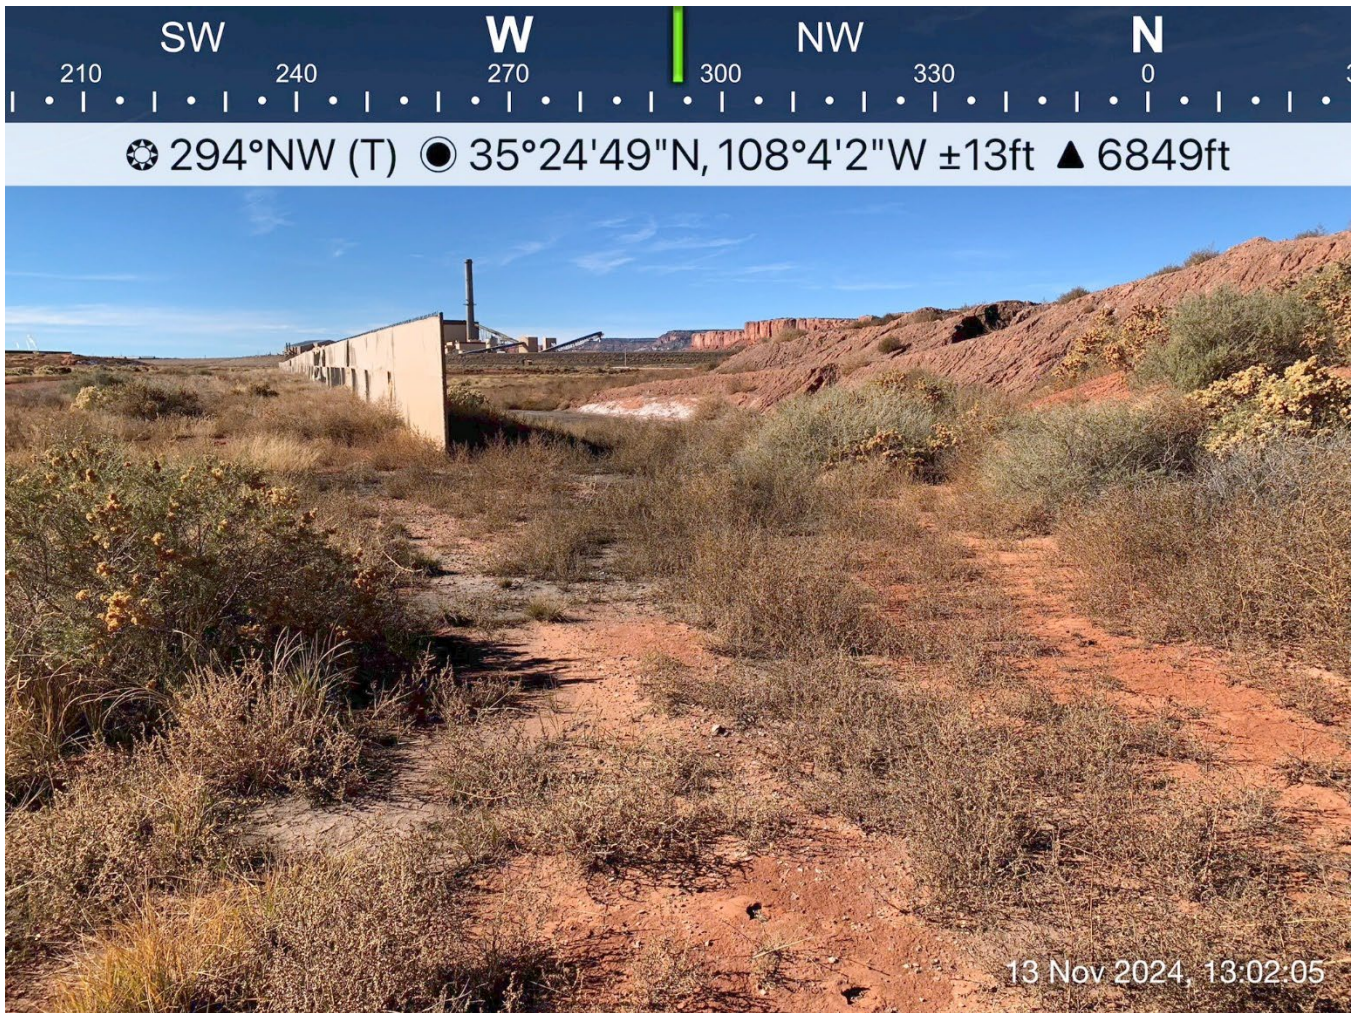
Photograph 2: Location Where Improvements Are Needed to Prevent CCR Contact Water Migration

WSP completed an annual inspection of the active CCR disposal facility at Escalante Station to address the requirements of 40 CFR 257.84(b)(1). Signs of distress or malfunction of the facility were not observed, and appearances of actual or potential structural weakness of the facility were not identified. A berm should be installed in one location near the southeast corner of the facility, where shown in Appendix A, to eliminate the potential for CCR contact water to accumulate after significant storm events and migrate outside of the facility boundary. Facility maintenance activities that should be carried out as the need is indicated by weekly inspections conducted in accordance with 40 CFR 257.84(a) include control of burrowing animals, repair of significant erosion damage on embankment slopes, revegetation of embankment slopes, control and containment of CCR contact water, and periodic removal of shrubs and sediment from the run-on control channel and the downchute channel.

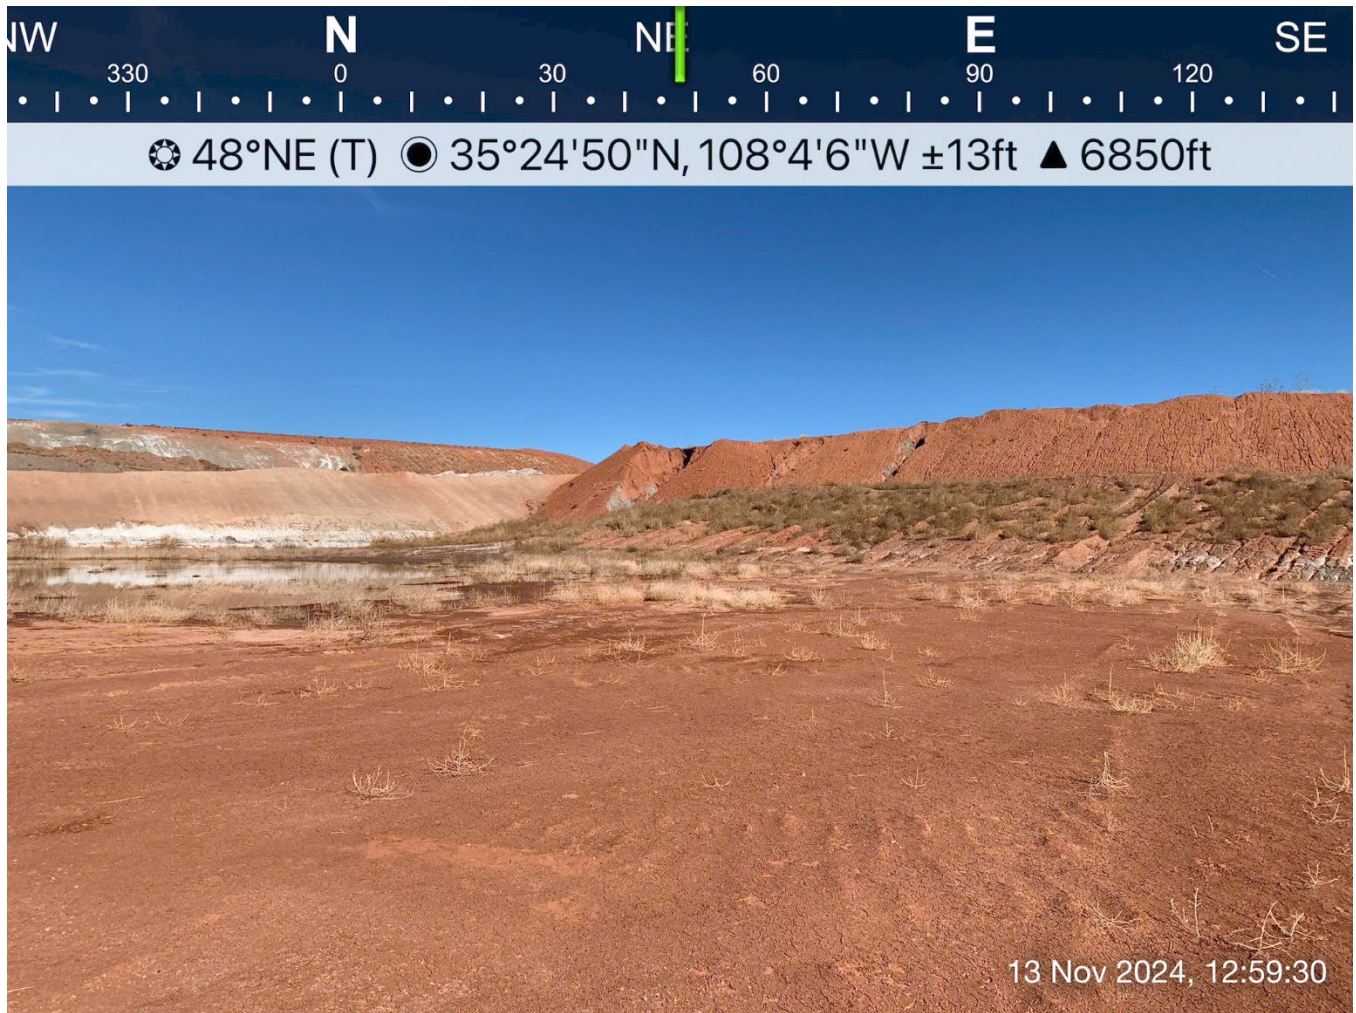
Significant erosion was observed on the relatively steep deposition slope in an area that had evidently been used for placement of waste materials earlier in 2024. This location is shown in Appendix A, and the erosion is depicted in Photograph 3. The erosion is limited to the interior of the facility and does not pose a threat to the structural stability of the embankment slopes. It is not disrupting the operation of the facility, but safeguards should be reviewed to protect personnel working in the area near the crest of the deposition slope. Weekly inspections should include verification that further erosion is not causing sedimentation that disrupts containment of CCR contact water.

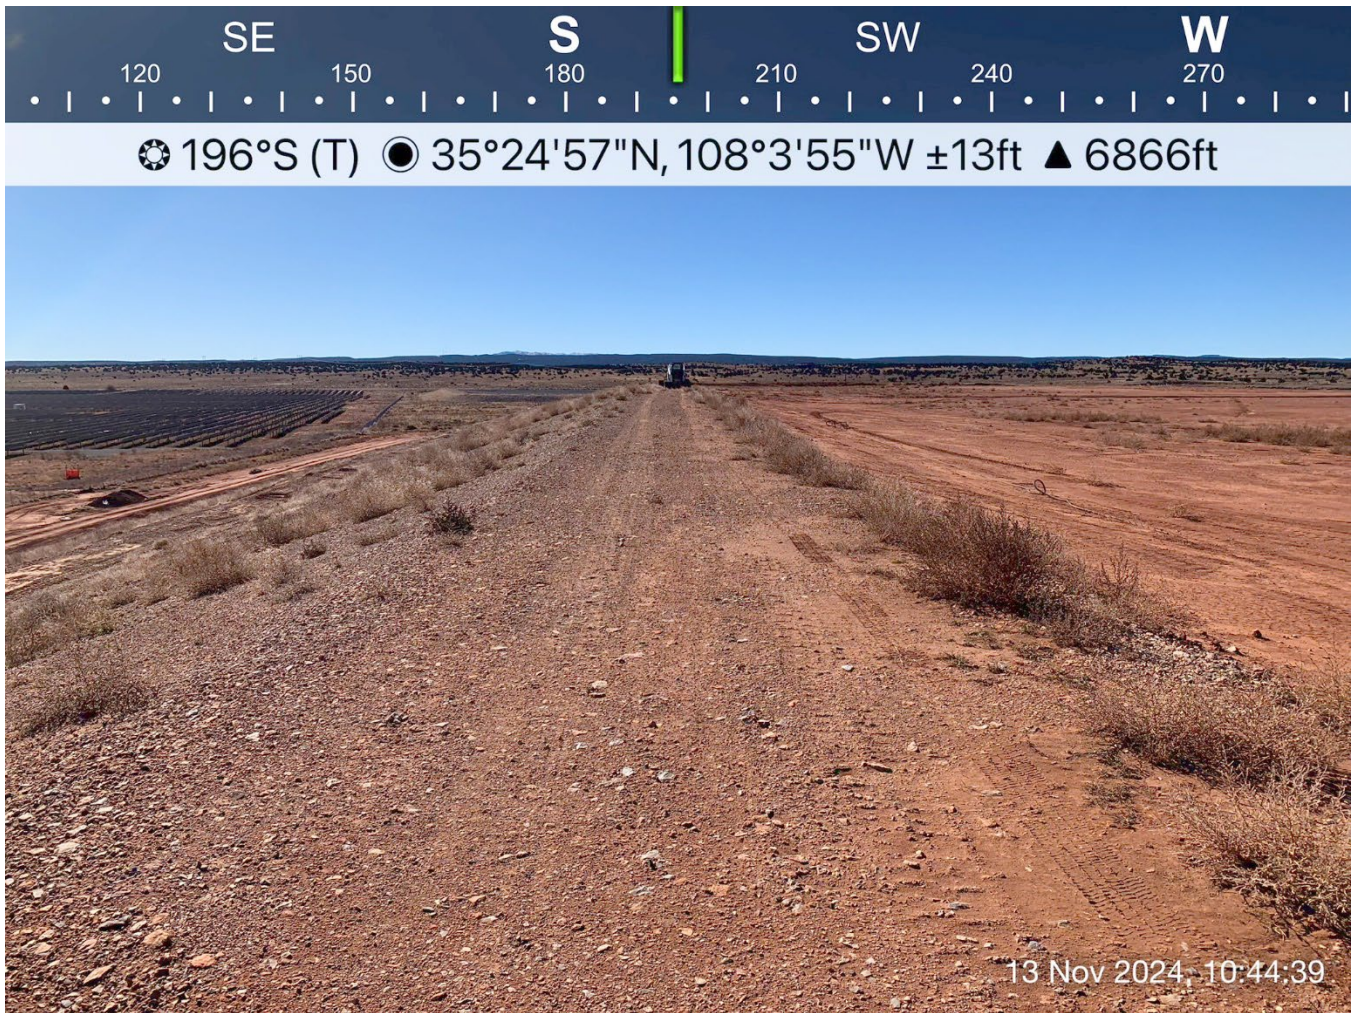
The embankment crest was observed to be in good condition. Cracking that could be indicative of ground movement was not observed along the embankment crest. Low areas that could be indicative of differential settlement were not observed along the embankment crest. The typical condition of the embankment crest is depicted in Photograph 4.

Photograph 4: Typical Condition of the Embankment Crest

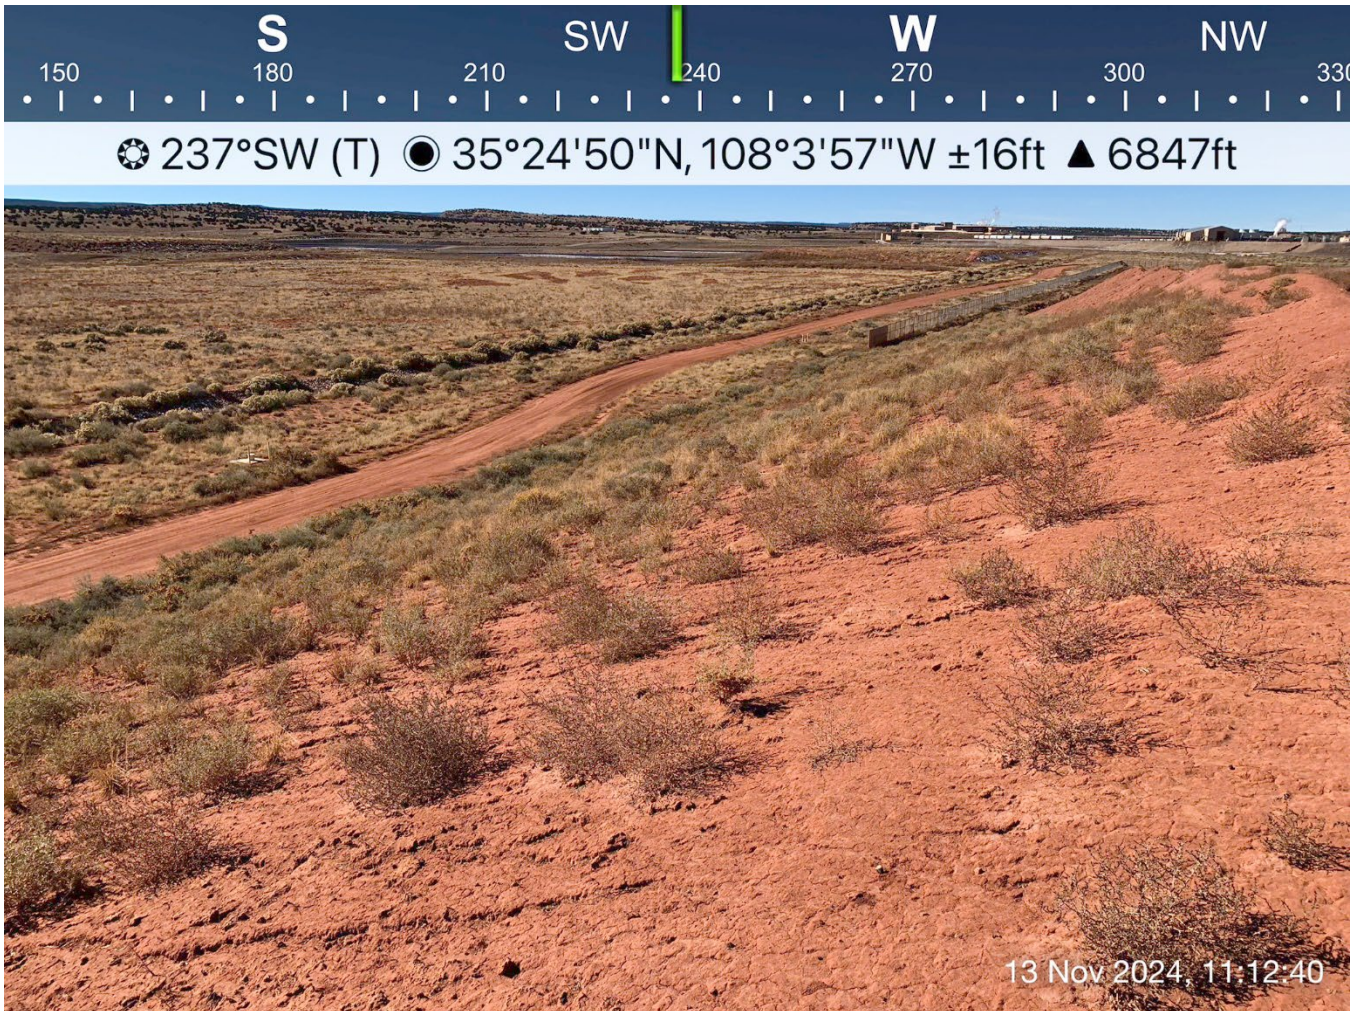
The embankment slopes were observed to be in fair to good condition. Signs of ground movement, such as sloughing or sliding, subsidence, or bulging, were not observed on the embankment slopes. Evidence of excessive erosion or slope deterioration was not observed on the embankment slopes, but minor rilling was observed on the south embankment slope. The severity of the rilling appeared to be slightly greater than during the previous annual inspection and was similarly observed to increase near the west end of the embankment slope. The rilling does not currently pose a threat to structural stability and is not disrupting the operation or safety of the facility, but it should be monitored and addressed if it becomes excessive. While localized repairs may periodically be needed for rills that become excessively deep or wide, WSP recommends that broad-scale rill repair efforts be deferred until the rills become more severe or a reseeding attempt is planned, as repair efforts would disrupt the erosion resistance provided by the vegetation and may therefore be counterproductive.

Photograph 5: Typical Condition of the South Embankment Slope

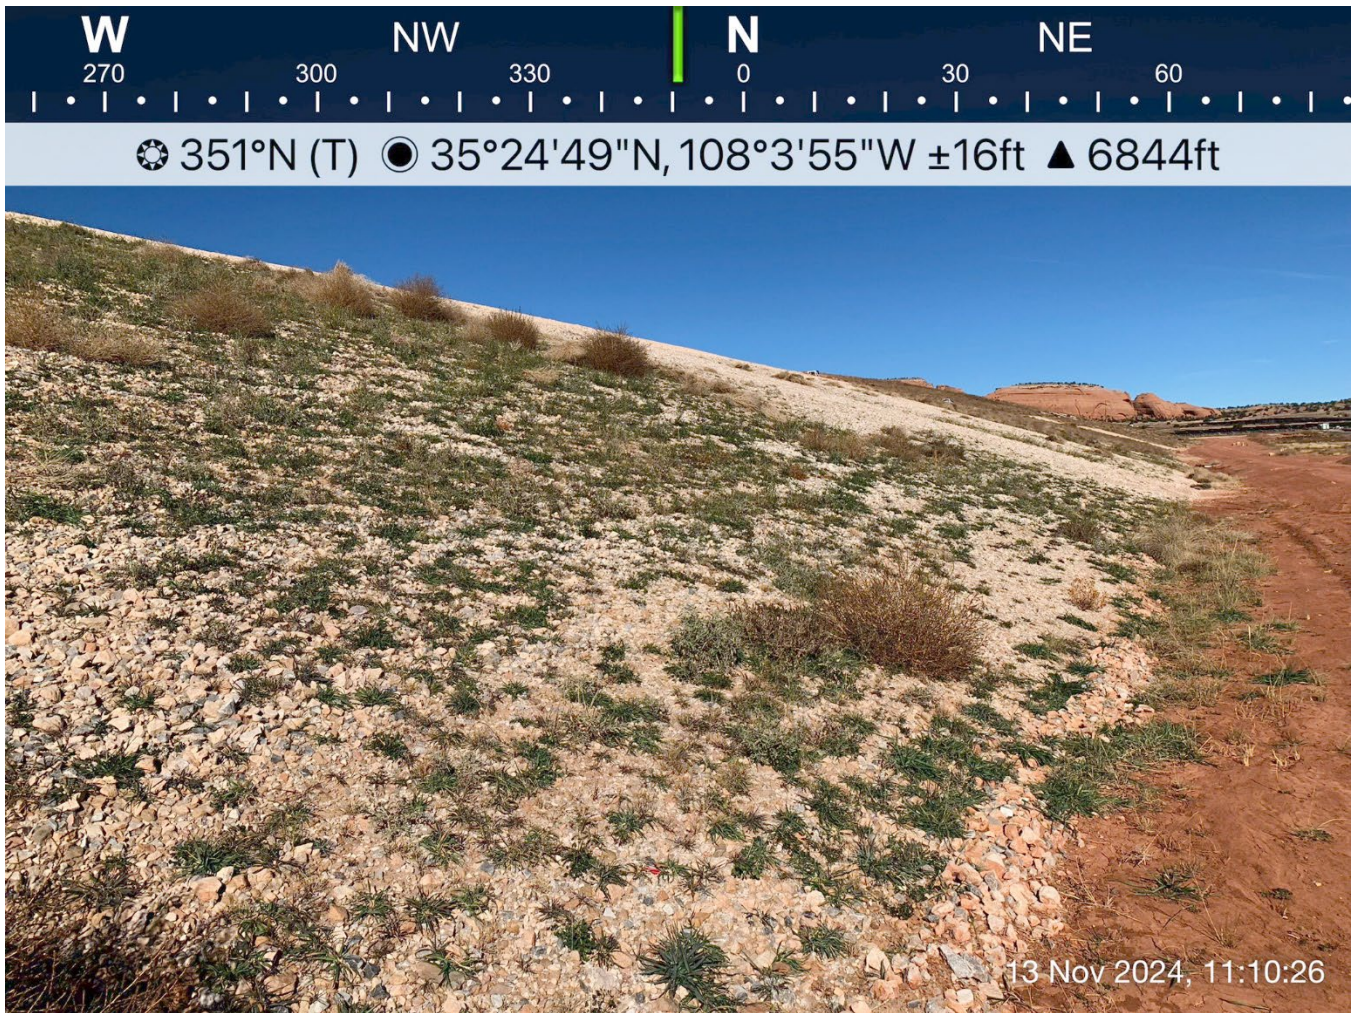
Native vegetation was observed across the south embankment slope and was being established in most areas on the east embankment slope following the completion of the improvements described in Section 2.2. Some areas on the east embankment slope had recently been resurfaced at the time of the visual observation to repair rill erosion, and reseeding will need to be conducted in these areas. Unusually poor or thriving vegetative growth was

Photograph 6: Typical Condition of the East Embankment Slope

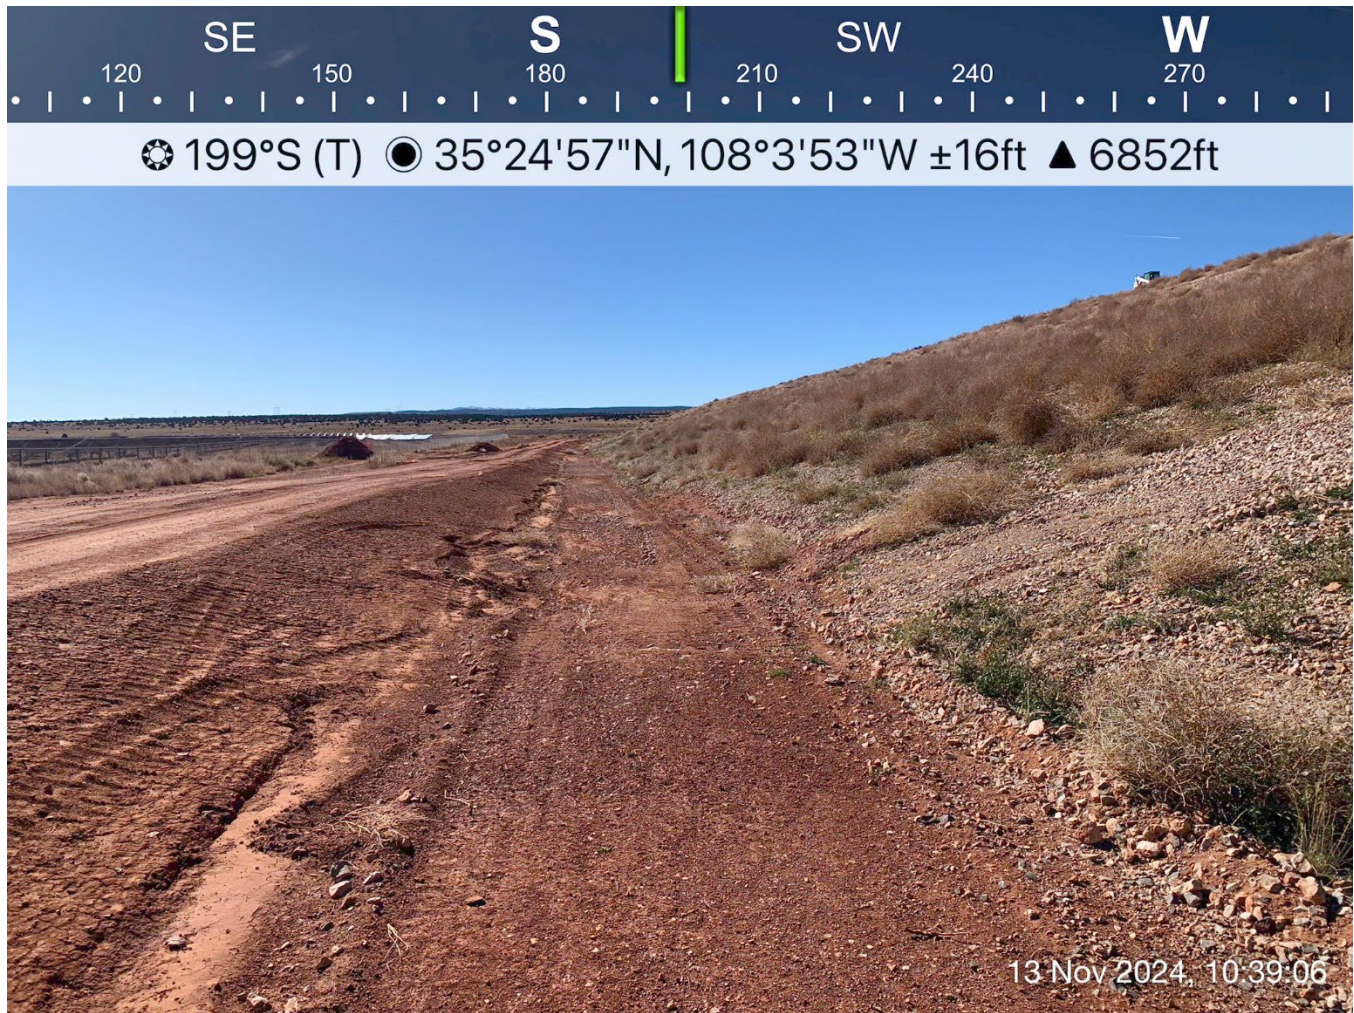
The embankment toe was observed to be in good condition. Signs of seepage, such as springs or boggy areas, were not observed along the embankment toe. The typical condition of the embankment toe is depicted in Photograph 7.

Photograph 7: Typical Condition of the Embankment Toe

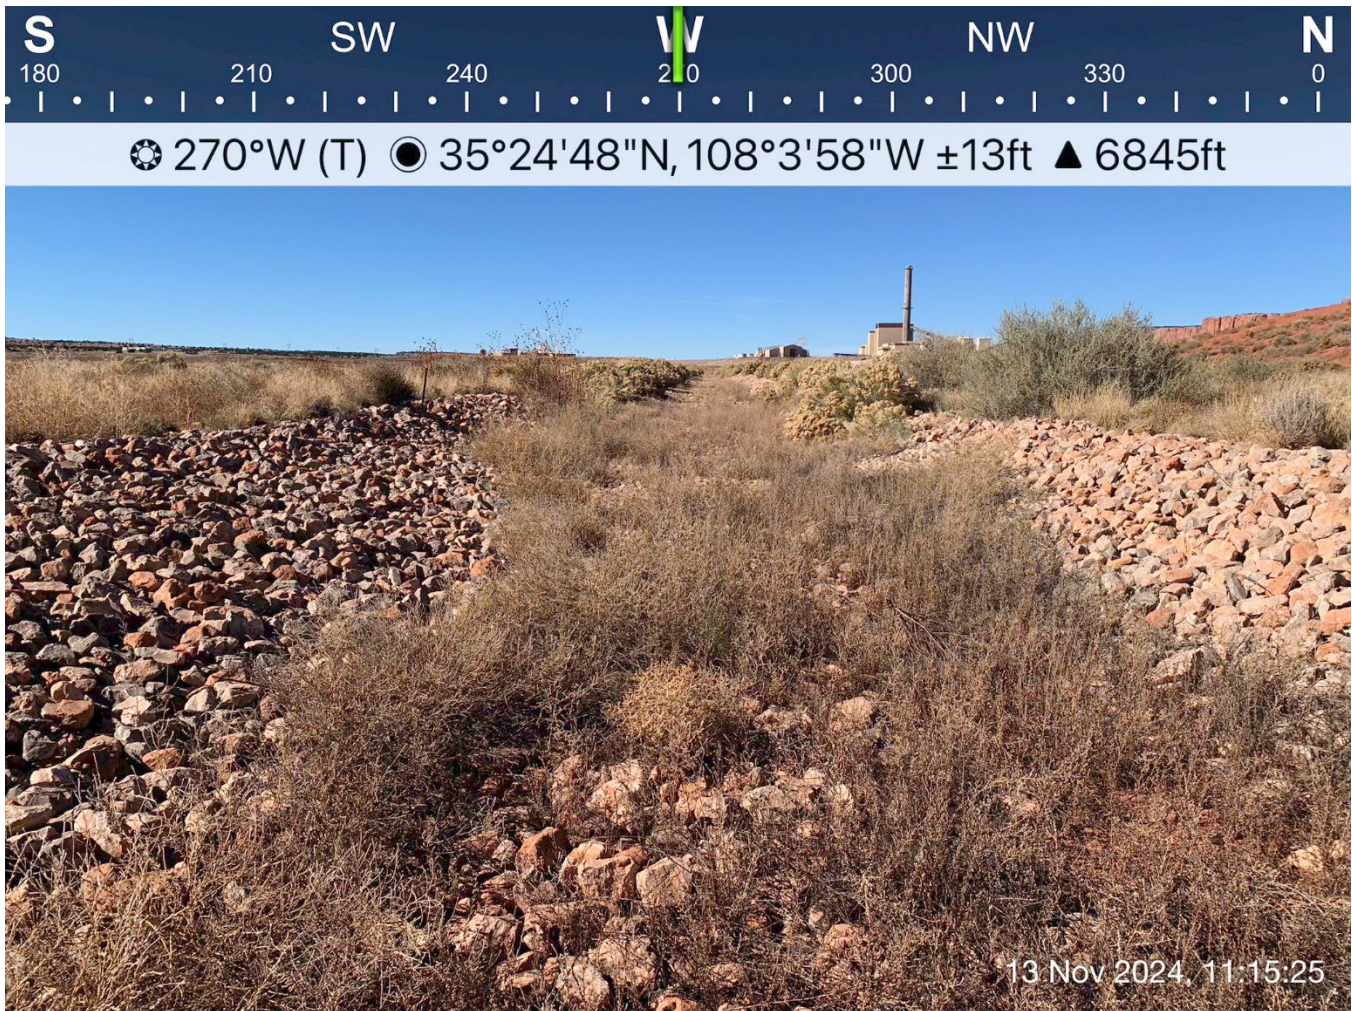
The stormwater control features at the facility were observed to be in fair condition. At the time of the visual observation, the permanent stormwater control features at the facility consisted of a run-on control channel that is designed to convey stormwater from west to east outside the south end of the facility, terrace channels on the east embankment slope, a downchute channel on the east embankment slope, and a perimeter channel and culverts along the toe of the east embankment slope. The run-on control channel is armored with riprap. Shrubs were observed to be growing in the flow path, and an area of sediment accumulation was observed near the east end of the channel. The shrubs and sediment are not disrupting the operation or safety of the facility, but they should be removed periodically to help maintain the channel’s flow capacity. The typical condition of the run-on control channel is depicted in Photograph 8. Portions of the terrace channels were being reshaped at the time of the visual inspection to prevent overtopping and resultant rill erosion. The typical condition of the terrace channels is depicted in Photograph 9. The perimeter channel and culverts are depicted in Photograph 7 and Photograph 10. The downchute channel is armored with riprap. Shrubs were observed to be growing in the flow path. The shrubs are not disrupting the operation or safety of the facility, but they should be removed periodically

Photograph 8: Typical Condition of the Run-on Control Channel

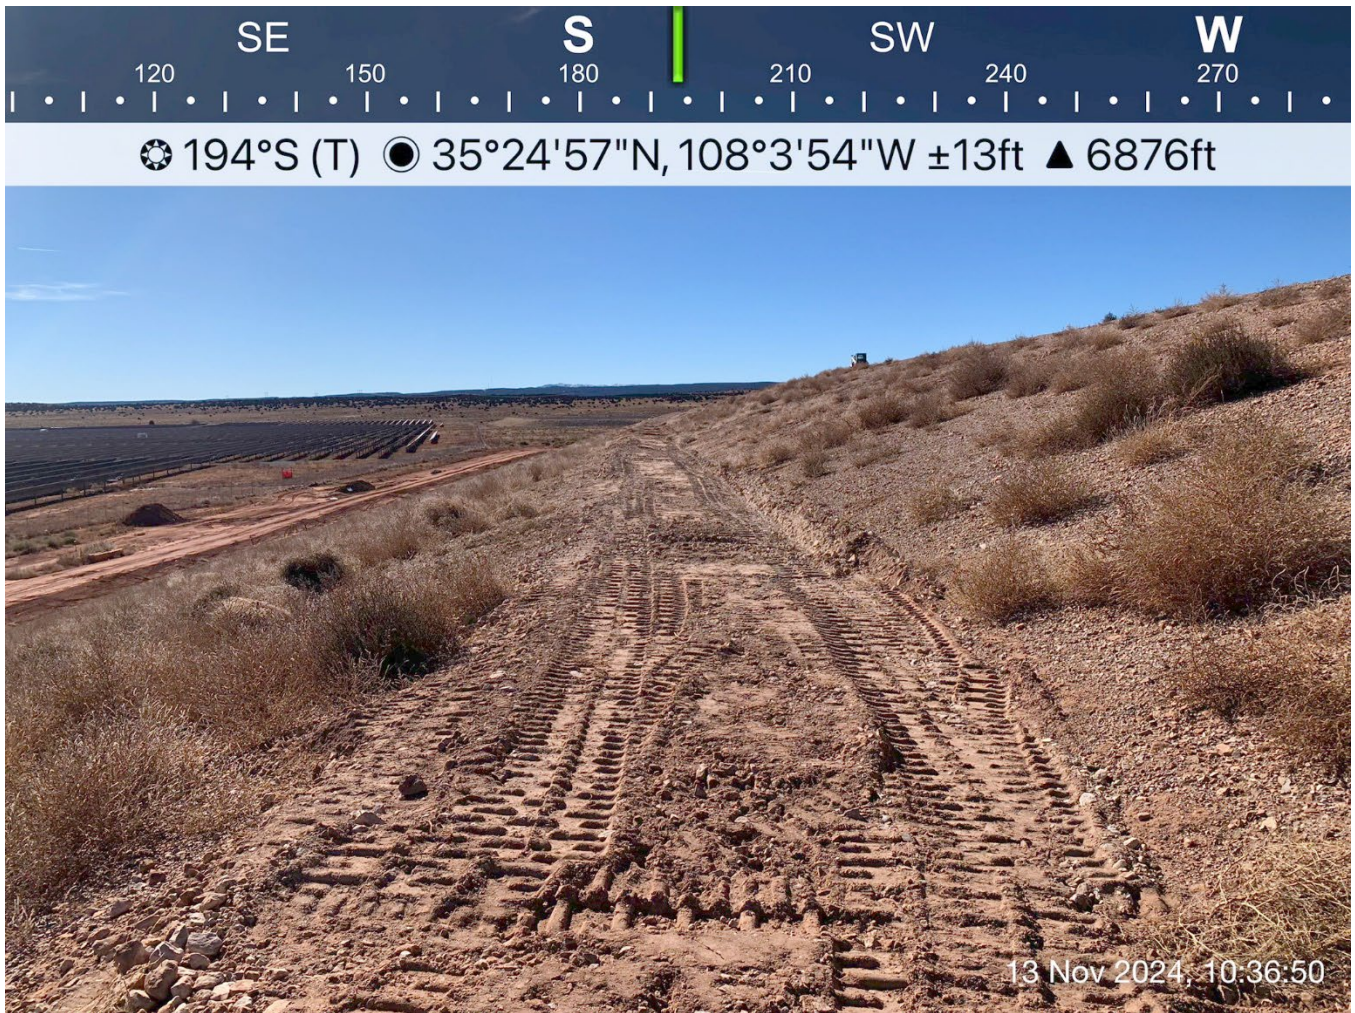
Photograph 9: Typical Condition of the Terrace Channels

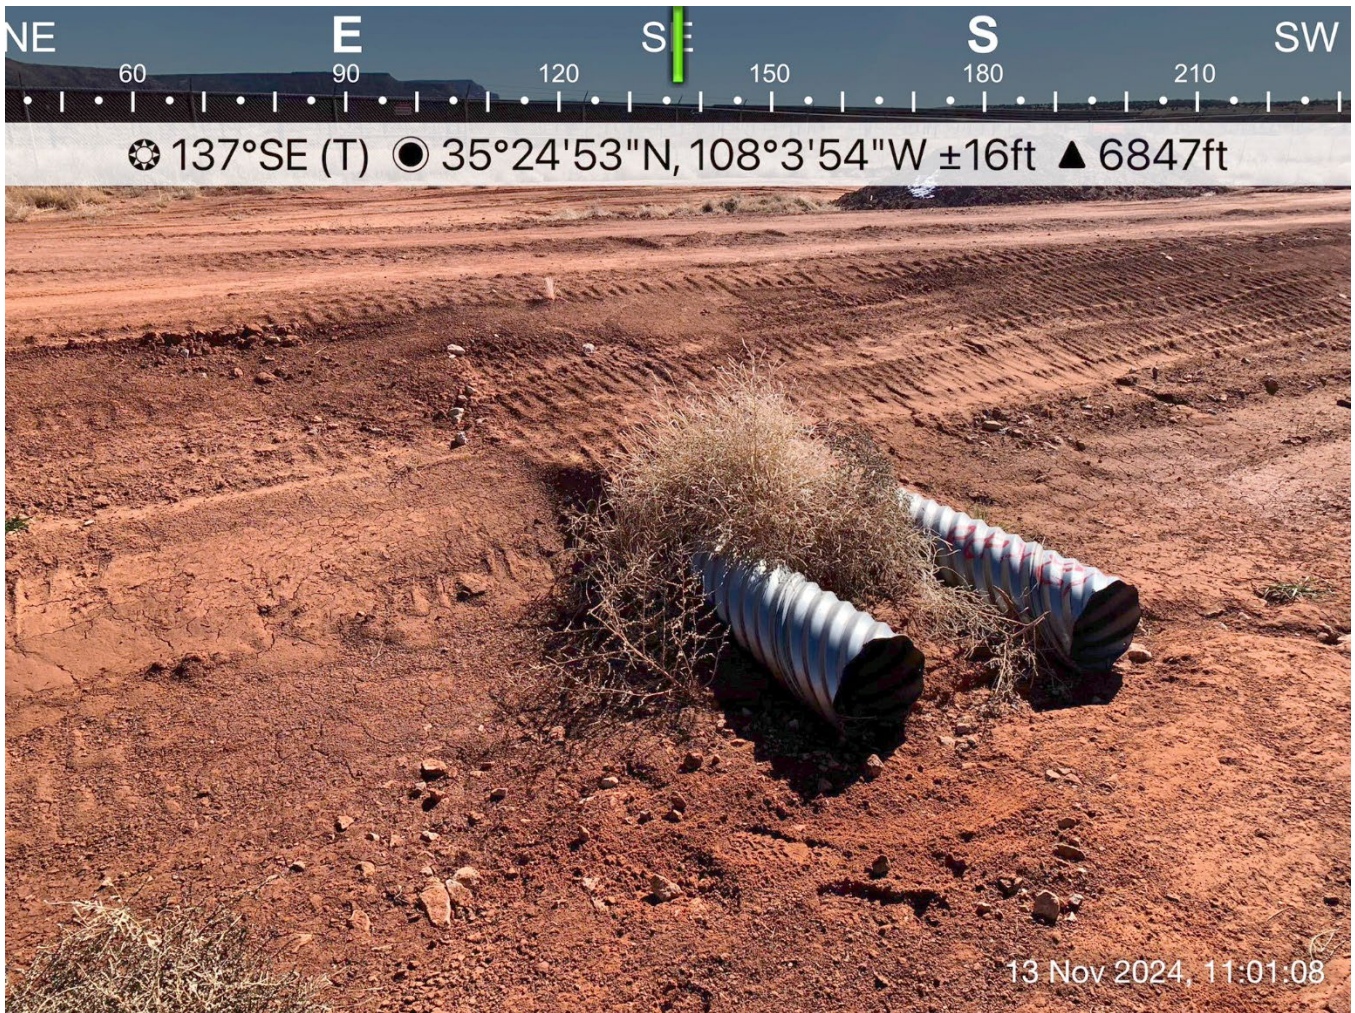
Photograph 10: Culvert Inlets

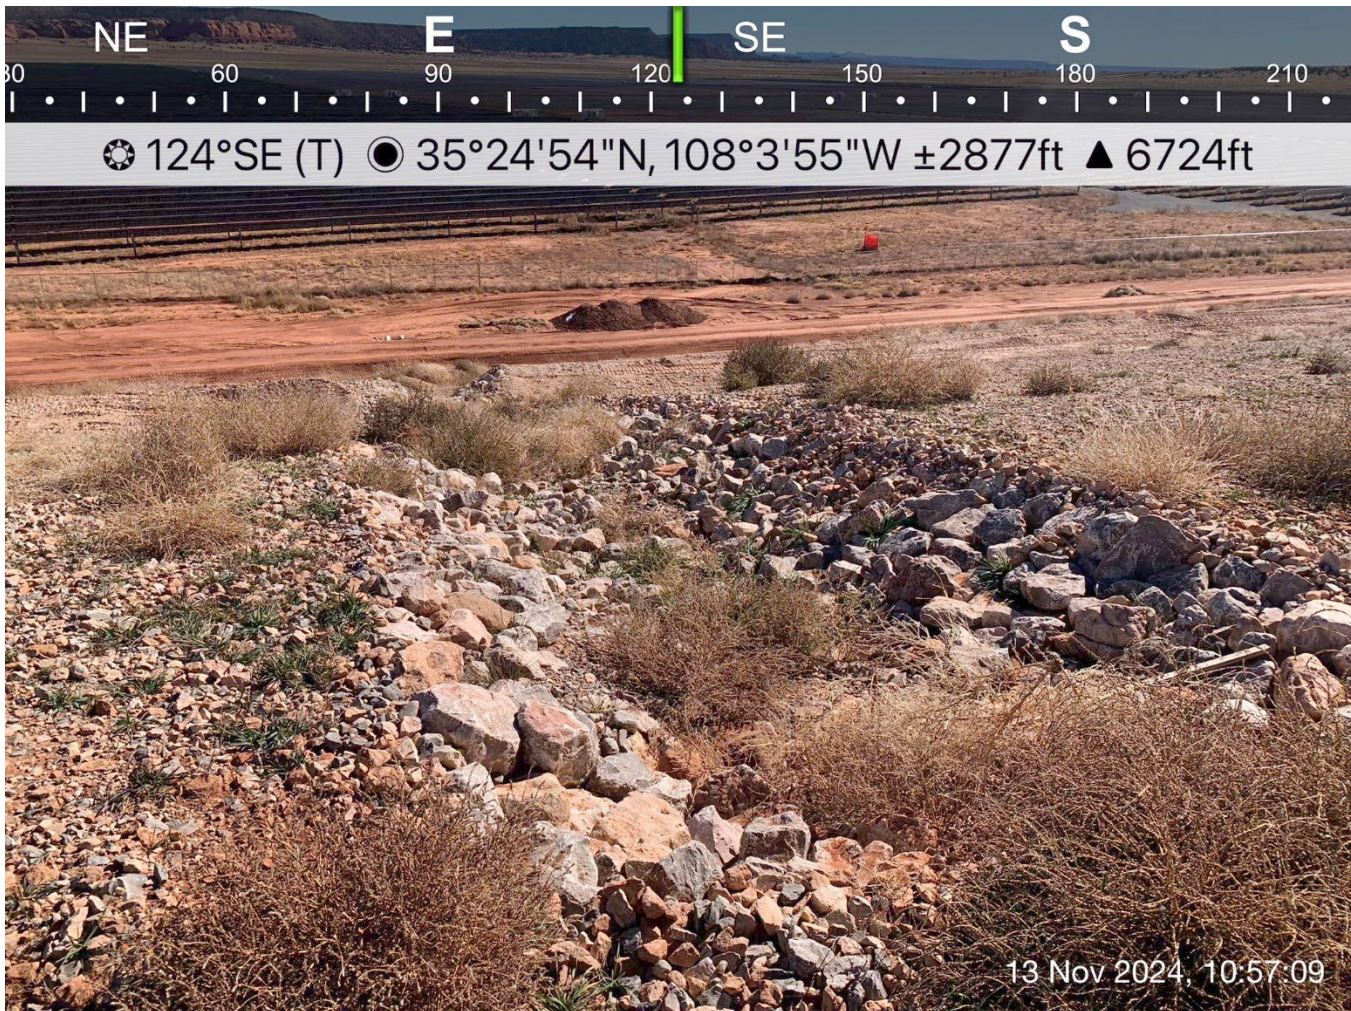
to help maintain the channel's flow capacity. The typical condition of the downchute channel is depicted in Photograph 11.

Photograph 11: Typical Condition of the Downchute Channel
