# Active Coal Combustion Residuals Disposal Facility

## 2025 Annual Inspection

*Escalante Station*

31403149.2416-005-RPT-0

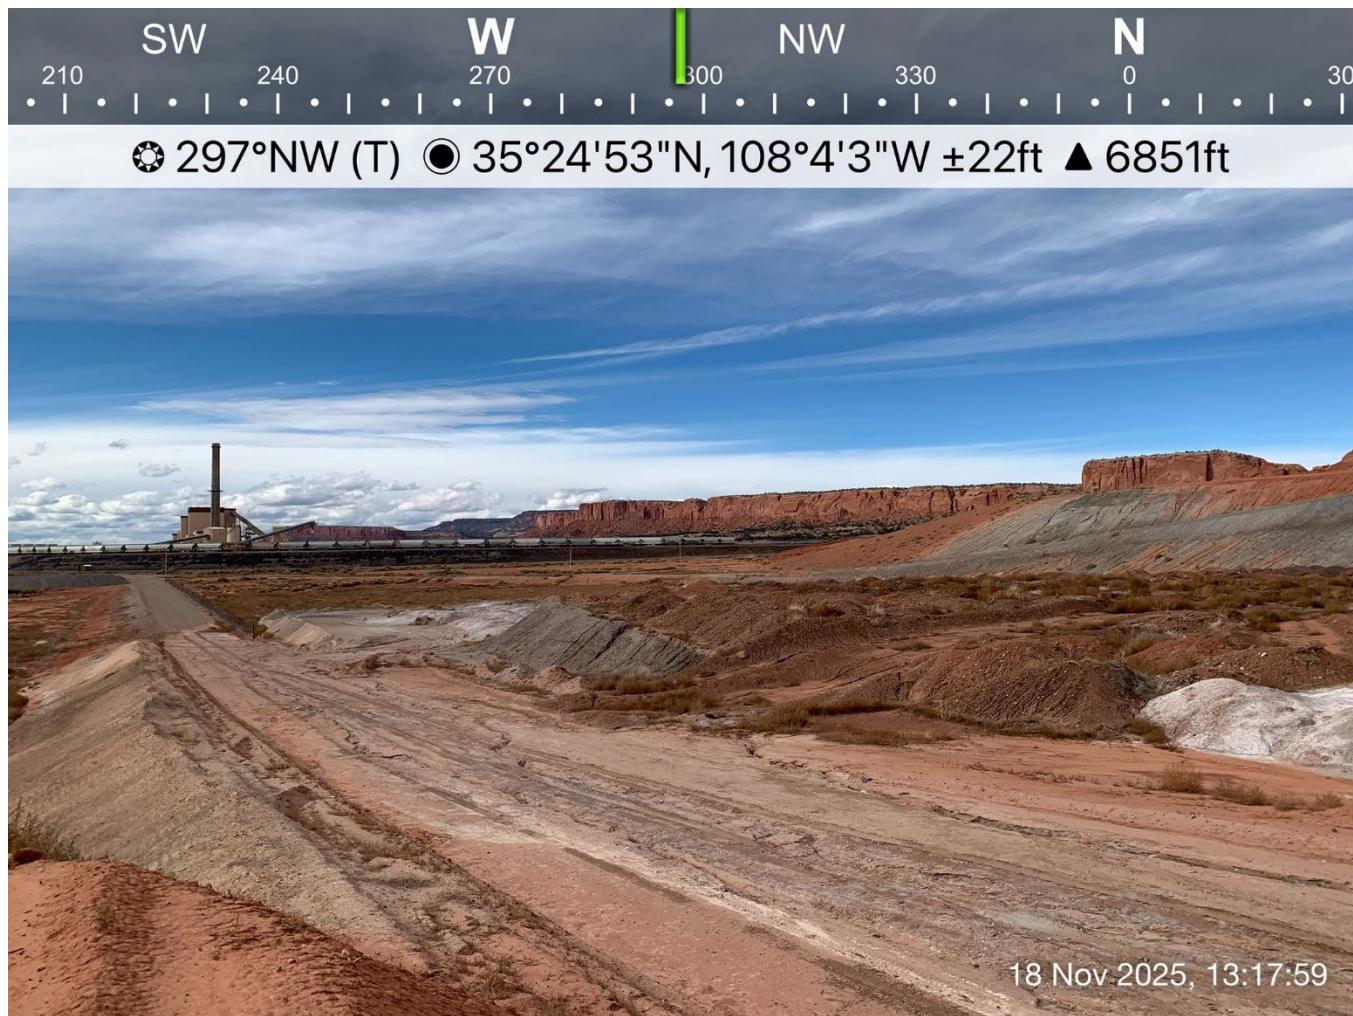
The deposition area was observed to be in fair condition. No waste was being deposited during the visual observation, but Appendix A shows the most recently used deposition area at the time of the visual observation. Signs of ground movement, such as sloughing or sliding, cracking, subsidence, or bulging, were not observed in the deposition area. Fugitive dust was not observed at the time of the visual observation. The typical condition of the deposition area is depicted in Photograph 1. Appropriate grading had been established to collect CCR contact water within the facility, and Tri-State had installed a small stormwater retention berm near the southwestern corner of the CCR placement limits to alleviate the potential for CCR contact water to accumulate after significant storm events and migrate outside the facility boundary. The berm was constructed in November 2024, according to Tri-State's weekly inspection forms, to address a deficiency that was identified during the previous visual

Significant erosion was observed in an area that was used for placement of waste materials in 2024. This area is shown in Appendix A. The erosion had been noted during the previous visual observation on November 13, 2024 (WSP 2025), and it did not appear to be more severe than at that time. The erosion is limited to the interior of the facility and does not pose a threat to the structural stability of the embankment slopes. It is not disrupting the operation of the facility, but safeguards should be reviewed to protect personnel working in this area. Weekly inspections should include verification that further erosion is not causing sedimentation that could disrupt the containment of CCR contact water.

**Photograph 1: Typical Condition of the Deposition Area**

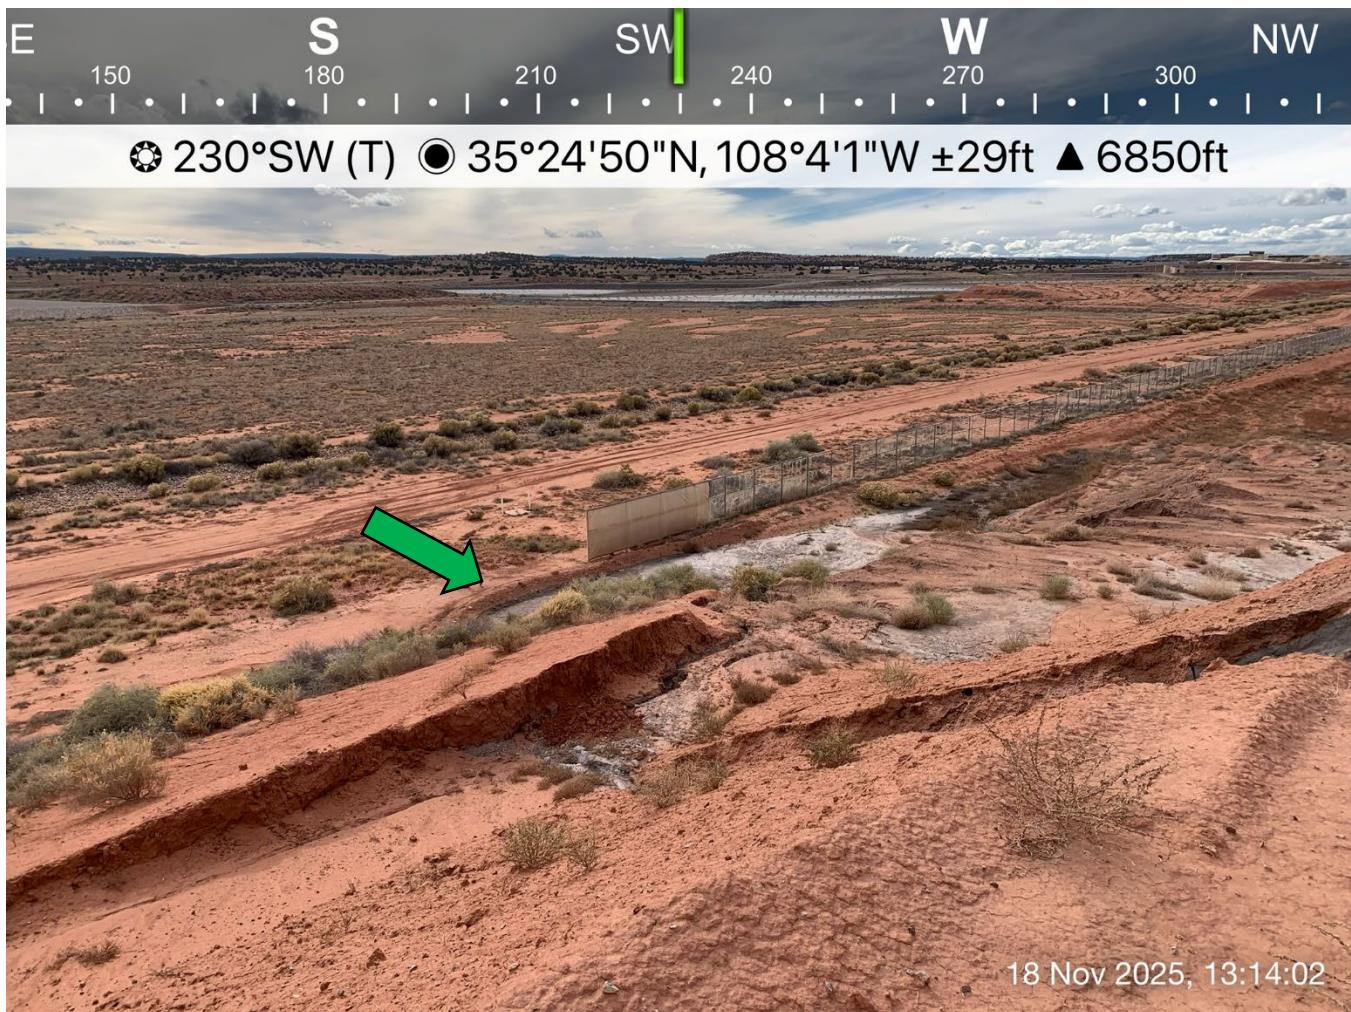
observation on November 13, 2024 (WSP 2025). The berm is depicted in Photograph 2, and the location of the berm is shown in Appendix A.

**Photograph 2: Location where a Berm was Installed to Prevent CCR Contact Water Migration**

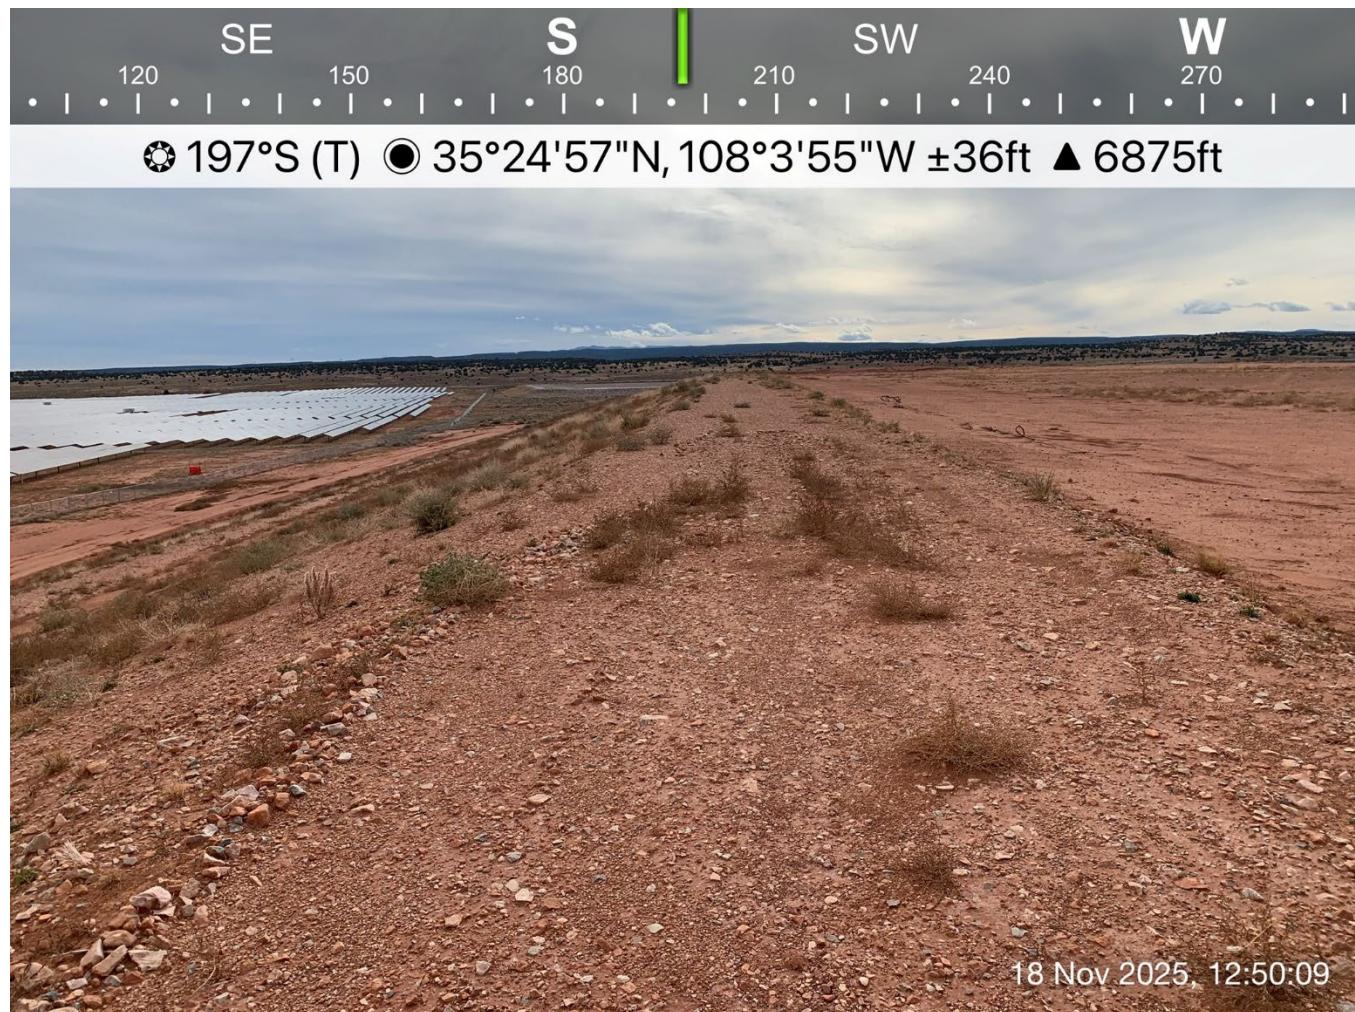
The embankment crest was observed to be in fair to good condition. Cracking that could be indicative of ground movement was not observed along the embankment crest. Low areas that could be indicative of differential settlement were not observed along the embankment crest. Animal burrows were observed in loose (i.e., uncompacted) soil piles along the embankment crest near the southeastern corner of the top surface. The animal burrows do not pose a threat to structural stability and are not disrupting the operation or safety of the facility, but they should be monitored and addressed if burrowing continues. The location of the animal burrows is shown in Appendix A. The typical condition of the embankment crest is depicted in Photograph 3. Representative animal burrows are shown in Photograph 4.

**Photograph 3: Typical Condition of the Embankment Crest**

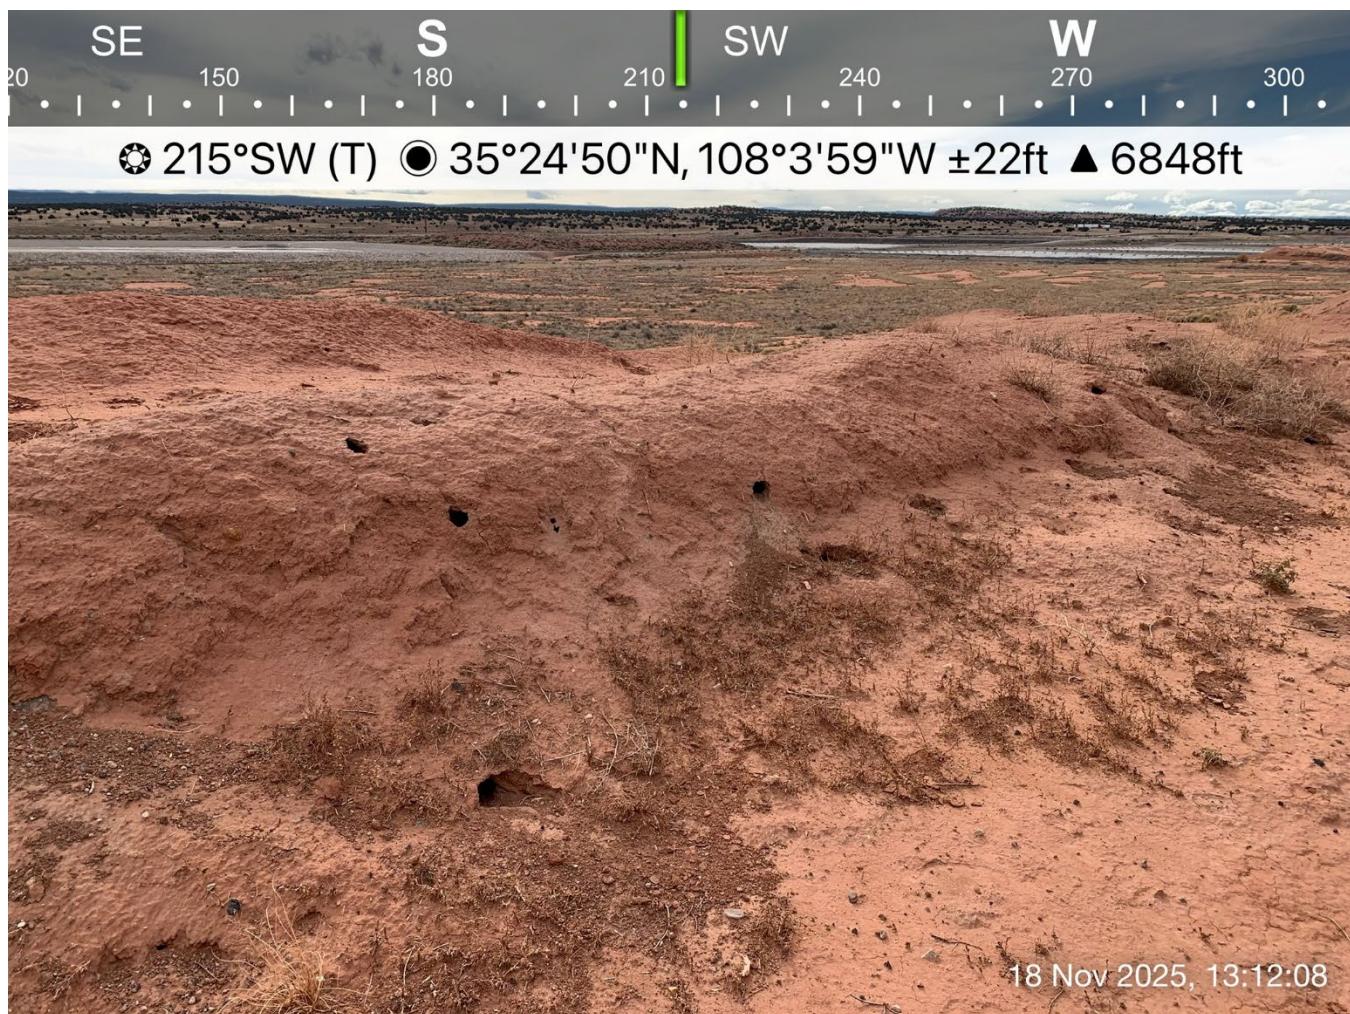
**Photograph 4: Animal Burrows Along the Embankment Crest**

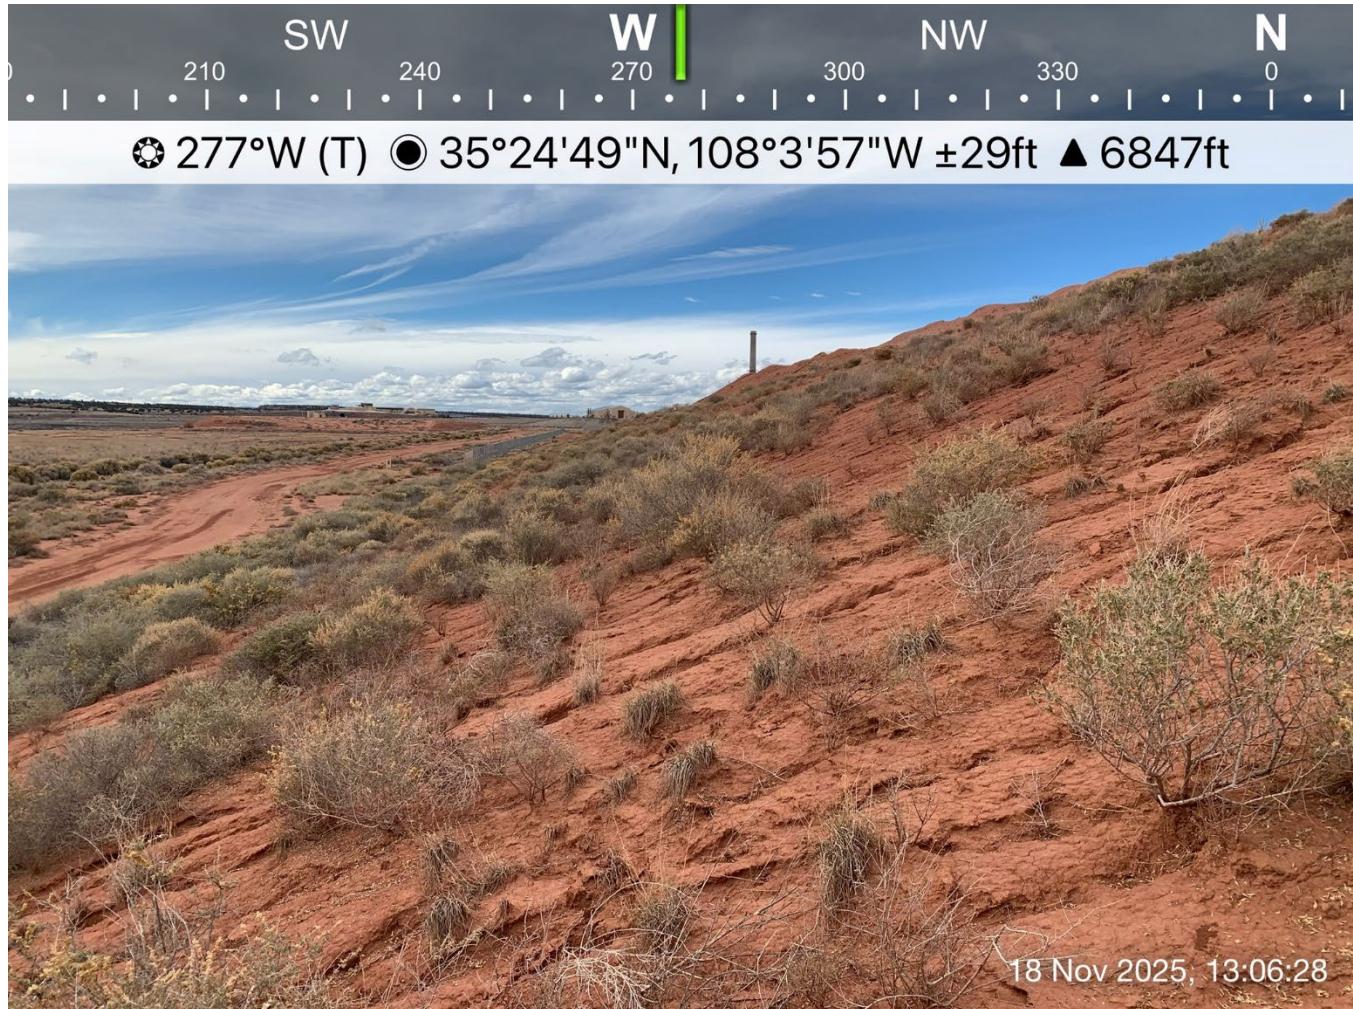
The embankment slopes were observed to be in fair to good condition. Signs of ground movement, such as sloughing or sliding, subsidence, or bulging, were not observed on the embankment slopes. Evidence of excessive erosion or slope deterioration was not observed on the embankment slopes, but minor rilling was observed on the south embankment slope. The severity of the rilling appeared to be about the same as during the previous visual observation on November 13, 2024, and was similarly observed to increase near the west end of the south embankment slope. The rilling does not currently pose a threat to structural stability and is not disrupting the operation or safety of the facility, but it should be monitored and addressed if it becomes excessive. While localized repairs may periodically be needed for rills that become excessively deep or wide, WSP recommends that broad-scale rill repair efforts be deferred until the rills become more severe or a reseeding attempt is planned, as repair efforts would disrupt the erosion resistance provided by the vegetation and may therefore be counterproductive.

Native vegetation was observed on the embankment slopes, including through the layer of stone that was placed across the surface of the east embankment slope in 2024 to enhance erosion resistance. Windblown soil had accumulated atop the layer of stone, with the thickness decreasing toward the south end of the east embankment slope. Unusually poor or thriving vegetative growth was not observed on the embankment slopes, but establishment of a mature vegetative community continues to be challenging given the climatic conditions at the site. No trees were observed on the embankment slopes. Active animal burrows were not observed on the embankment slopes. The typical condition of the south embankment slope is depicted in Photograph 5. The typical condition of the east embankment slope is depicted in Photograph 6.

### Photograph 5: Typical Condition of the South Embankment Slope

F.3. Rilling was observed on the south embankment slope, with severity increasing near the western end (see page 3 for the approximate extents of notable rilling). The severity of the rilling was observed to be about the same as during the previous annual inspection. The rilling does not currently pose a threat to structural stability and is not disrupting the operation or safety of the facility, so immediate repair is not required. The rilling should be monitored and addressed if it becomes excessive.

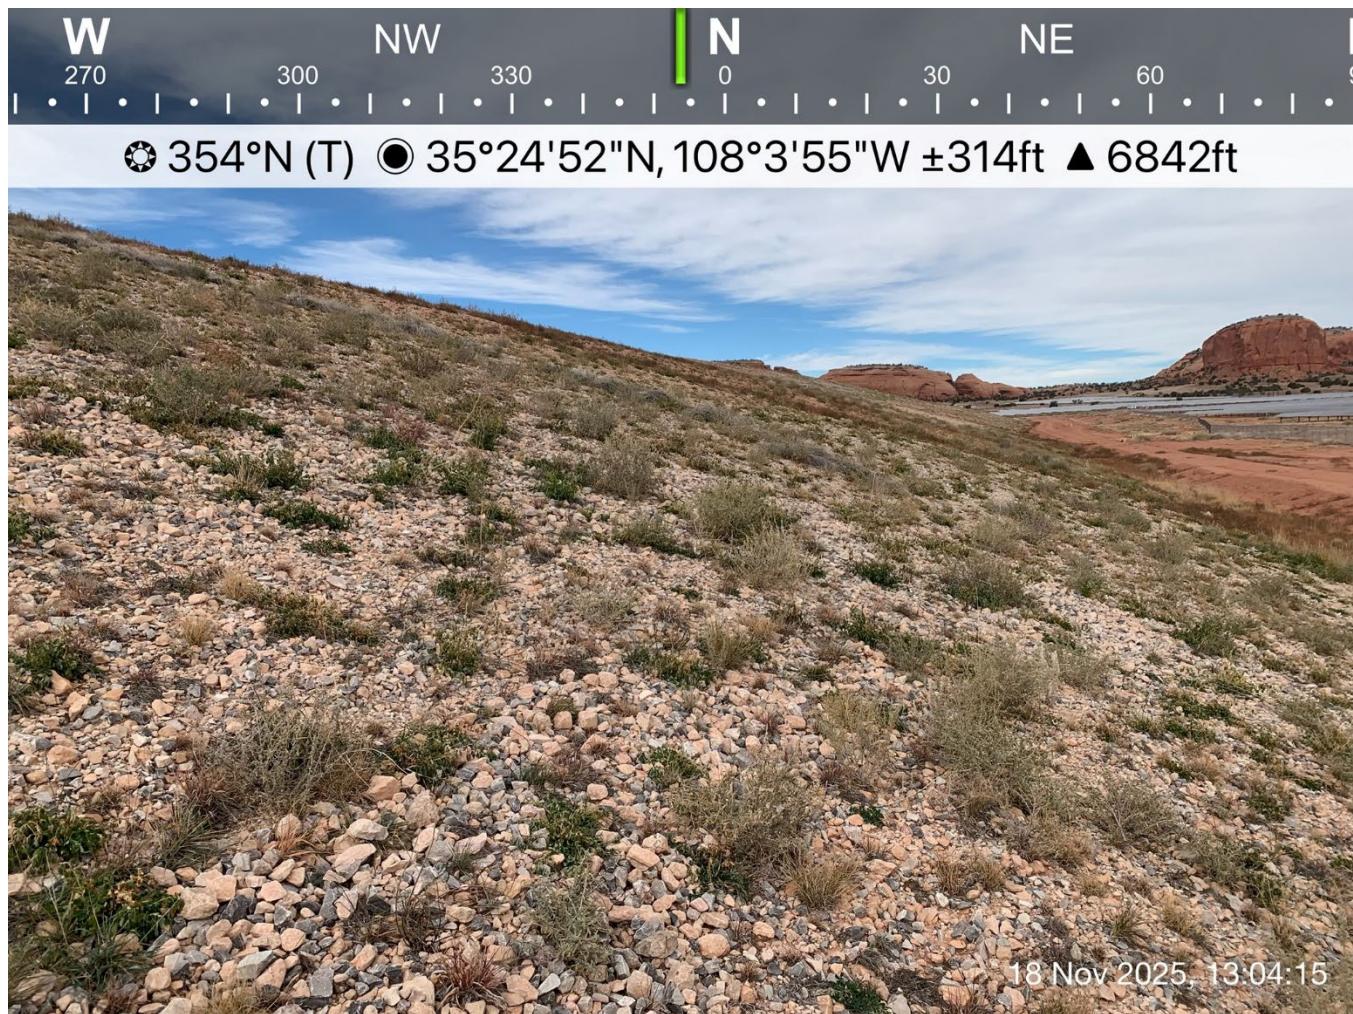
**Photograph 6: Typical Condition of the East Embankment Slope**

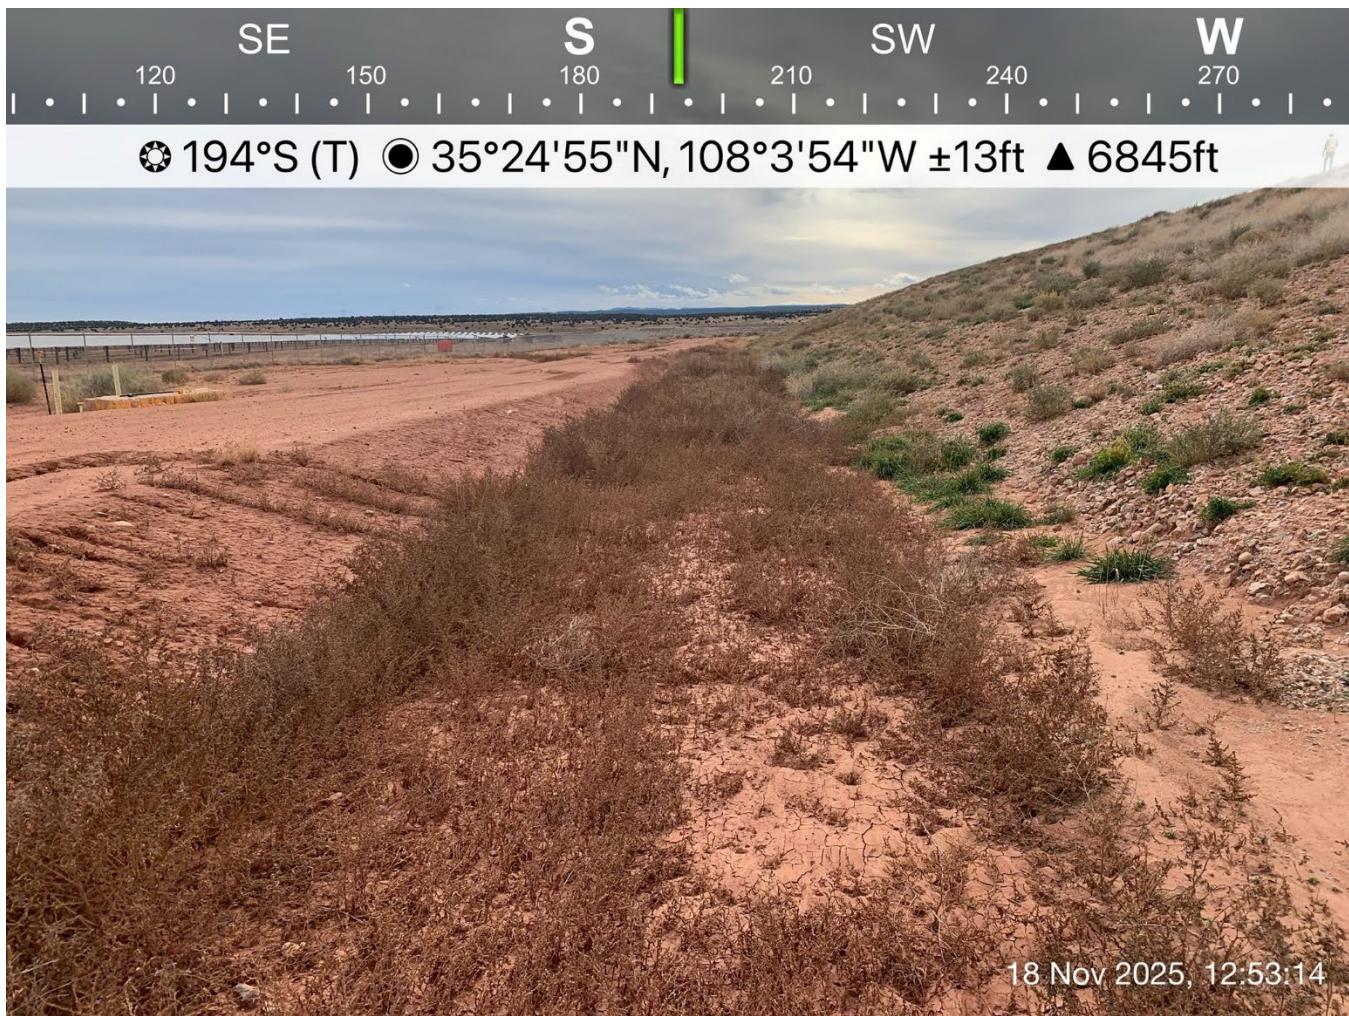
The embankment toe was observed to be in good condition. Signs of seepage, such as springs or boggy areas, were not observed along the embankment toe. The typical condition of the embankment toe is depicted in Photograph 7.

**Photograph 7: Typical Condition of the Embankment Toe**

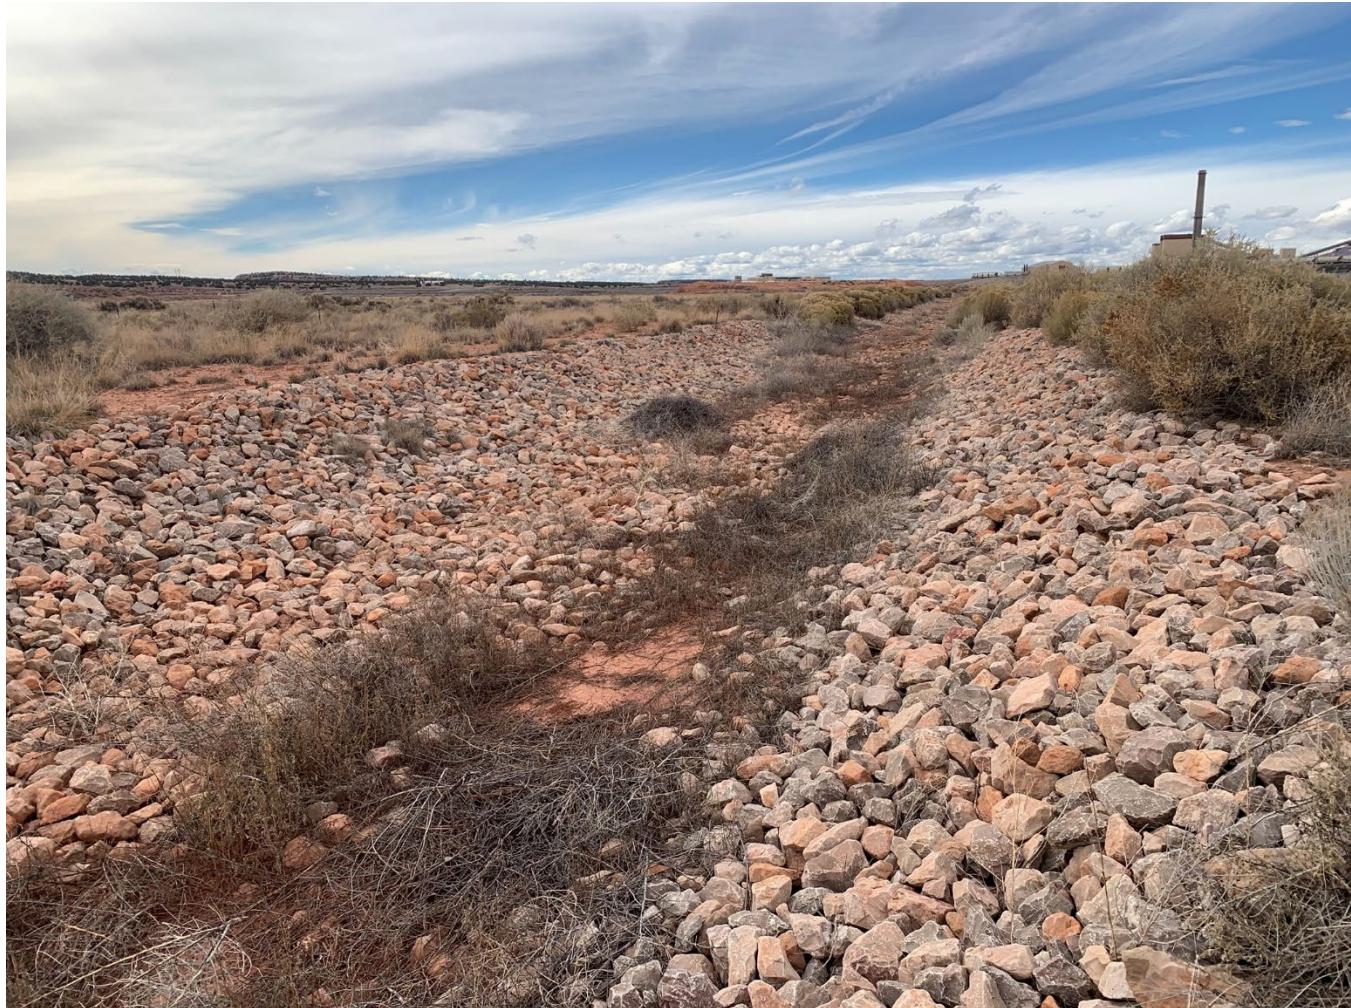
The stormwater control features at the facility were observed to be in fair condition. At the time of the visual observation, the permanent stormwater control features at the facility consisted of a run-on control channel that is designed to convey stormwater from west to east outside the south end of the facility, terrace channels on the east embankment slope, a downchute channel on the east embankment slope, and a perimeter channel and culverts along the toe of the east embankment slope. The run-on control channel is armored with riprap. Shrubs that were observed to be growing in the flow path during the previous visual inspection on November 13, 2024, appeared to have been cut shorter to help maintain the channel's flow capacity. The typical condition of the run-on control channel is depicted in Photograph 8. The terrace channels appeared to be functional, but sediment accumulation was observed in the terrace channels. The sediment accumulation was minor along the lengths of channels, becoming more significant at the downstream ends, where the terrace channels route into the downchute channel. The accumulated sediment is not disrupting the operation or safety of the facility, but it should be removed periodically to help maintain the flow capacity of the terrace channels. The typical condition of the terrace channels is depicted in Photograph 9. The downchute channel is armored with riprap. Minor sediment accumulation was observed in the downchute channel, particularly where the terrace channels direct water into

**Photograph 8: Typical Condition of the Run-on Control Channel**

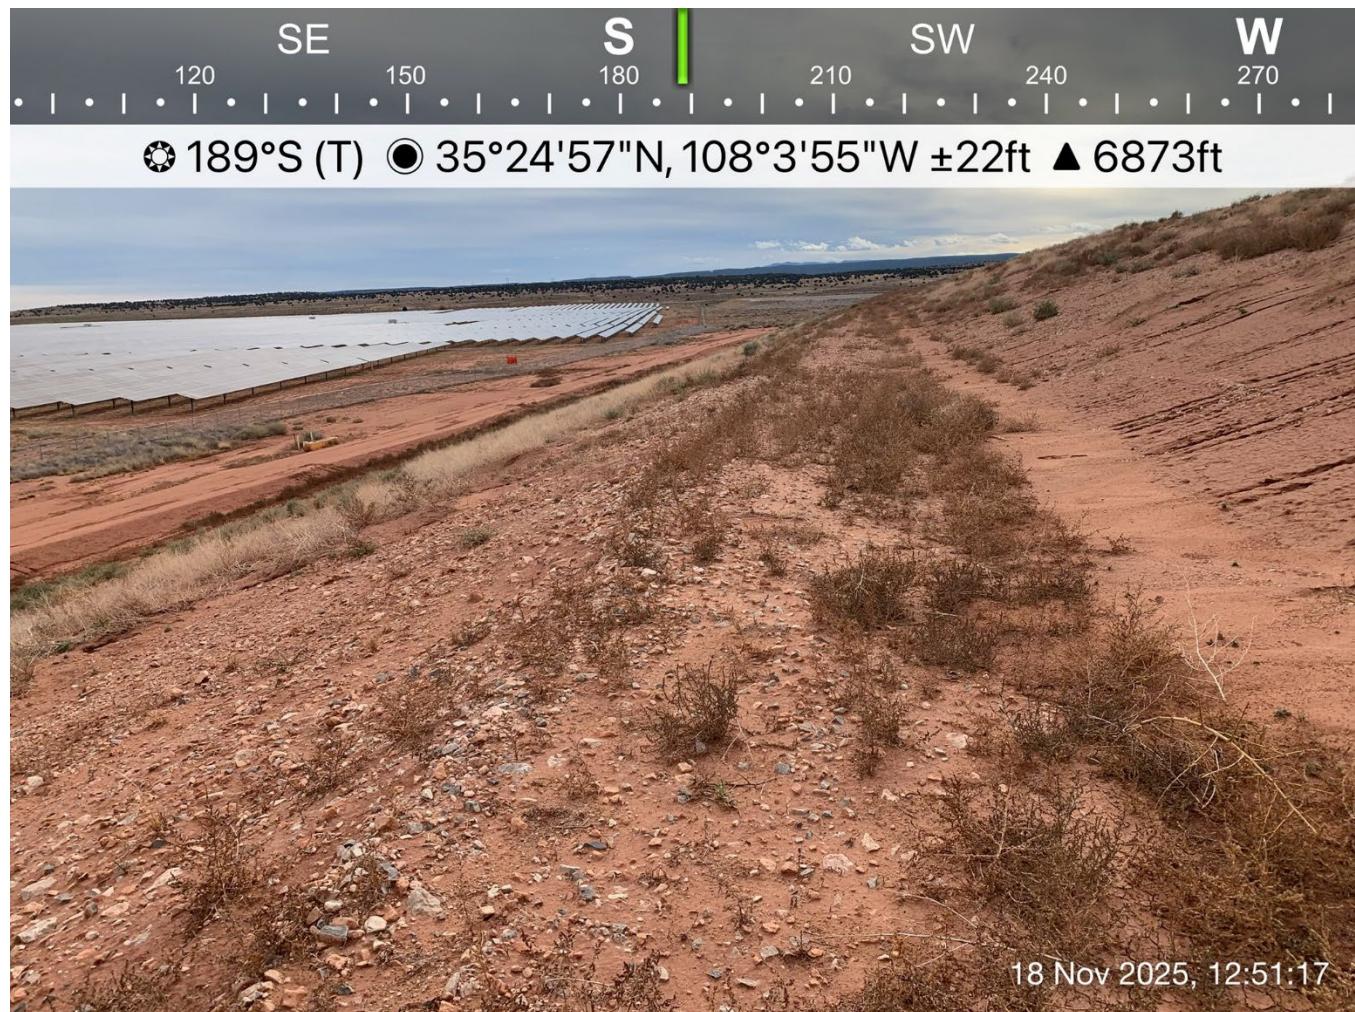
**Photograph 9: Typical Condition of the Terrace Channels**

H.2. Sediment accumulation was observed in the terrace channels, particularly near where they route into the downchute channel. The accumulated sediment is not disrupting the operation or safety of the facility, but it should be removed periodically to help maintain the flow capacity of the terrace channels.

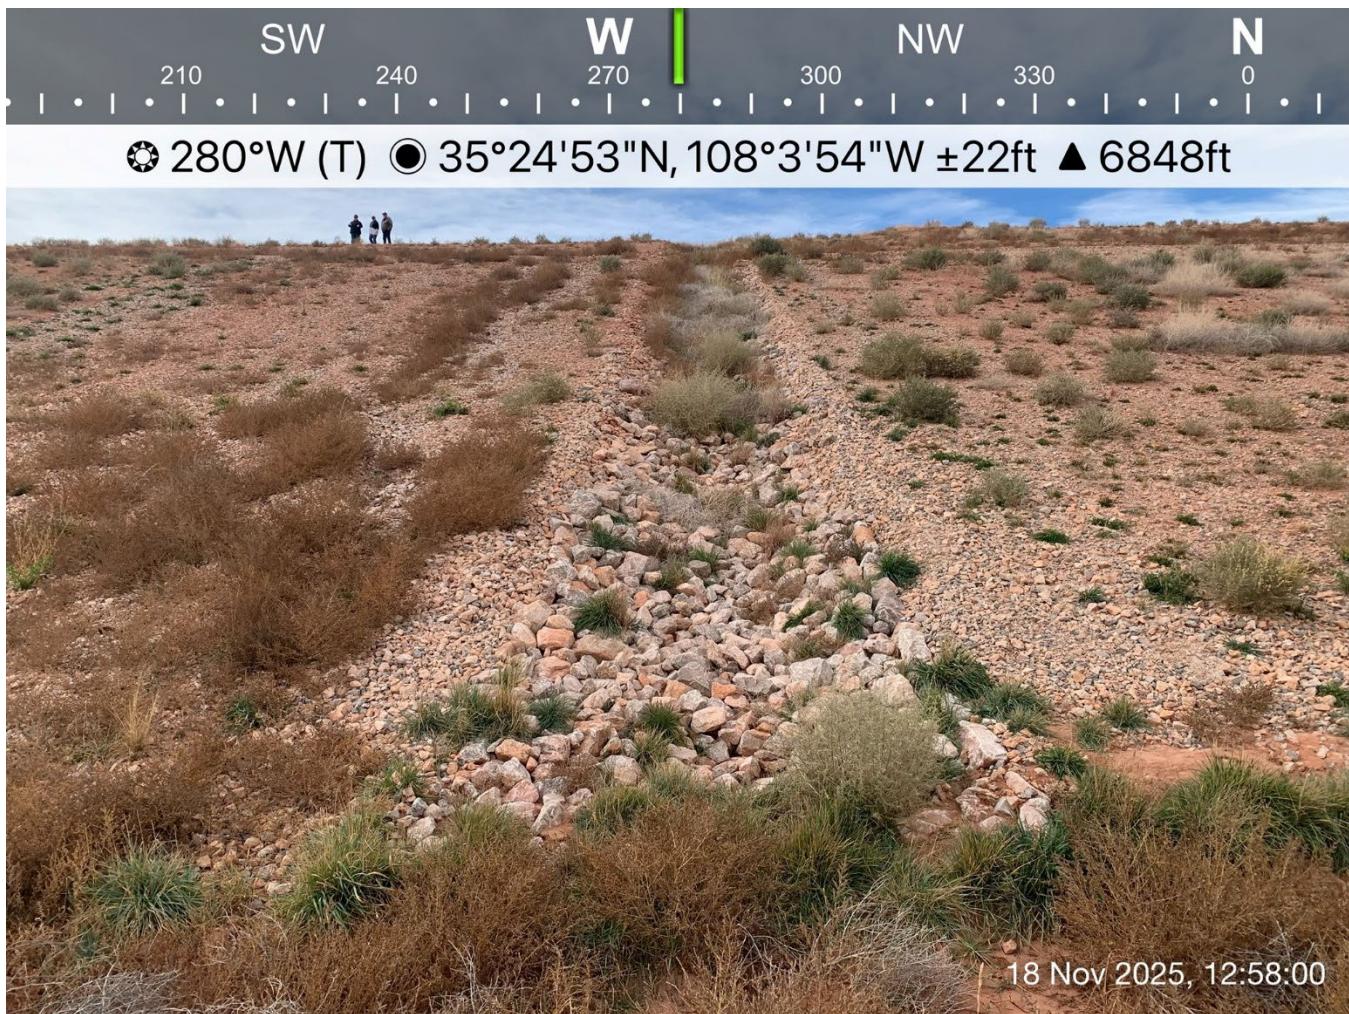
the downchute channel. The accumulated sediment is not disrupting the operation or safety of the facility, but it should be removed periodically to help maintain flow continuity and the flow capacity of the downchute channel. Shrubs were observed to be growing in the flow path of the downchute channel. The shrubs are not disrupting the operation or safety of the facility, but they should be removed periodically to help maintain the channel's flow capacity. The typical condition of the downchute channel is depicted in Photograph 10. The perimeter channel and culverts appeared to be functional. The perimeter channel is depicted in Photograph 7.

**Photograph 10: Typical Condition of the Downchute Channel**

H.3. Shrubs and sediment accumulation were observed in the downchute channel. The shrubs and accumulated sediment are not disrupting the operation or safety of the facility, but they should be removed periodically to help maintain the flow capacity of the downchute channel.
