Coal Combustion Residuals Landfill Inspection
Nucla Station Ash Disposal Facility

Tri-State Generation and Transmission Association, Inc.

21453425.003-002-RPT-0

December 15, 2023

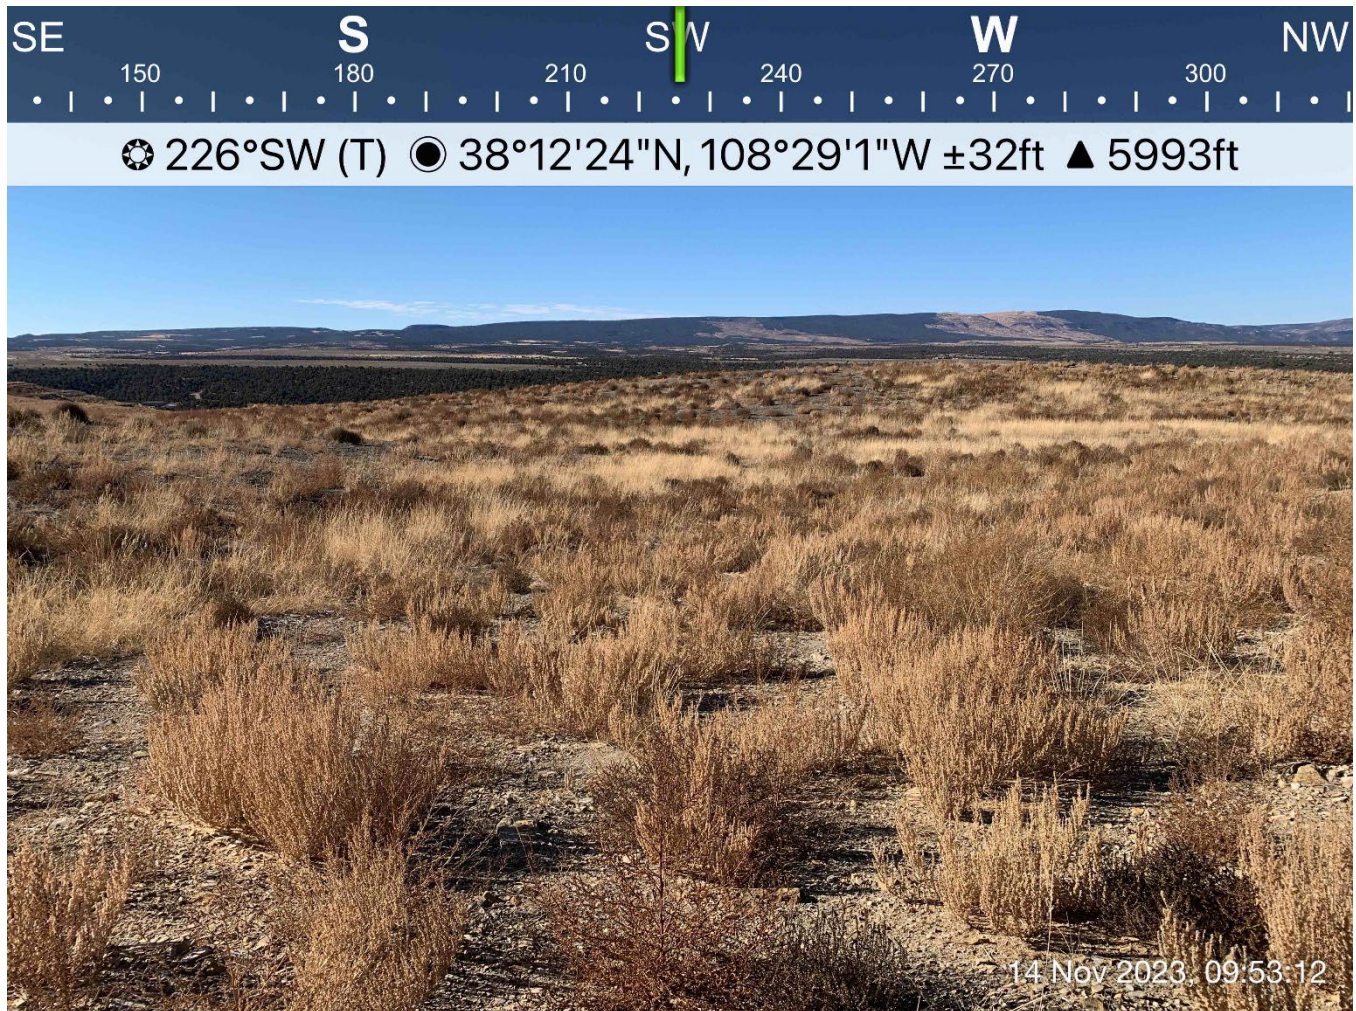
The top surface was observed to be in good condition. Signs of ground movement, such as sloughing or sliding, cracking, subsidence, or bulging, were not observed across the top surface. The top surface was appropriately graded so that stormwater will be routed away from the facility to the designated locations. Minor erosion rills were observed at one location, where indicated in Appendix A. The erosion rills do not currently pose a threat to structural stability and did not hinder WSP's ability to inspect the facility. Tri-State personnel indicated that work to repair the erosion rills and reduce the potential for future erosion was scheduled to be implemented in December 2023, weather permitting. Vegetation has been established across the top surface following completion of closure activities in 2022. Tri-State personnel indicated that Halogeton, which is generally considered to be an undesirable plant species, has been identified in some areas on the top surface. The typical condition of the top surface is depicted in Photograph 1.

Photograph 1: Typical Condition of the Top Surface

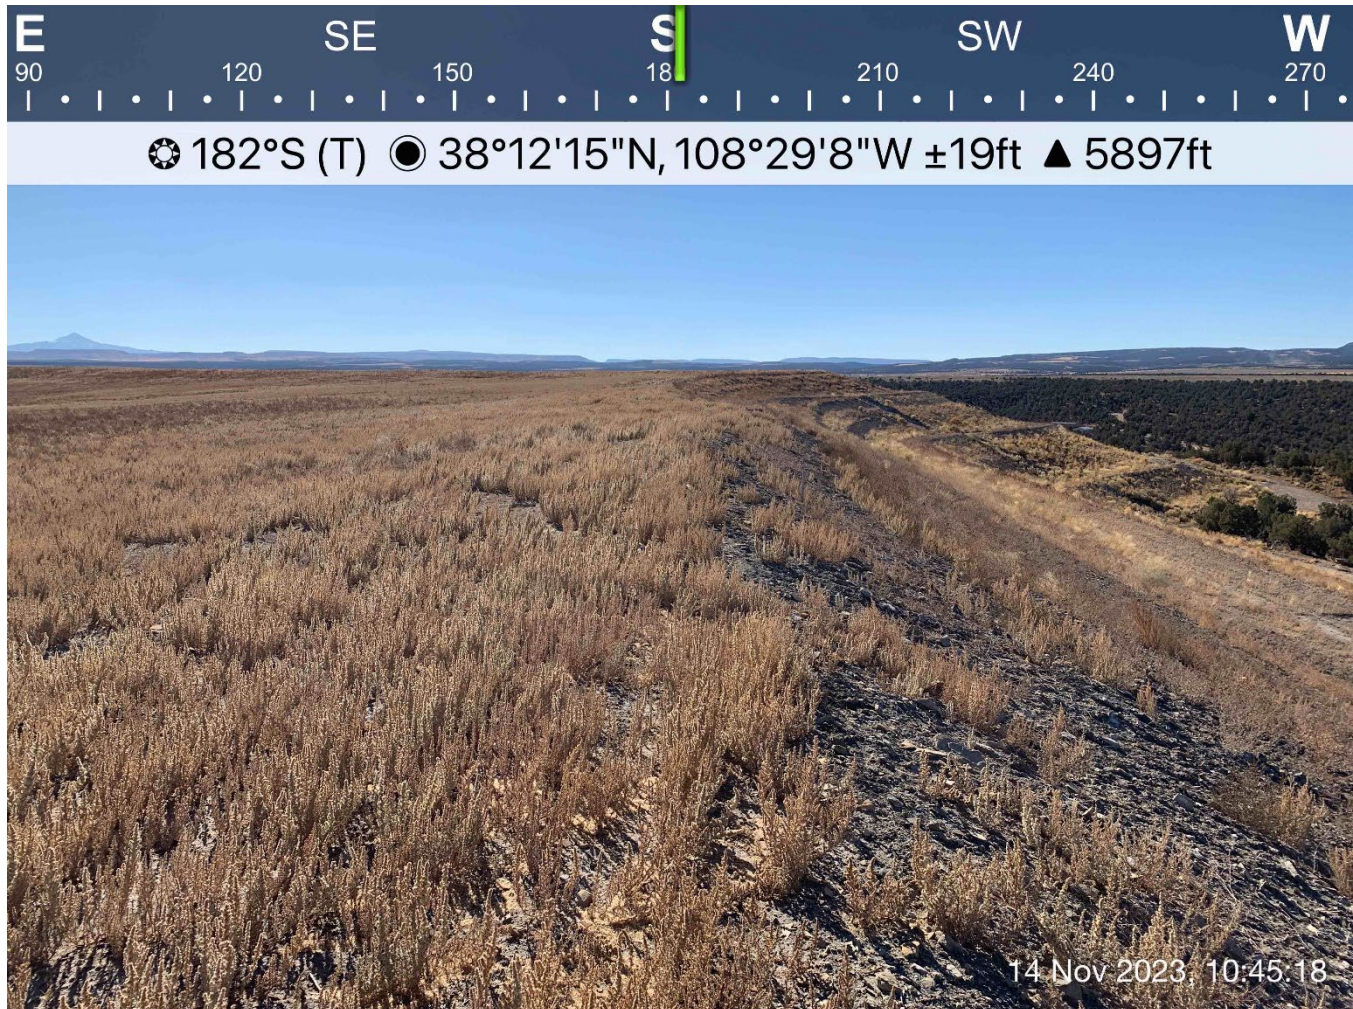
The embankment crest was observed to be in good condition. Cracking that would be indicative of ground movement was not observed along the embankment crest. Low areas that would be indicative of differential settlement were not observed along the embankment crest. The typical condition of the embankment crest is depicted in Photograph 2.

Photograph 2: Typical Condition of the Embankment Crest

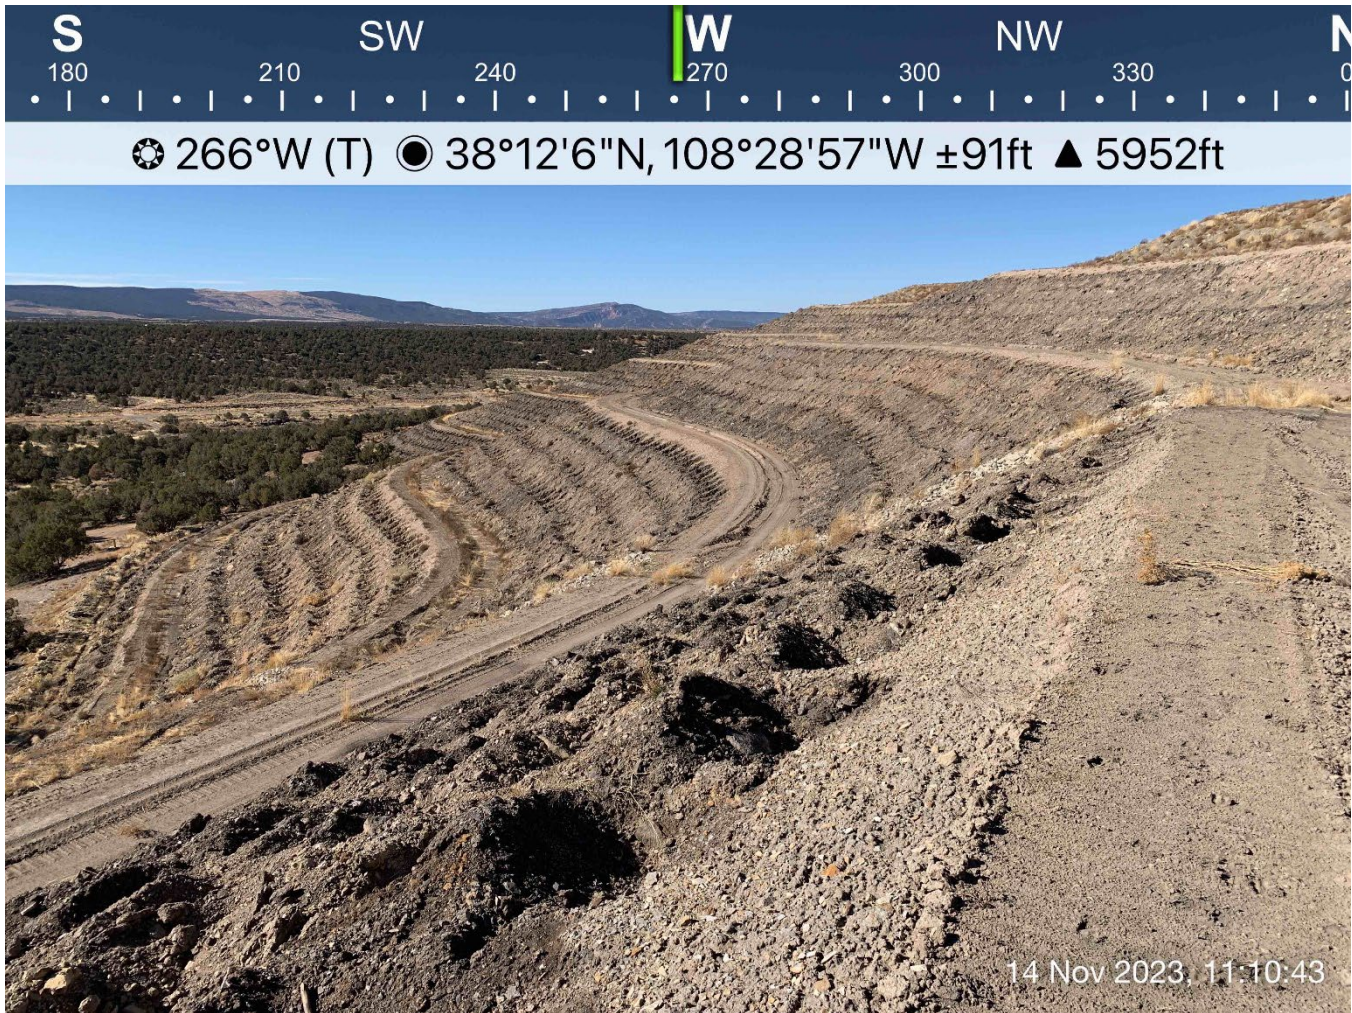
The embankment slopes were observed to be in fair to good condition. Signs of ground movement, such as sloughing or sliding, cracking, subsidence, or bulging, were not observed on the embankment slopes. Evidence of excessive erosion or slope deterioration was not observed on the embankment slopes. Native vegetation has been established on the embankment slopes, with the exception of the south embankment slopes. At the time of the visual observation, the south embankment slopes had been roughened to create an undulating surface (refer to Section 2.2) but not yet reseeded. The west, north, and east embankment slopes generally had adequate vegetative coverage at the time of the visual observation. Unusually poor or thriving vegetative growth was not observed on these embankment slopes. A few animal burrows were observed on the embankment slopes, where

indicated in Appendix A. The animal burrows did not appear to be active, do not currently pose a threat to structural stability, and did not hinder WSP’s ability to inspect the facility. The typical condition of the south embankment slopes is depicted in Photograph 3. The typical condition of the west, north, and east embankment slopes is depicted in Photograph 4.

Photograph 3: Typical Condition of the South Embankment Slopes

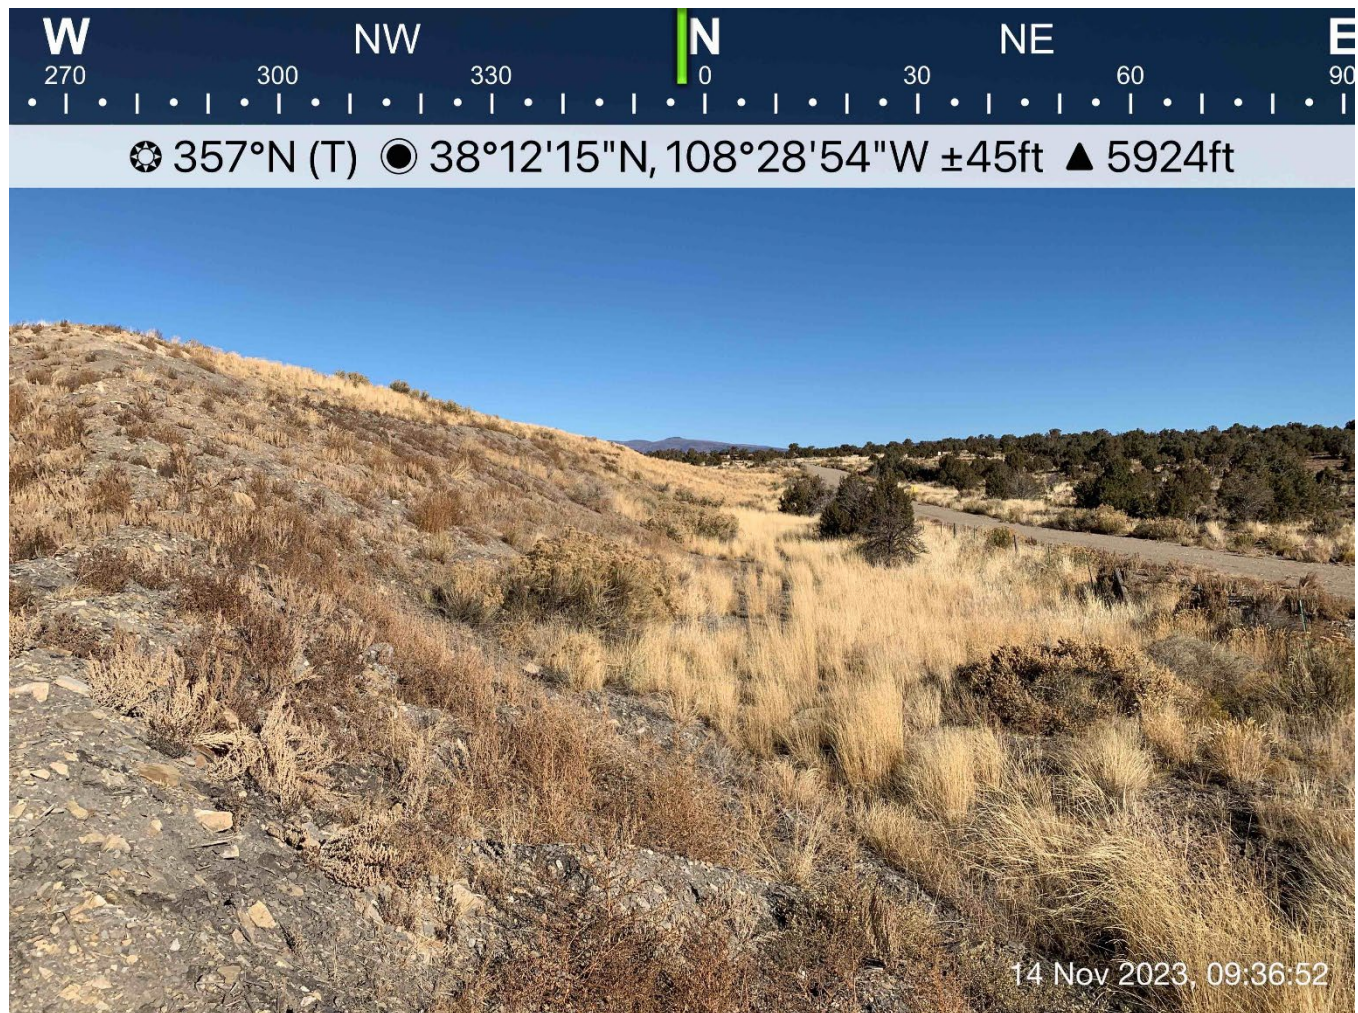
Photograph 4: Typical Condition of the West, North, and East Embankment Slopes

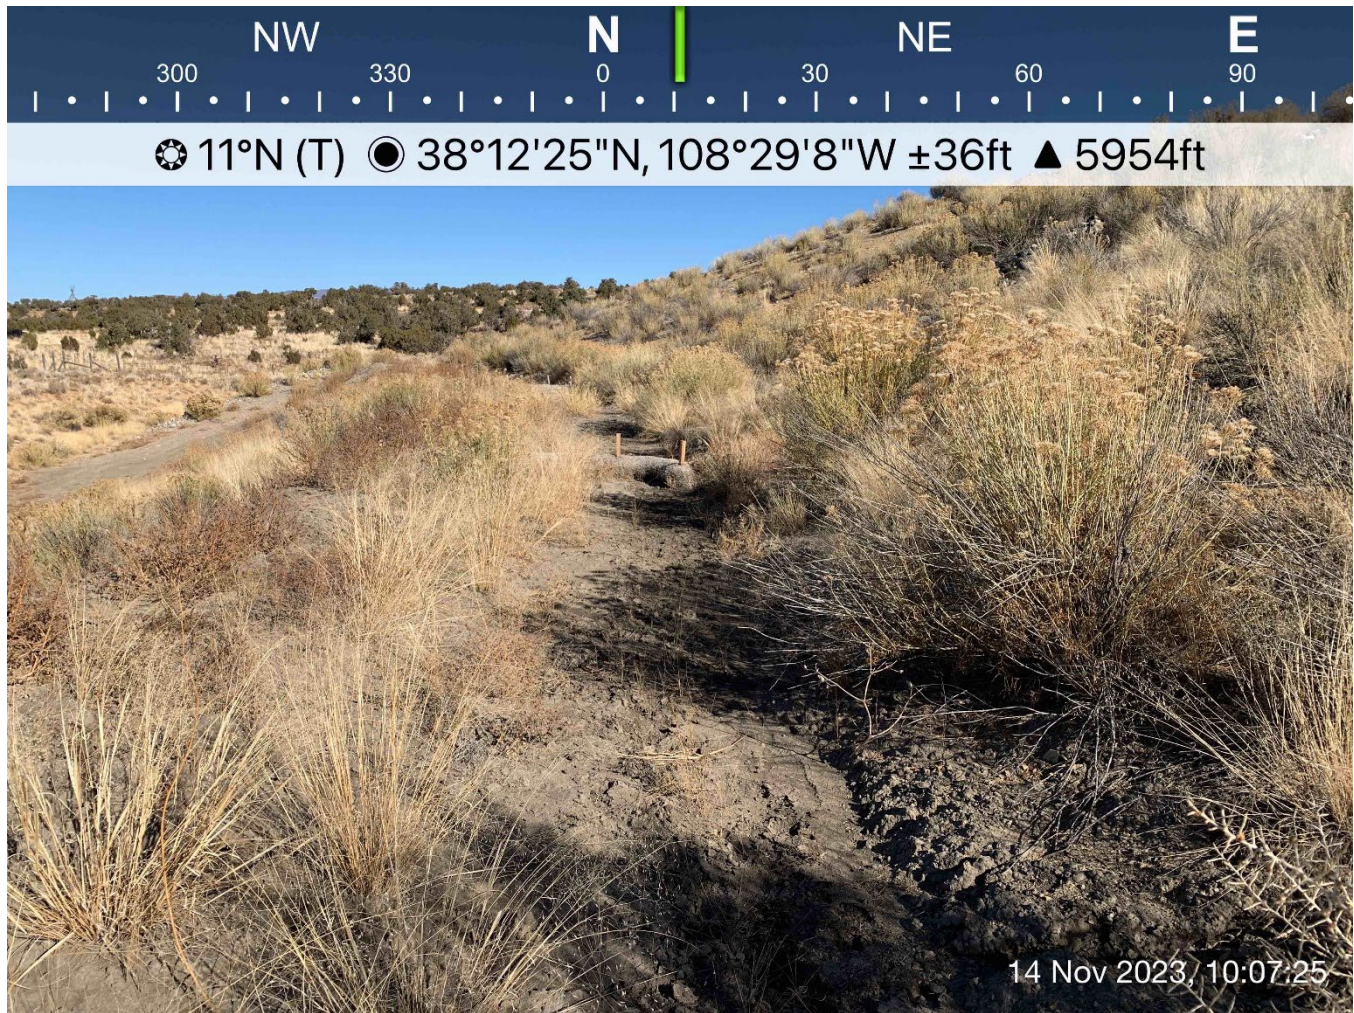
The embankment toe was observed to be in good condition. Signs of seepage, such as springs or boggy areas, were not observed along the embankment toe. The typical condition of the embankment toe is depicted in Photograph 5.

Photograph 5: Typical Condition of the Embankment Toe

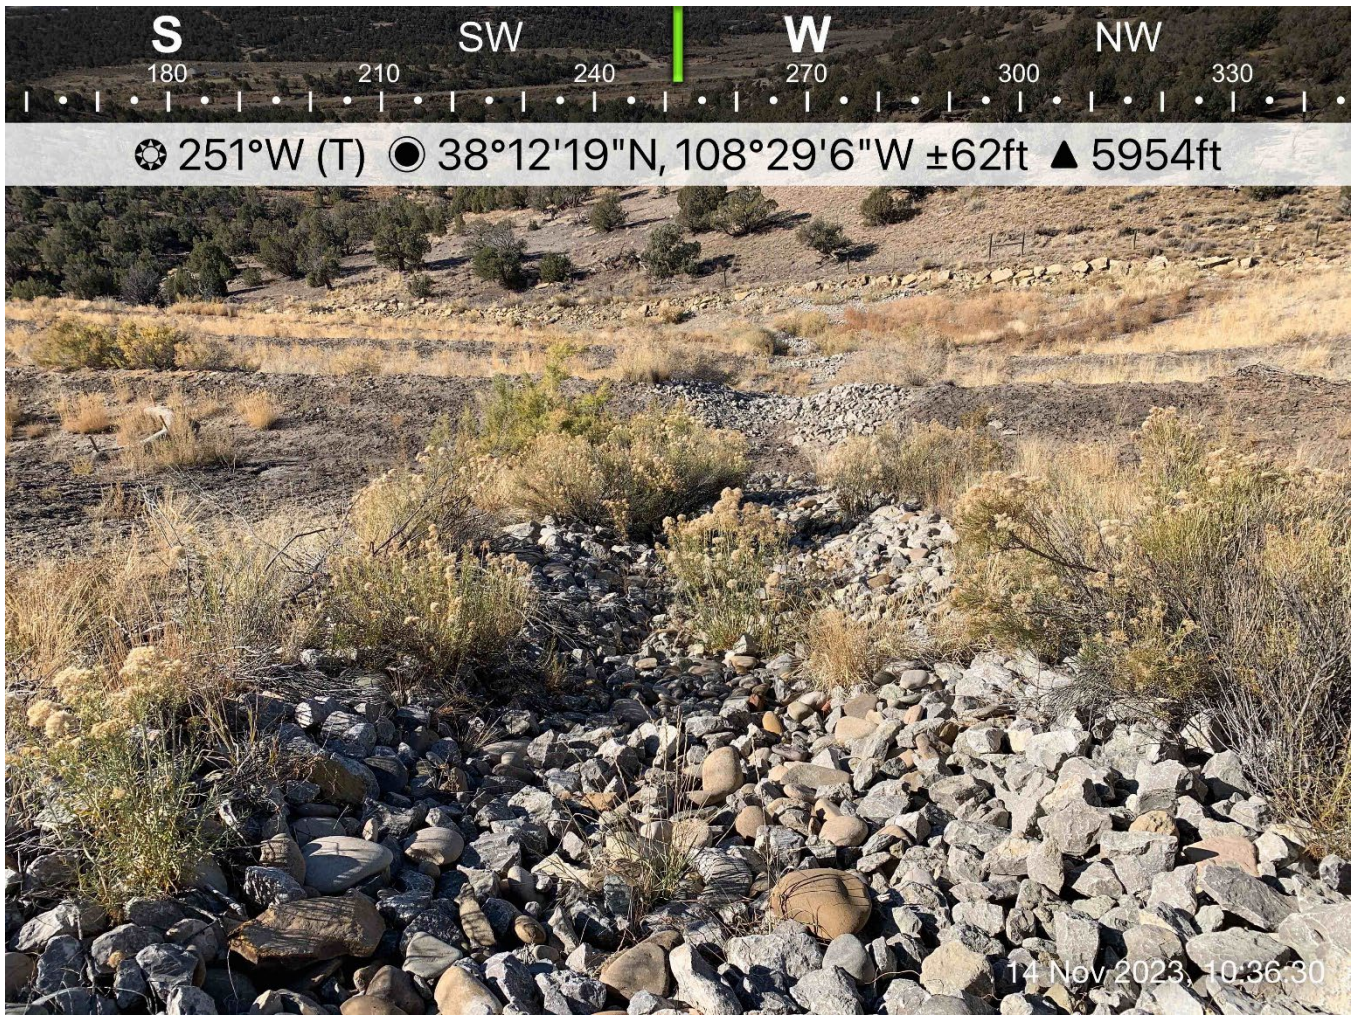
The stormwater control features at the facility were observed to be in good condition. Downchute channels and energy dissipation basins at the facility are constructed with riprap. The typical condition of the downchute channels is depicted in Photograph 6. Terrace channels at the facility are provided at approximate 20-foot vertical intervals. Erosion control wattles have been installed to control erosion and capture sediment in the terrace channels at appropriate intervals. The typical condition of the terrace channels is depicted in Photograph 7. Perimeter channels are in place around the facility where they are needed to control stormwater. Perimeter channels at the facility are generally constructed with soil and rock. Erosion control wattles have been installed at appropriate intervals in the perimeter channels to control erosion and capture sediment. The typical condition of the perimeter channels is depicted in Photograph 8. During the visual observation, WSP observed that the damage to a stormwater outfall that was caused by major storm events in late September and early October 2022, where indicated in Appendix A, had not yet been repaired. The damage is shown in Photograph 9. Tri-State indicated that the repair work was scheduled to be implemented in December 2023, weather permitting. The damage does not currently pose a threat to structural stability and did not hinder WSP's ability to inspect the facility.

Photograph 6: Typical Condition of Downchute Channels

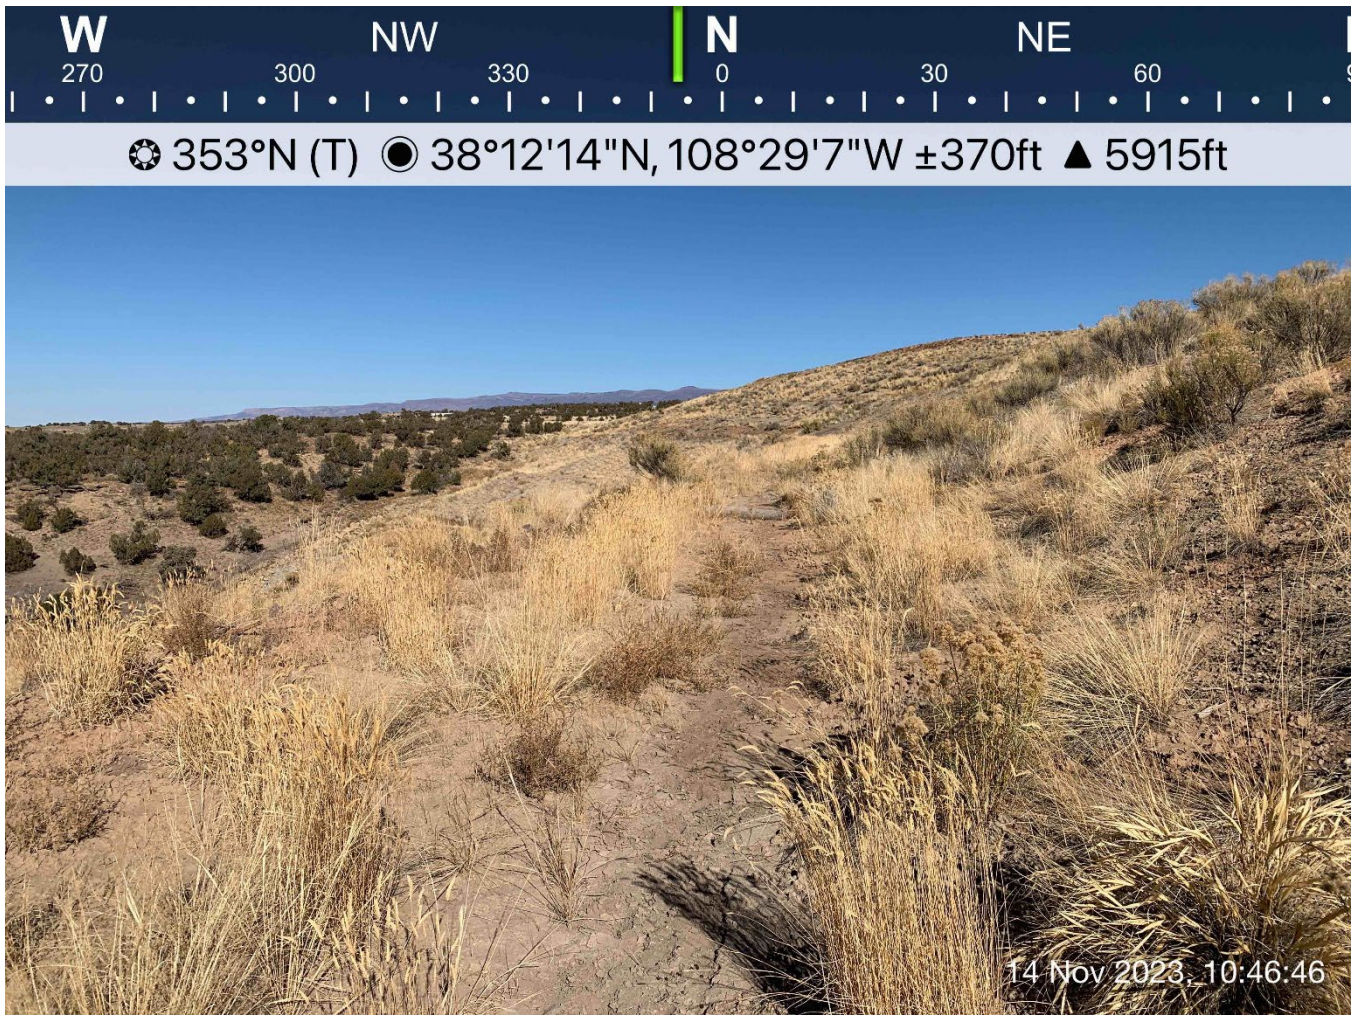
Photograph 7: Typical Condition of Terrace Channels

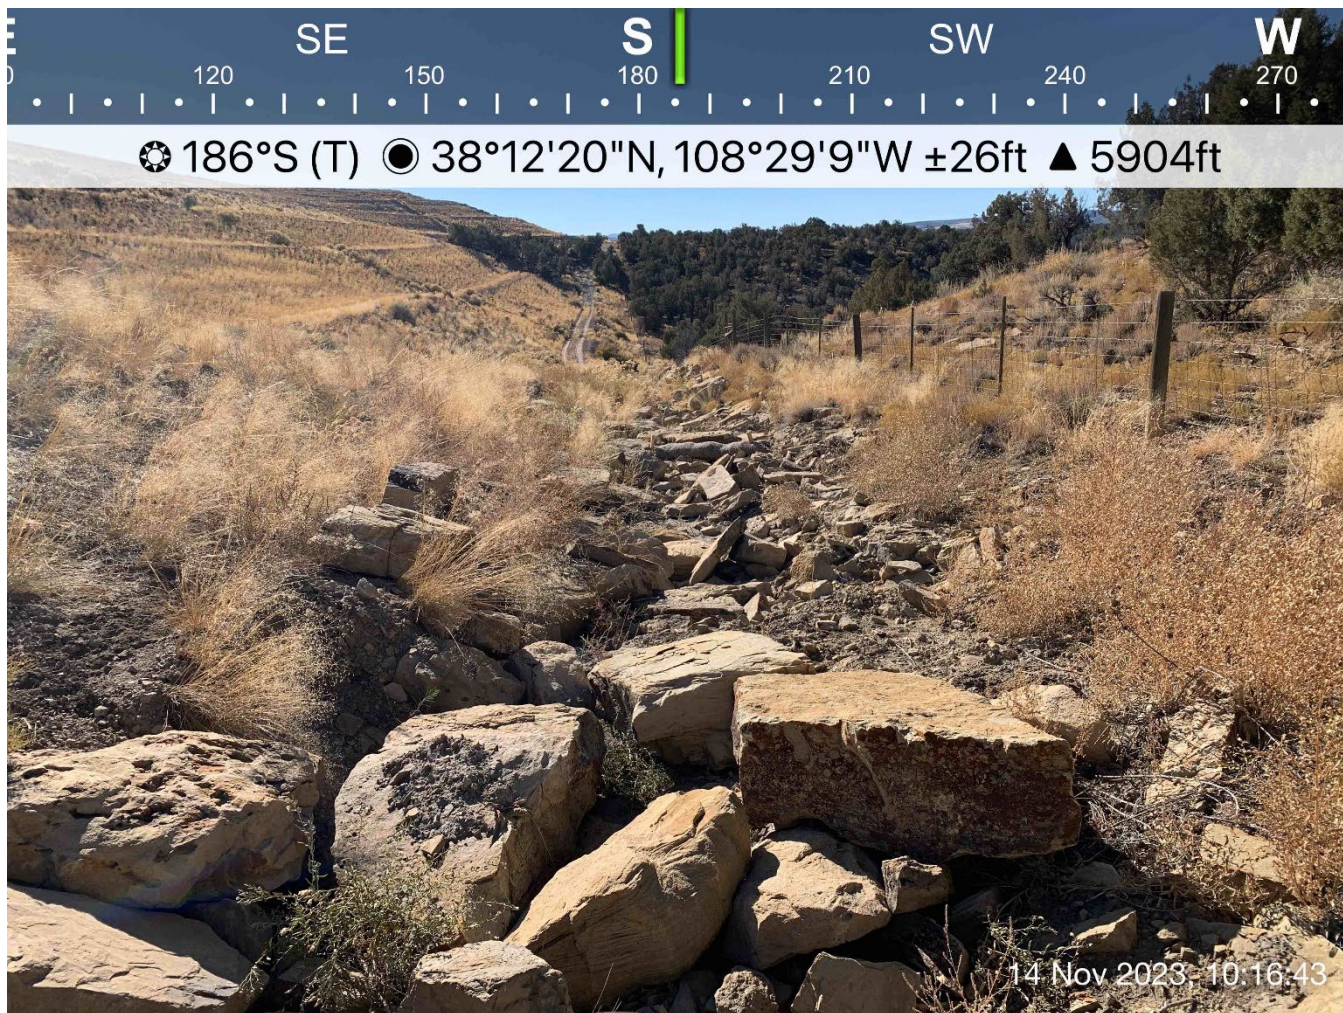
Photograph 8: Typical Condition of Perimeter Channels

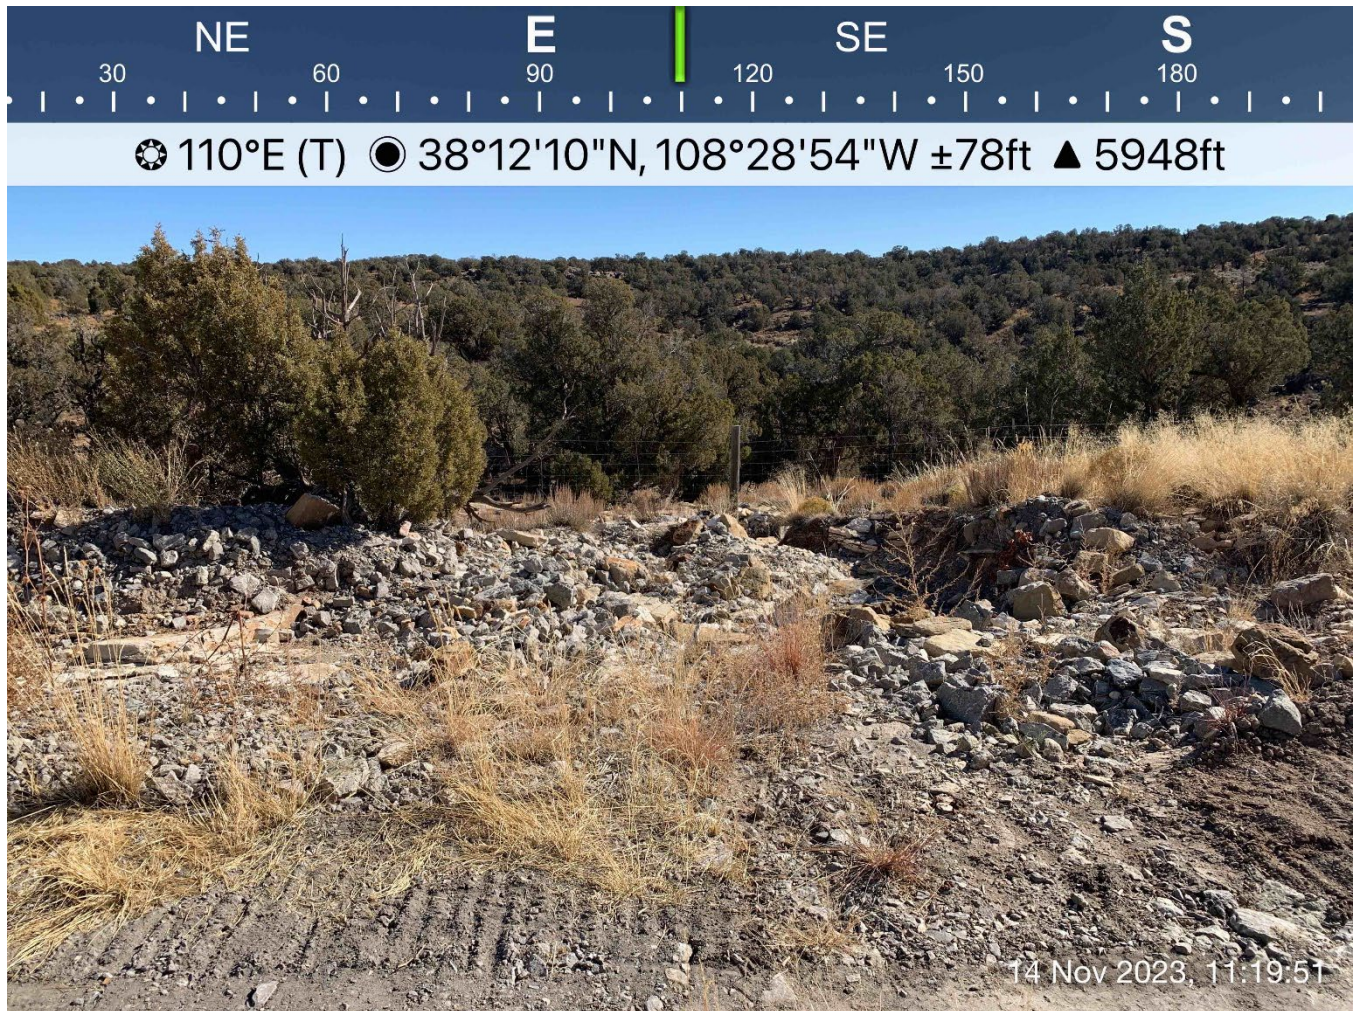
Photograph 9: Damage to Stormwater Outfall

e.						
J. Elaboration						
Identify the specific item number (for instance, F.2.) and elaborate on each deficiency or issue identified during the inspection. Attach documentation (photographs or sketches) if practical.						
A.1.a/H.4. The stormwater outfall on the southern half of the east perimeter (see the map on page 3) was damaged by major storm events in late September and early October 2022, according to Tri-State personnel. Repair work is needed and is scheduled to be implemented in December 2023, weather permitting.						
D.4. Tri-State personnel indicated that Halogeton has been identified in some areas on the top surface.						
D.5. Small animal burrows were observed in two locations on the top surface (see the map on page 3). The burrows did not appear to be active.						
F.4. The south embankment slopes have not yet been reseeded after being roughened to create an undulating surface. Reseeding should be carried out during the appropriate season.

WSP completed an inspection of the Nucla Station Ash Disposal Facility, including a visual observation conducted on November 14, 2023. The facility was observed to be in good condition overall. Signs of distress or malfunction of the facility were not observed, appearances of actual or potential structural weakness of the facility were not identified, and existing conditions that are disrupting or have the potential to disrupt the maintenance and safety of the facility were not observed. Current facility maintenance practices such as control of burrowing animals, monitoring and maintenance of embankment slopes, establishment of suitable vegetation on embankment slopes, and use of appropriate erosion control measures should continue, with repairs or improvements made as the need is indicated by periodic inspections. Reseeding of the south embankment slopes should be carried out during the appropriate season. Repair of the damaged stormwater outfall and the observed erosion rills should be completed when weather conditions allow. The need to address or control the growth of Halogeton on the top surface should also be evaluated.
