Coal Combustion Residuals Landfill 2024 Annual Inspection

Nucla Station Ash Disposal Facility

31403149.3795-001-RPT-0

December 13, 2024

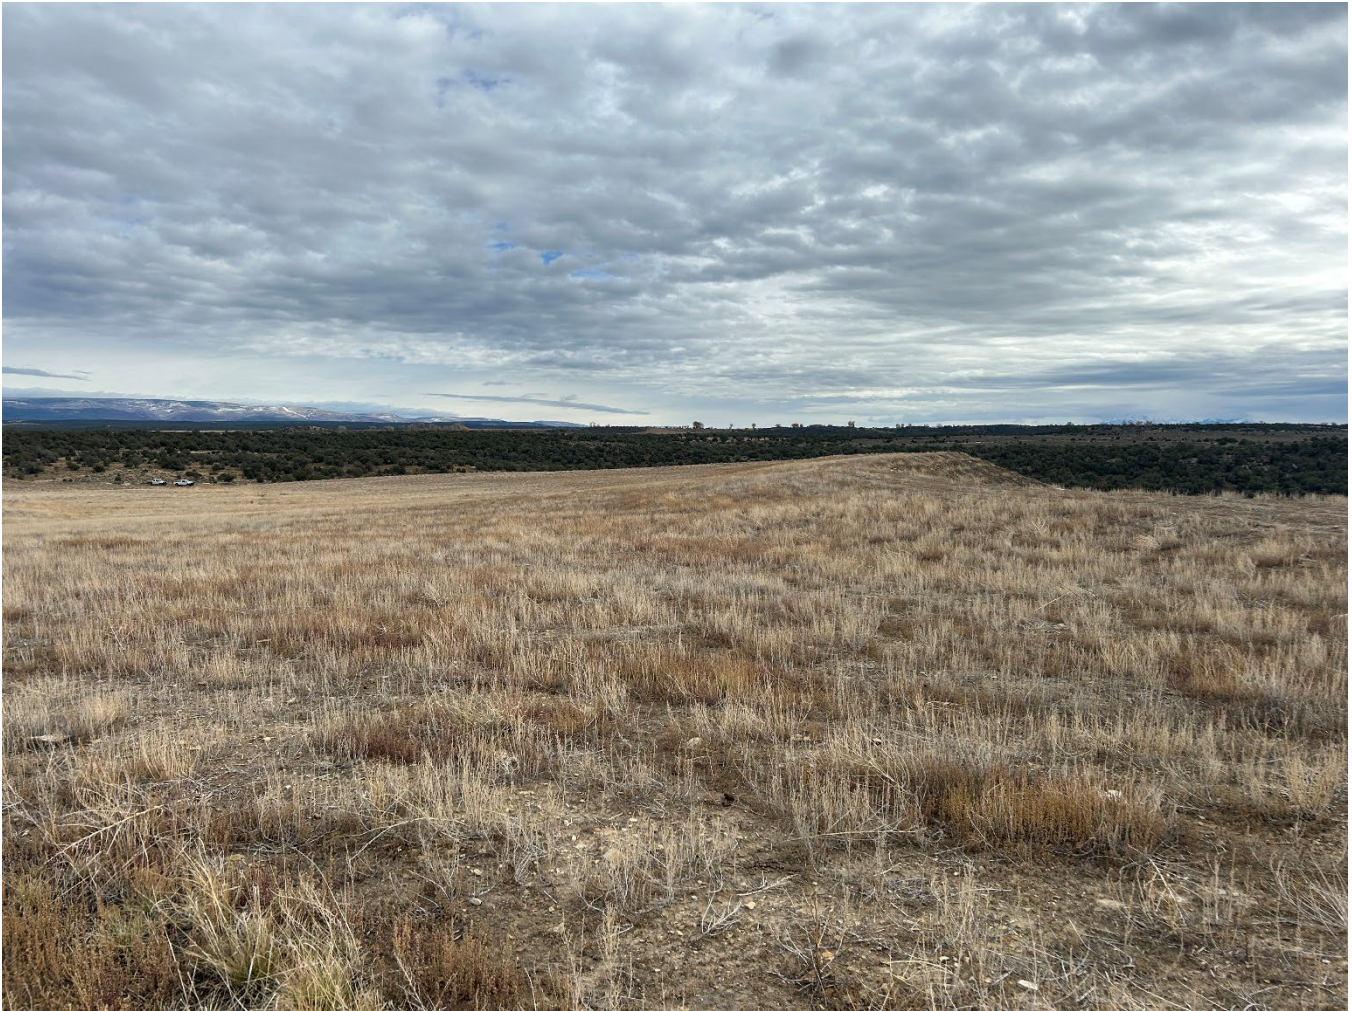
The top surface was observed to be in good condition. Signs of ground movement, such as sloughing or sliding, cracking, subsidence, or bulging, were not observed across the top surface. The top surface was appropriately graded so that stormwater will be routed away from the facility to the designated locations. A minor animal burrow was observed in one location on the top surface where indicated in Appendix A. The animal burrow does not currently pose a threat to structural stability and did not hinder WSP's ability to inspect the facility.

Vegetation has been established across the top surface following completion of closure activities in 2022, and a small area south of the diversion berm was revegetated in 2024 following repair of erosion rills. Vegetation was generally observed to be in fair condition across the top surface of the facility. Halogeton was observed on the top surface and is generally considered to be an undesirable plant species. The typical condition of the top surface is depicted in Photograph 1.

Photograph 1: Typical Condition of the Top Surface

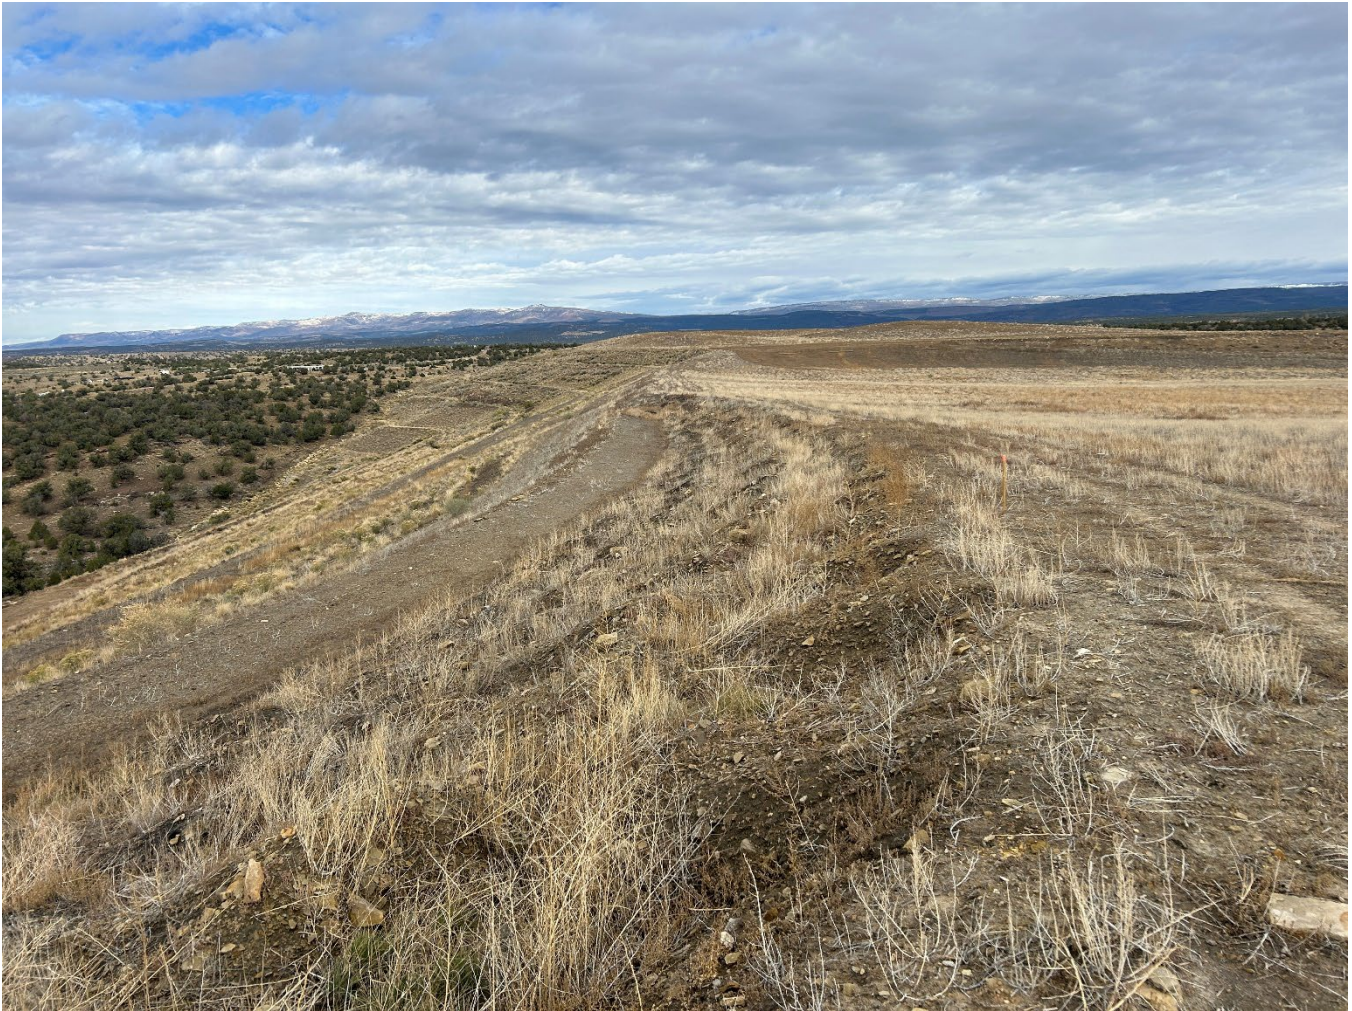
The embankment crest was observed to be in good condition. Cracking that would be indicative of ground movement was not observed along the embankment crest. Low areas that would be indicative of differential settlement were not observed along the embankment crest. The typical condition of the embankment crest is depicted in Photograph 2.

Photograph 2: Typical Condition of the Embankment Crest

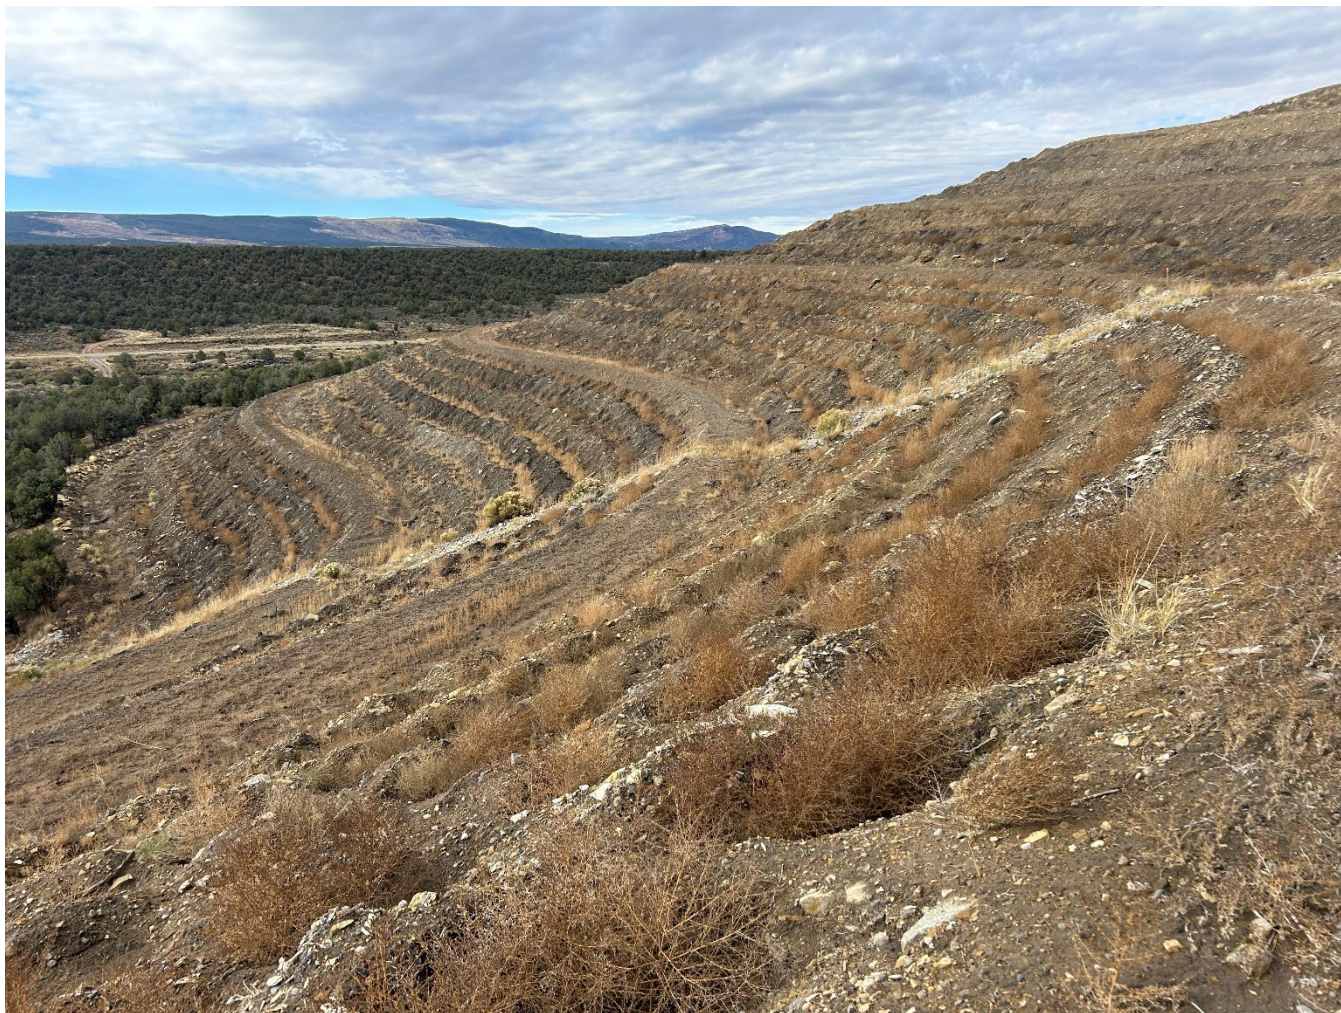
The embankment slopes were observed to be in fair to good condition. Signs of ground movement, such as sloughing or sliding, cracking, subsidence, or bulging, were not observed on the embankment slopes. Evidence of excessive erosion or slope deterioration was not observed on the embankment slopes. Fair to good native vegetation has been established on the embankment slopes, with the exception of the south embankment slopes, which had sparse vegetative cover. The south embankment slopes were roughened in 2023 to create an undulating surface and had recently been reseeded at the time of the visual observation. Vegetation was observed within the undulations across the south embankment slopes. The west, north, and east embankment slopes generally had adequate vegetative coverage at the time of the visual observation. Unusually poor or thriving vegetative growth was not observed on these embankment slopes.

Photograph 3: Typical Condition of the South Embankment Slopes

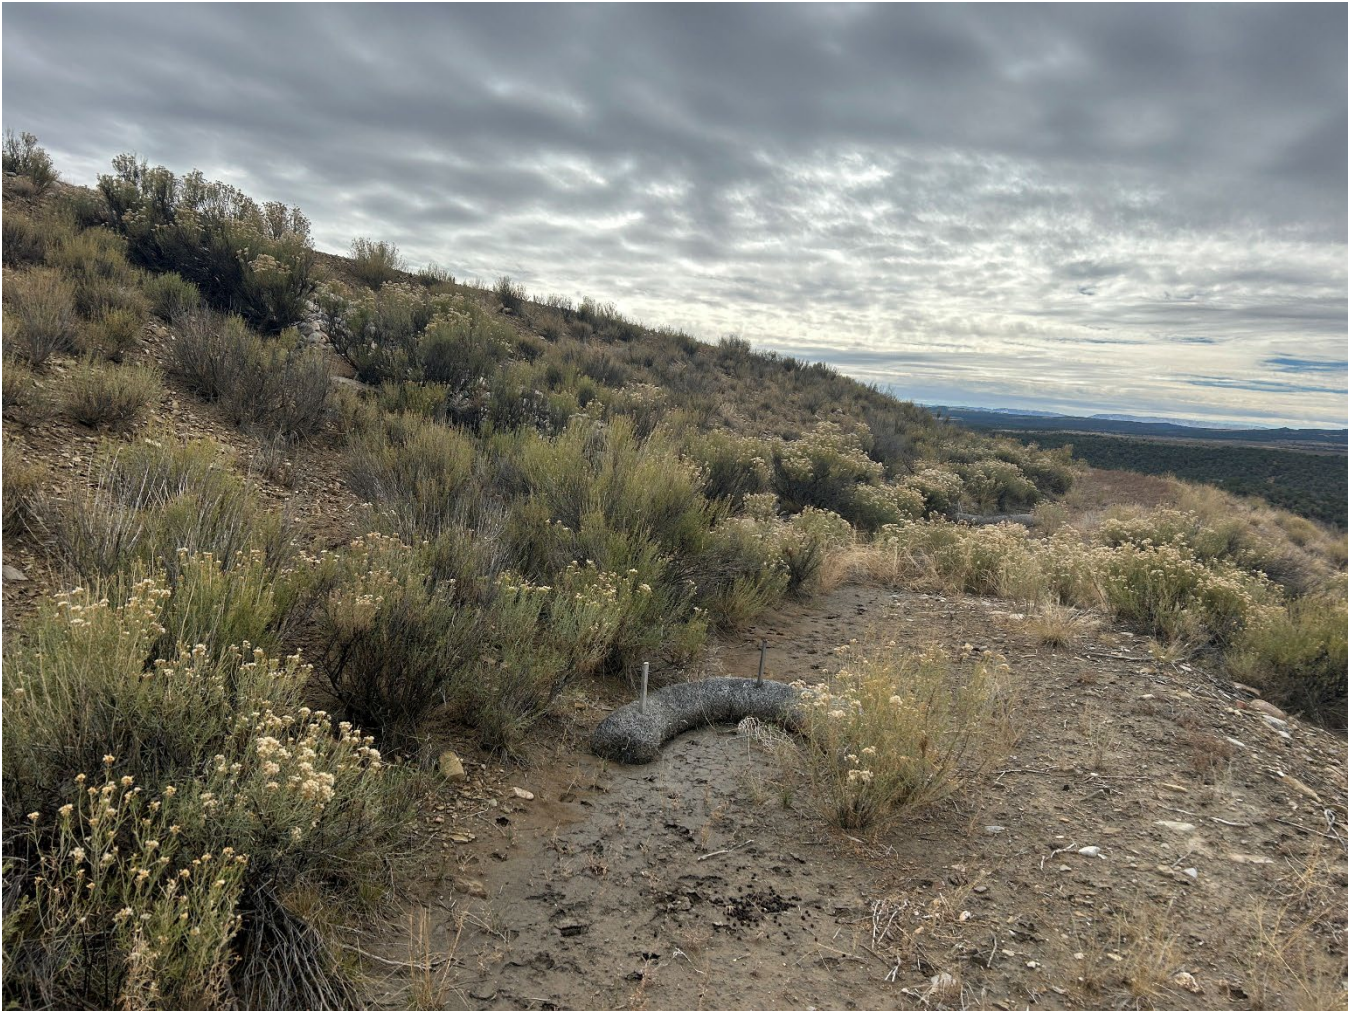
Photograph 4: Typical Condition of the West, North, and East Embankment Slopes

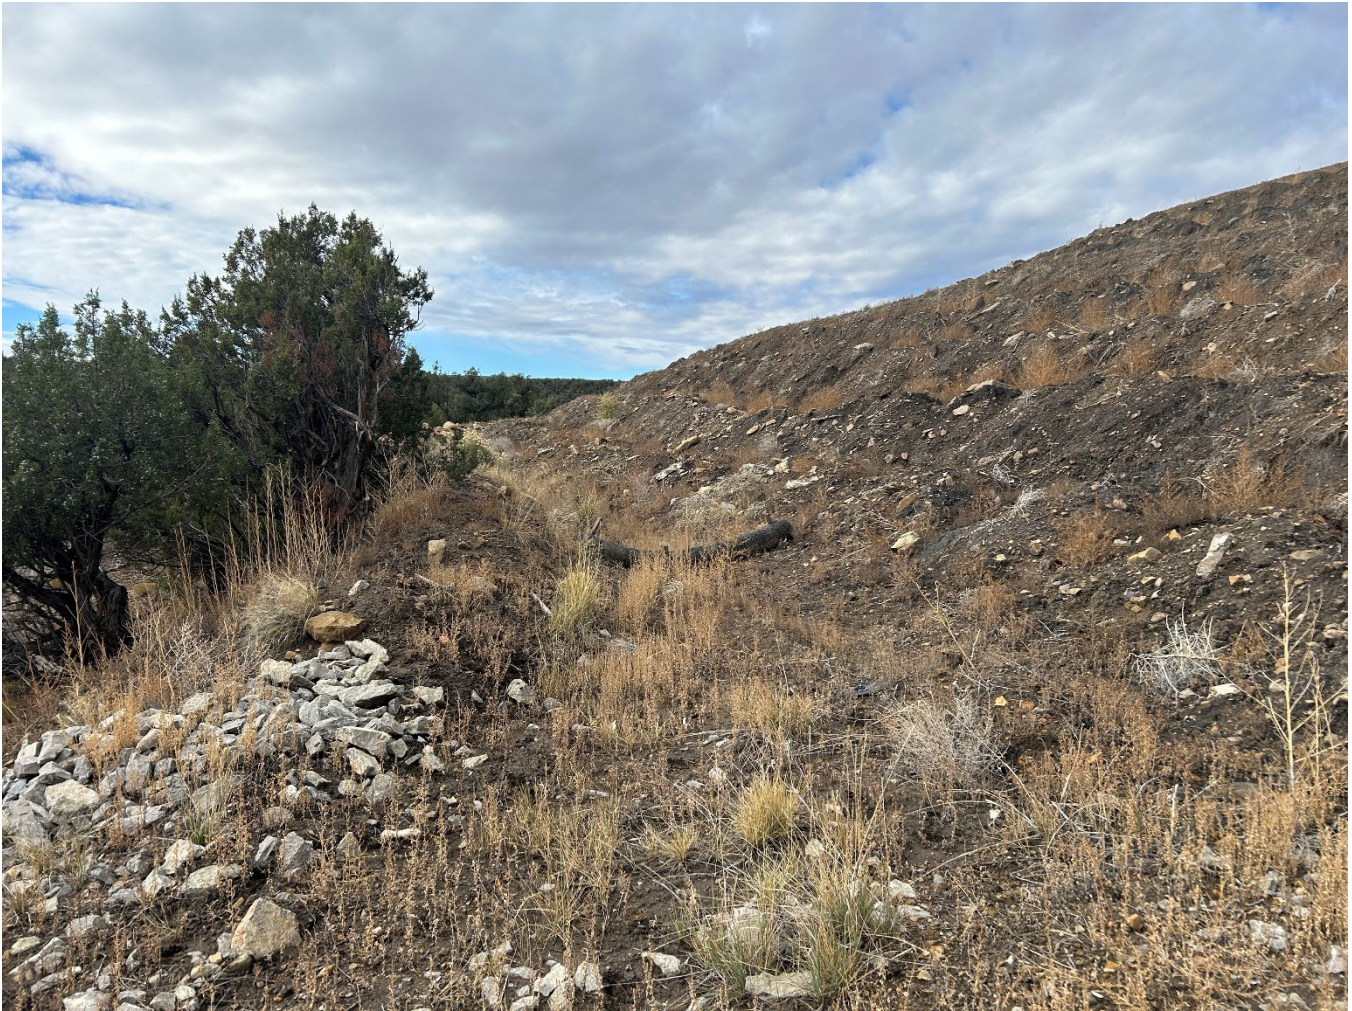
The embankment toe was observed to be in good condition. Signs of seepage, such as springs or boggy areas, were not observed along the embankment toe. The typical condition of the embankment toe is depicted in Photograph 5.

Photograph 5: Typical Condition of the Embankment Toe

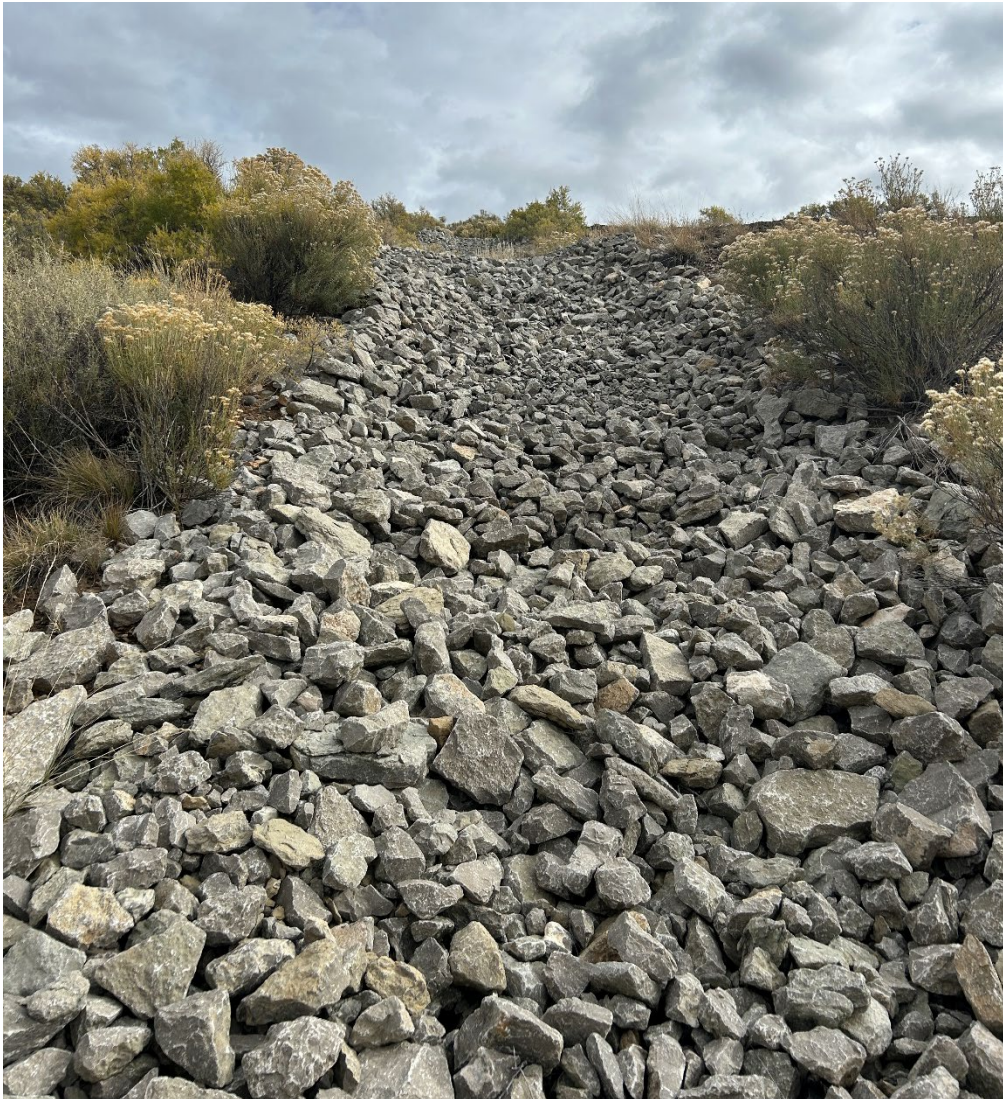
The stormwater control features at the facility were observed to be in good condition. Downchute channels and energy dissipation basins at the facility are constructed with riprap. The typical condition of the downchute channels is depicted in Photograph 6. Terrace channels at the facility are provided at approximate 20-foot vertical intervals. Erosion control wattles have been installed to control erosion and capture sediment in the terrace channels at appropriate intervals. A few animal burrows were observed within the terrace channels where indicated in Appendix A. The animal burrows did not appear to be active, do not currently pose a threat to structural stability, and did not hinder WSP's ability to inspect the facility. The typical condition of the terrace channels is depicted in Photograph 7. Perimeter channels are in place around the facility where they are needed to control stormwater. Perimeter channels at the facility are generally constructed with soil and rock. Erosion control wattles have been installed at appropriate intervals in the perimeter channels to control erosion and capture sediment. The typical condition of the perimeter channels is depicted in Photograph 8.

Photograph 6: Typical Condition of Downchute Channels

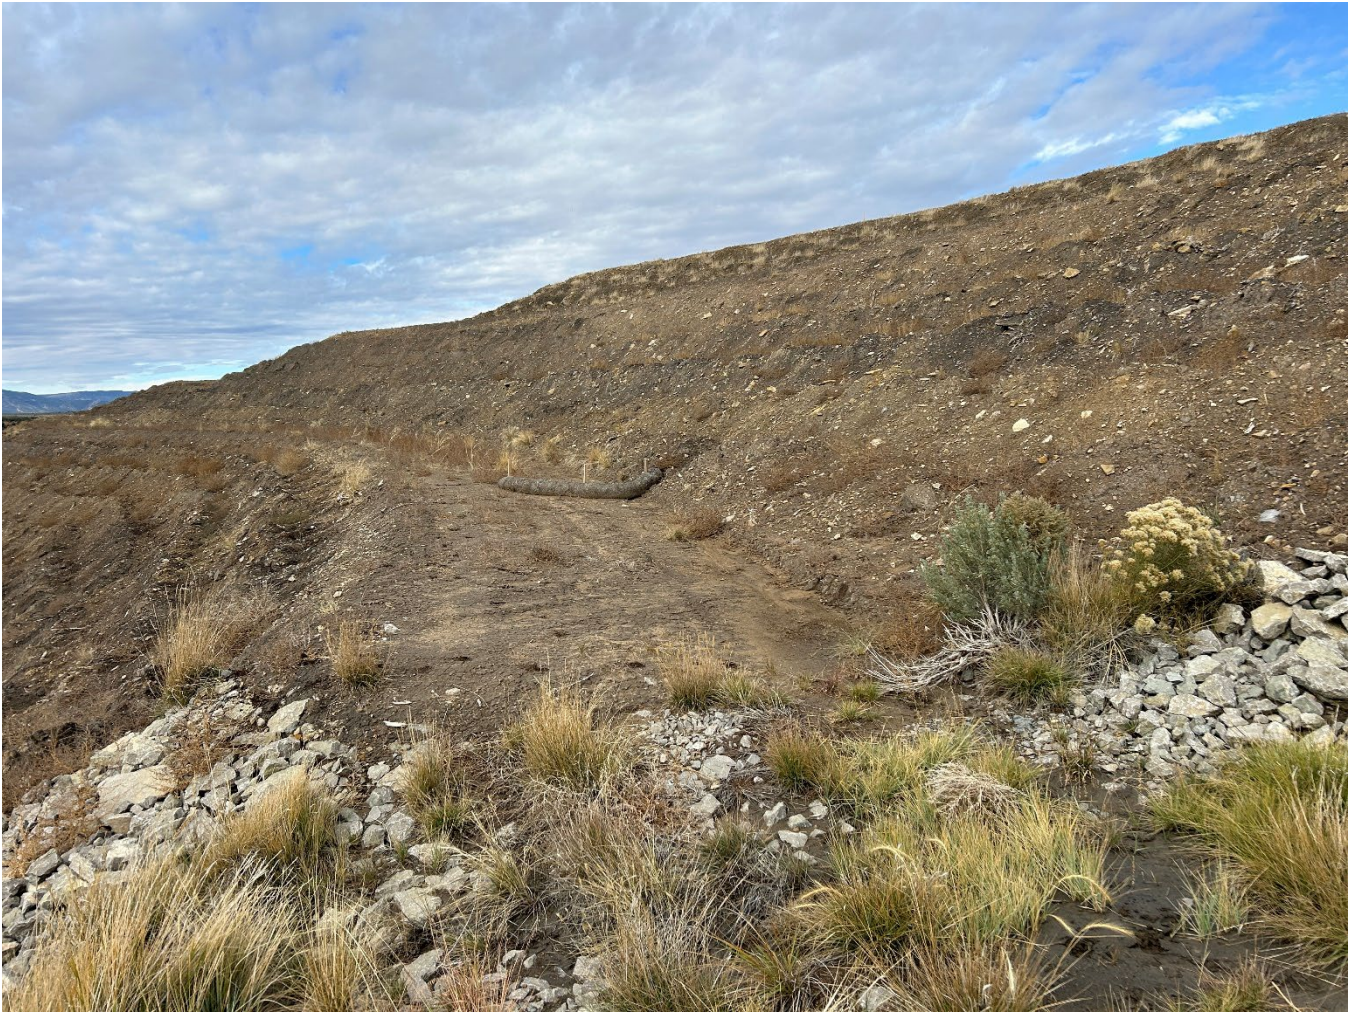
Photograph 7: Typical Condition of Terrace Channels

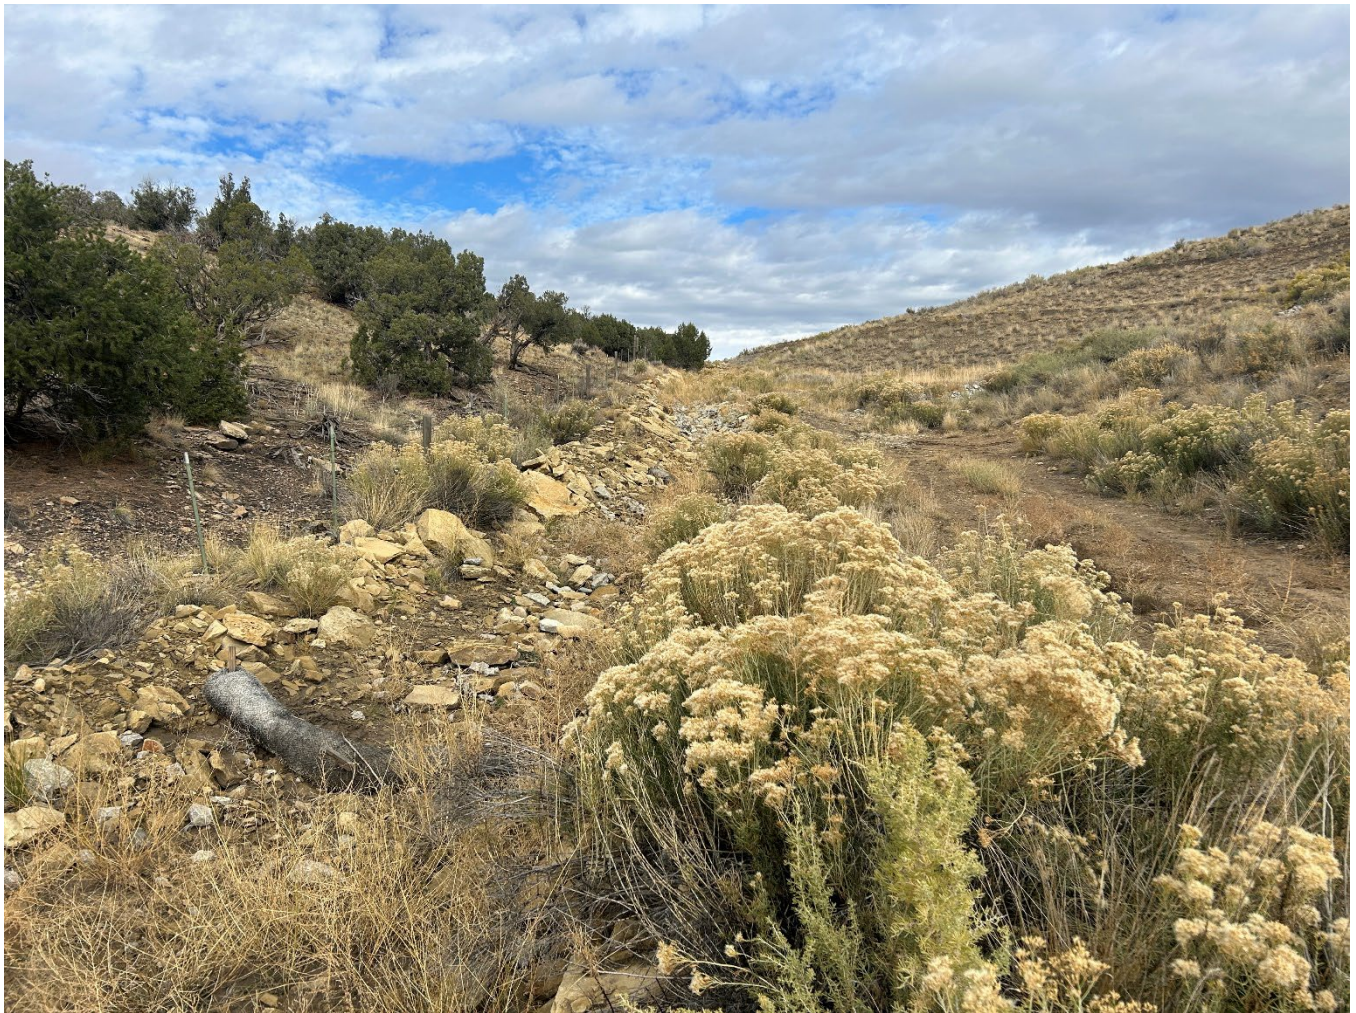
Photograph 8: Typical Condition of Perimeter Channels

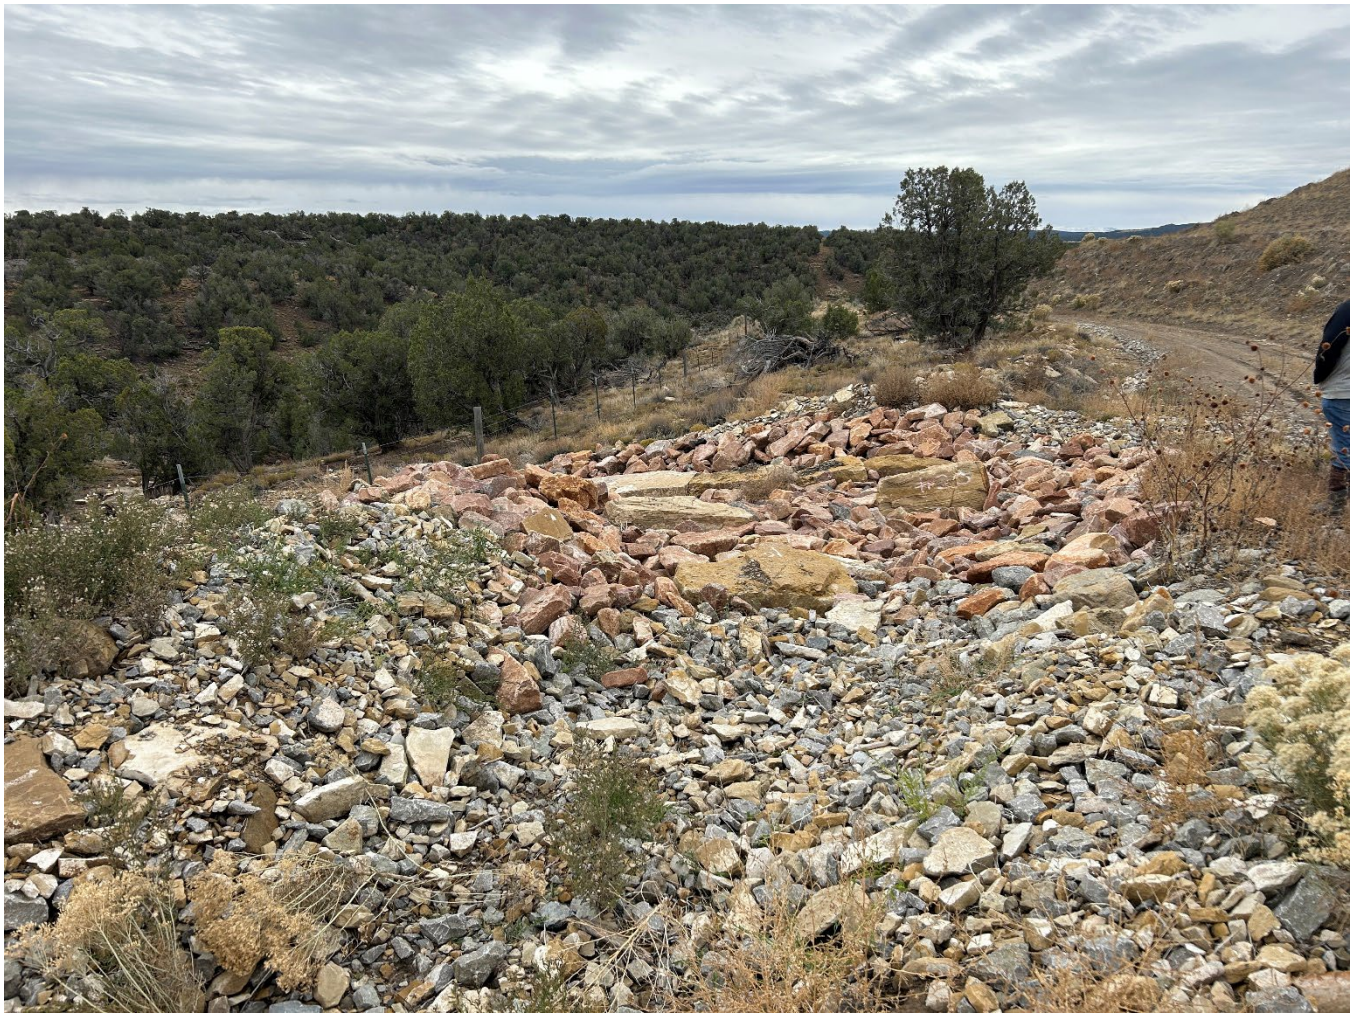
Photograph 9: Stormwater Outfall 07 (looking south)

Tri-State repaired the riprap-lined channel at Outfall 07 following the 2023 inspection. In 2022, the riprap layer within the channel and at the outfall was damaged during a large storm event. To repair this area, Tri-State lined the channel with larger riprap, estimated to have an approximate average diameter of six inches, and installed

multiple boulders within the channel and at the outfall. Three larger boulders were placed within the channel to dissipate energy of stormwater runoff upstream of the outfall. Approximately four large boulders were placed at the downstream end of the channel, where the flow direction is diverted 90 degrees from the south-flowing channel to the east-flowing outfall, in an effort to provide additional protection against erosion. The repaired riprap-lined channel at Outfall 07 is shown in Photograph 9 and Photograph 10.

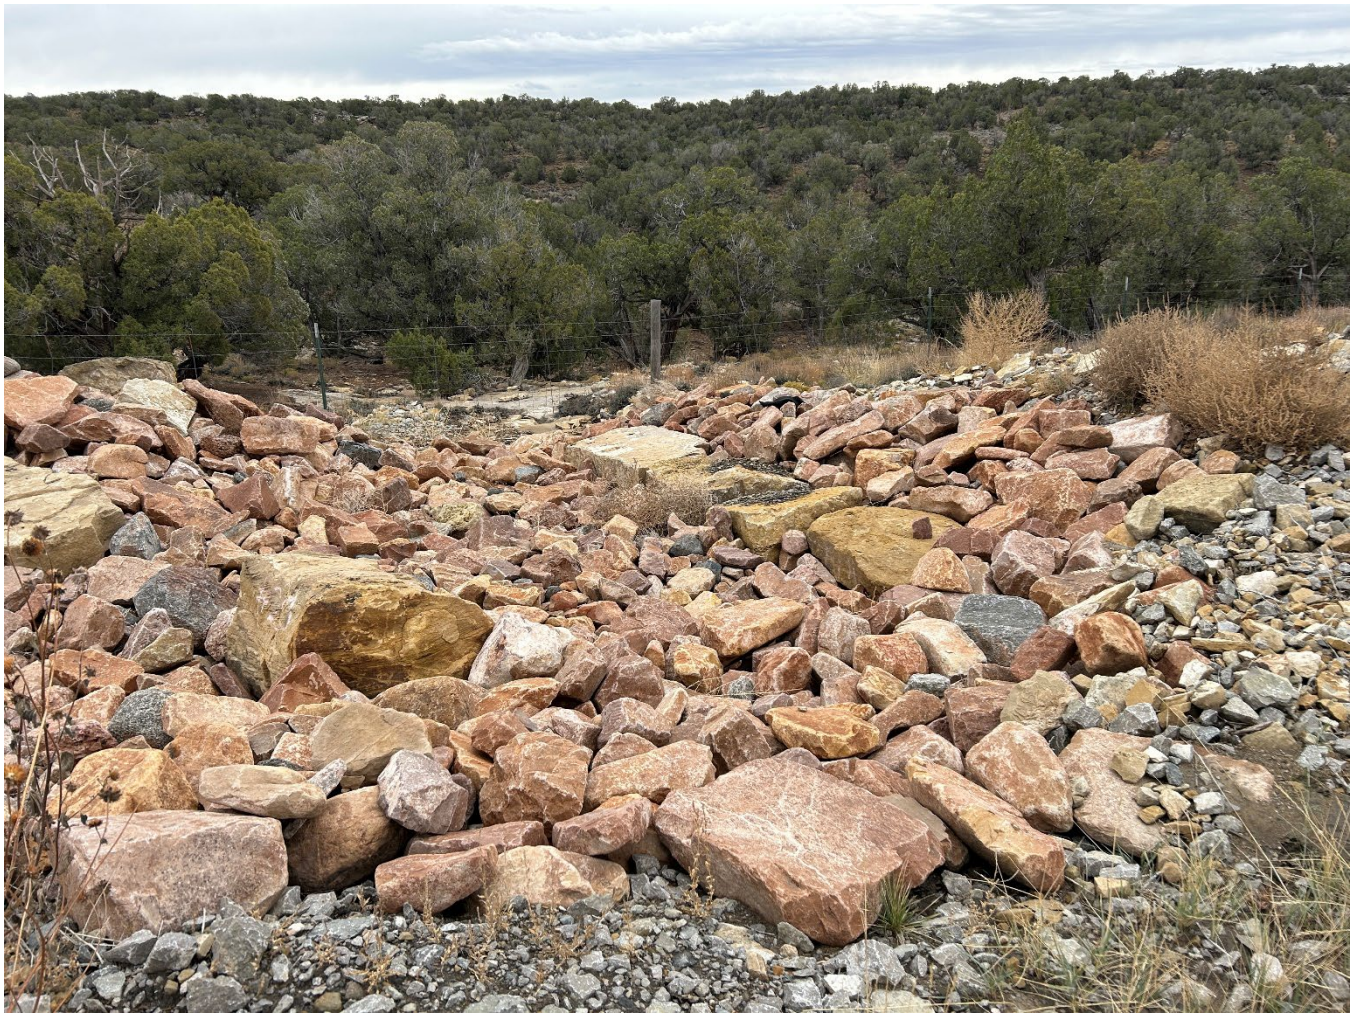
Photograph 10: Stormwater Outfall 07 (looking east)

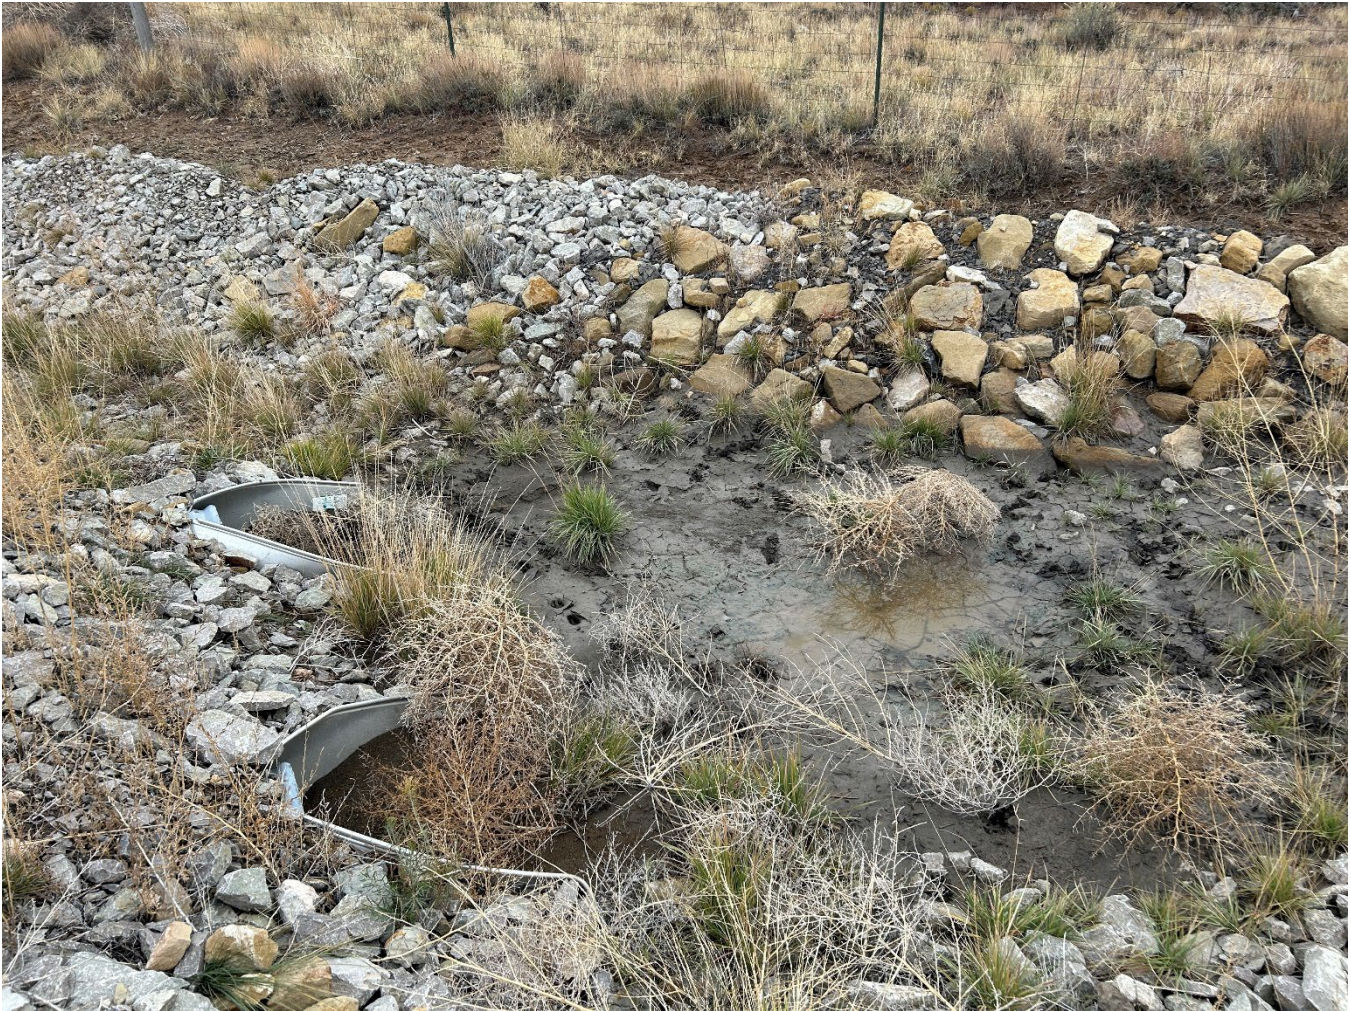
Culverts near the site entrance were inspected. The culverts were generally observed to be in good condition. The southernmost culverts at the site entrance were observed to have sediment buildup on the downstream ends, as depicted in Photograph 11. The culverts should be periodically cleaned out if sediment is observed within the culverts. Straw wattles in the channels upstream of the culverts were observed to be in good condition.

Photograph 11: Sediment Buildup at Downstream End of Culverts

WSP completed an inspection of the Nucla Station Ash Disposal Facility, including a visual observation conducted on November 5, 2024. The facility was observed to be in good condition overall. Signs of distress or malfunction of the facility were not observed, appearances of actual or potential structural weakness of the facility were not identified, and existing conditions that are disrupting or have the potential to disrupt the maintenance and safety of the facility were not observed. Current facility maintenance practices such as control of burrowing animals, monitoring and maintenance of embankment slopes, establishment of suitable vegetation on embankment slopes, and use of appropriate erosion control measures should continue, with repairs or improvements made as the need is indicated by periodic inspections. The need to address or control the growth of Halogeton on the top surface should also be evaluated.
