# Coal Combustion Residuals Landfill 2025 Inspection

## *Nucla Station Ash Disposal Facility*

31403149.2403-002-RPT-0

December 15, 2025

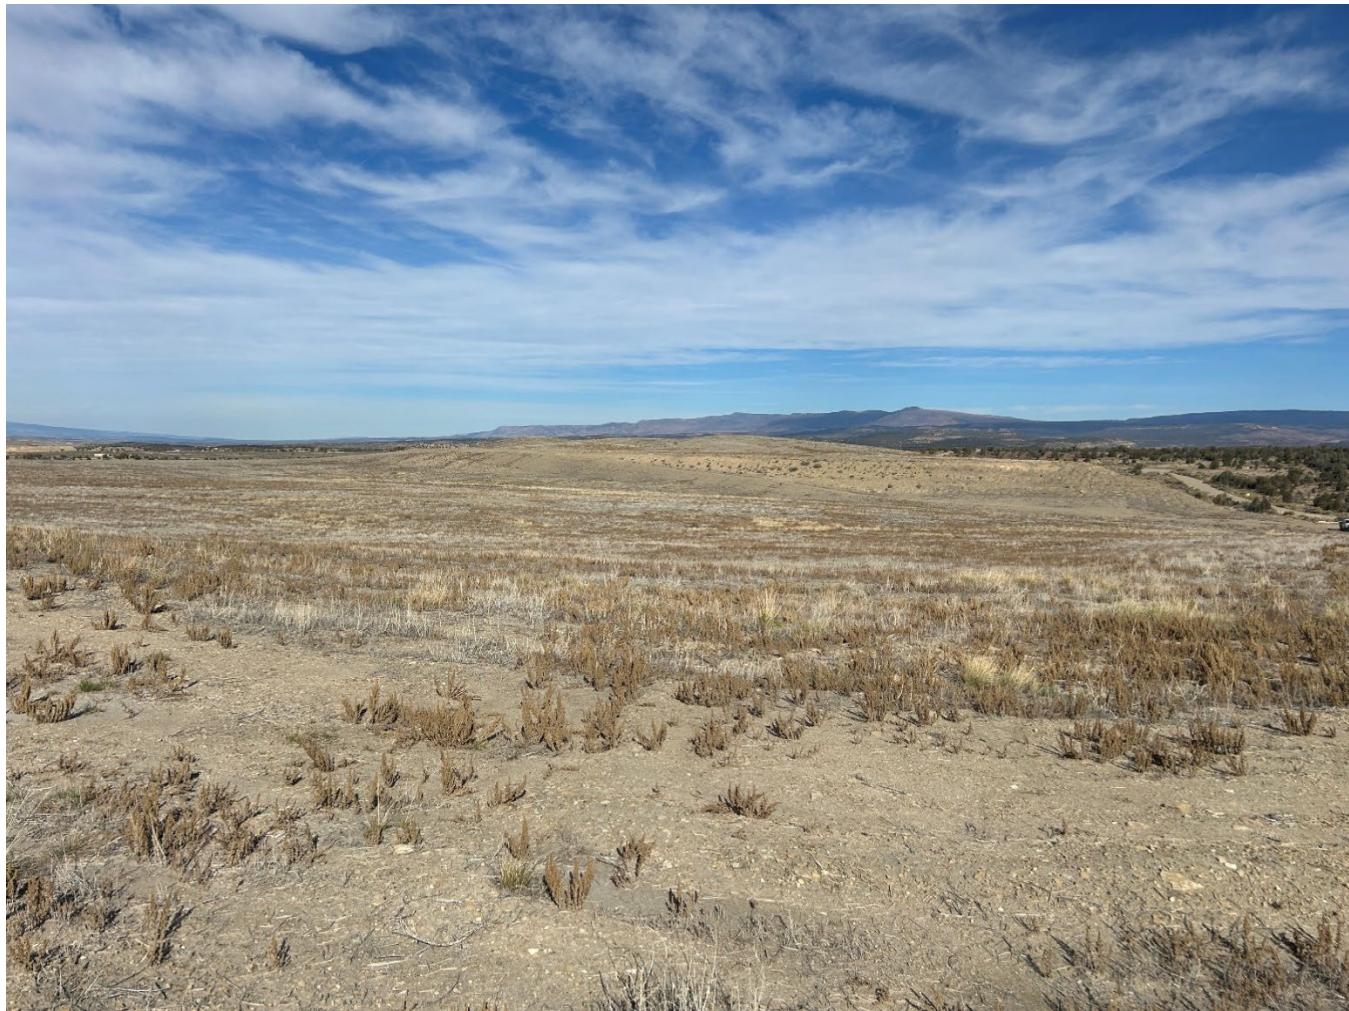
Vegetation has been established across the top surface following completion of closure activities in 2022. Vegetation was generally observed to be in fair to poor condition across the top surface of the facility, with areas of relatively sparse vegetative growth. Halogeton was observed on the top surface and is generally considered to be an undesirable plant species. The typical condition of the top surface is depicted in Photograph 1.

**Photograph 1: Typical Condition of the Top Surface**

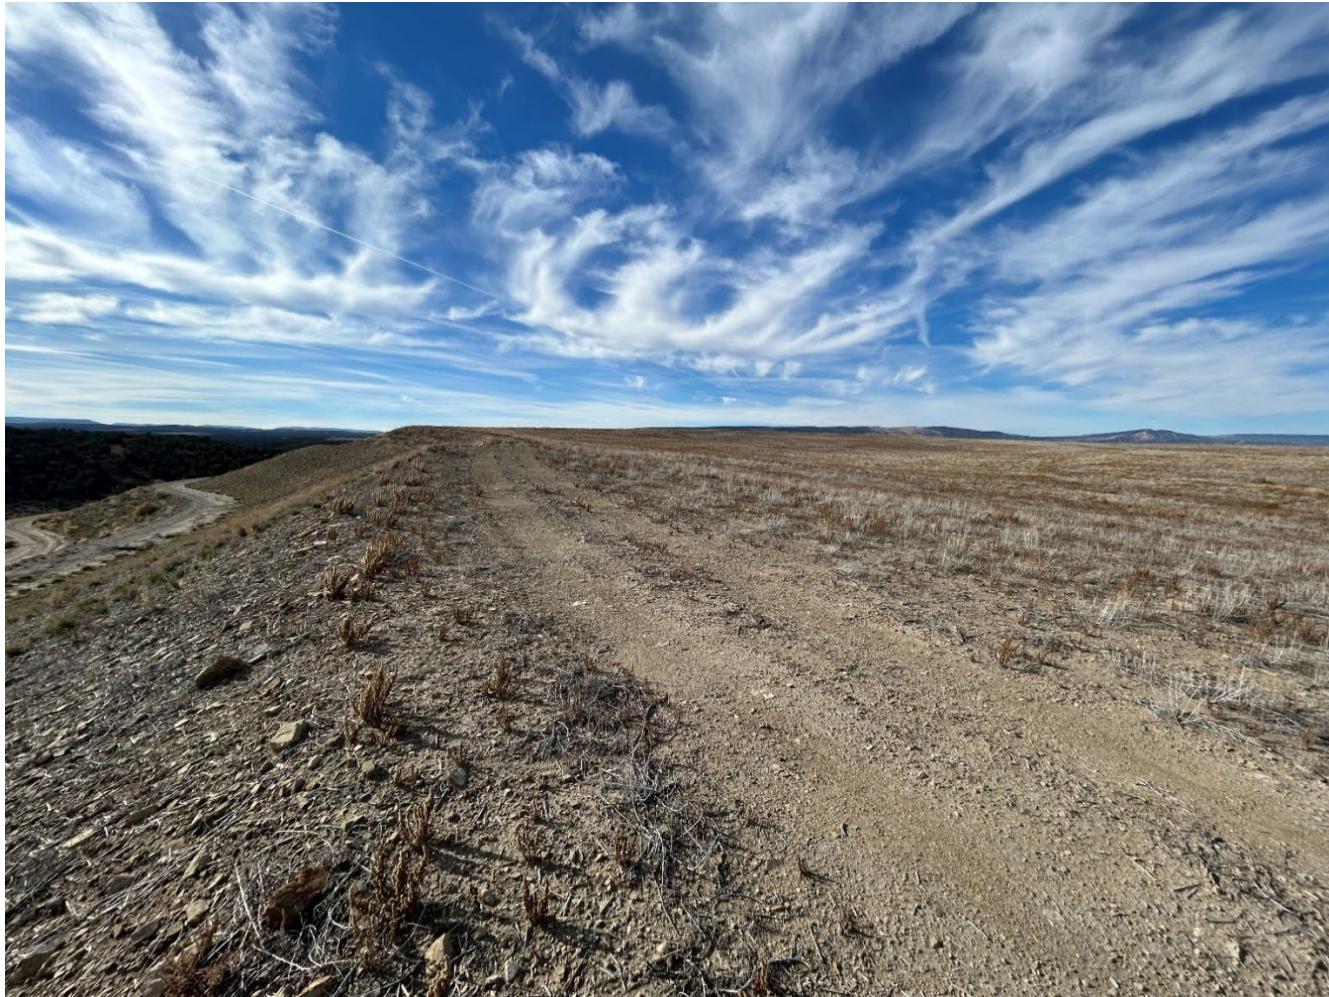
The embankment crest was observed to be in good condition. Cracking that would be indicative of ground movement was not observed along the embankment crest. Low areas that would be indicative of differential settlement were not observed along the embankment crest. The typical condition of the embankment crest is depicted in Photograph 2.

**Photograph 2: Typical Condition of the Embankment Crest**

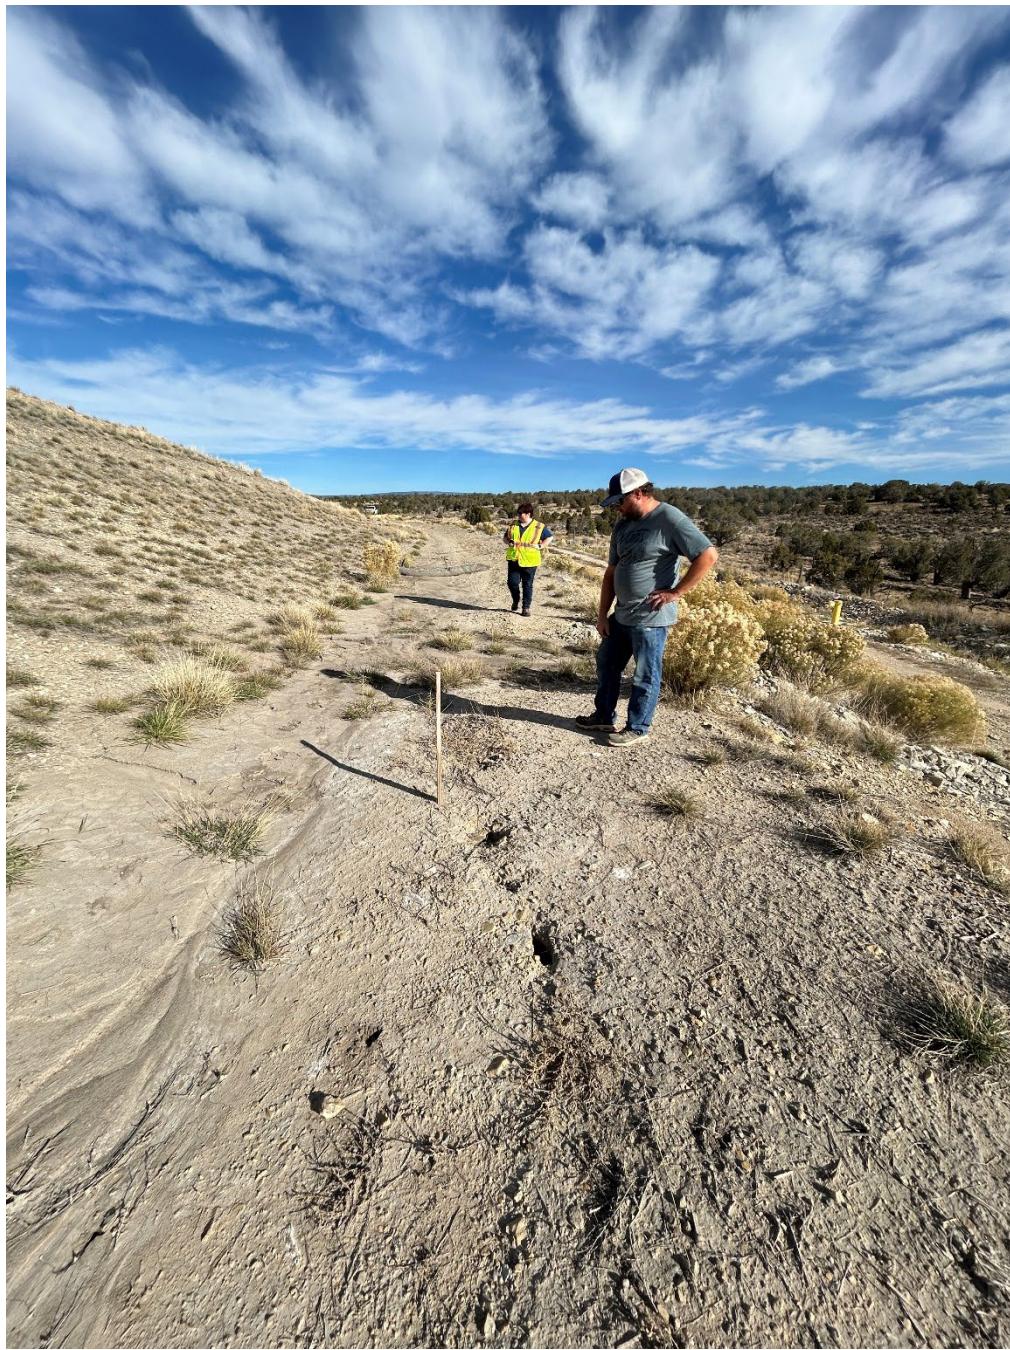
The embankment slopes were observed to be in fair to good condition. A crack was observed within a terrace channel on the eastern side slope, upslope from the nearby stormwater outfall. The crack was observed to be approximately 8 feet long and approximately 2 inches wide and was generally parallel to the terrace channel approximately 4 feet from the crest of the adjacent slope, as depicted in Photograph 3. The depth of the crack could not be visually ascertained. The adjacent side slope was carefully inspected, and no further signs of movement or structural instability were observed. The surficial soil should be excavated along the length of the crack, to a depth at least as deep as the crack, and replaced with competent fill material to prevent exacerbation by water intrusion. Periodic observation in this area should continue in order to identify potential signs of structural instability, should they occur.

**Photograph 3: Crack in an East-facing Side Slope Terrace Channel**

a. F.2. Cracking was observed along the terrace channel above Outfall 07. A single crack was observed. The crack was approximately 8 feet long by 2 inches wide, with an unknown depth. No signs of slope movement or other concerns were observed in the surrounding area. The surficial soil should be excavated along the length of the crack, to a depth at least as deep as the crack, and replaced with competent fill material.

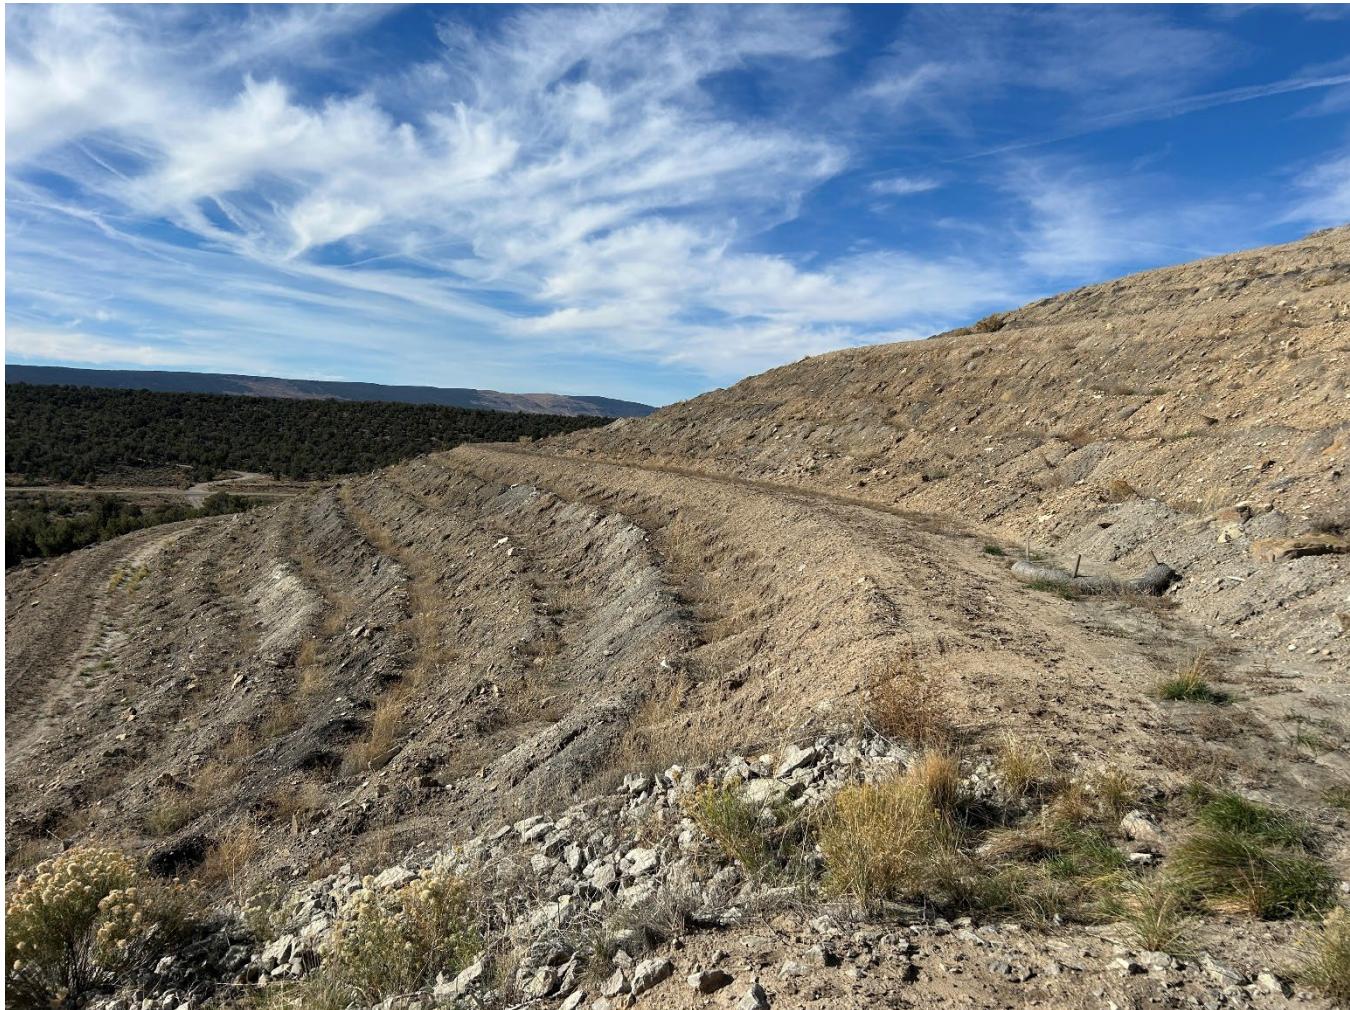
overall vegetative cover on the south embankment slope is characterized as poor. The west, north, and east embankment slopes generally had fair vegetative coverage at the time of the visual observation. Unusually poor or thriving vegetative growth was not observed on these embankment slopes. The typical condition of the south embankment slope is depicted in Photograph 4. The typical condition of the west, north, and east embankment slopes is depicted in Photograph 5.

**Photograph 4: Typical Condition of the South Embankment Slope**

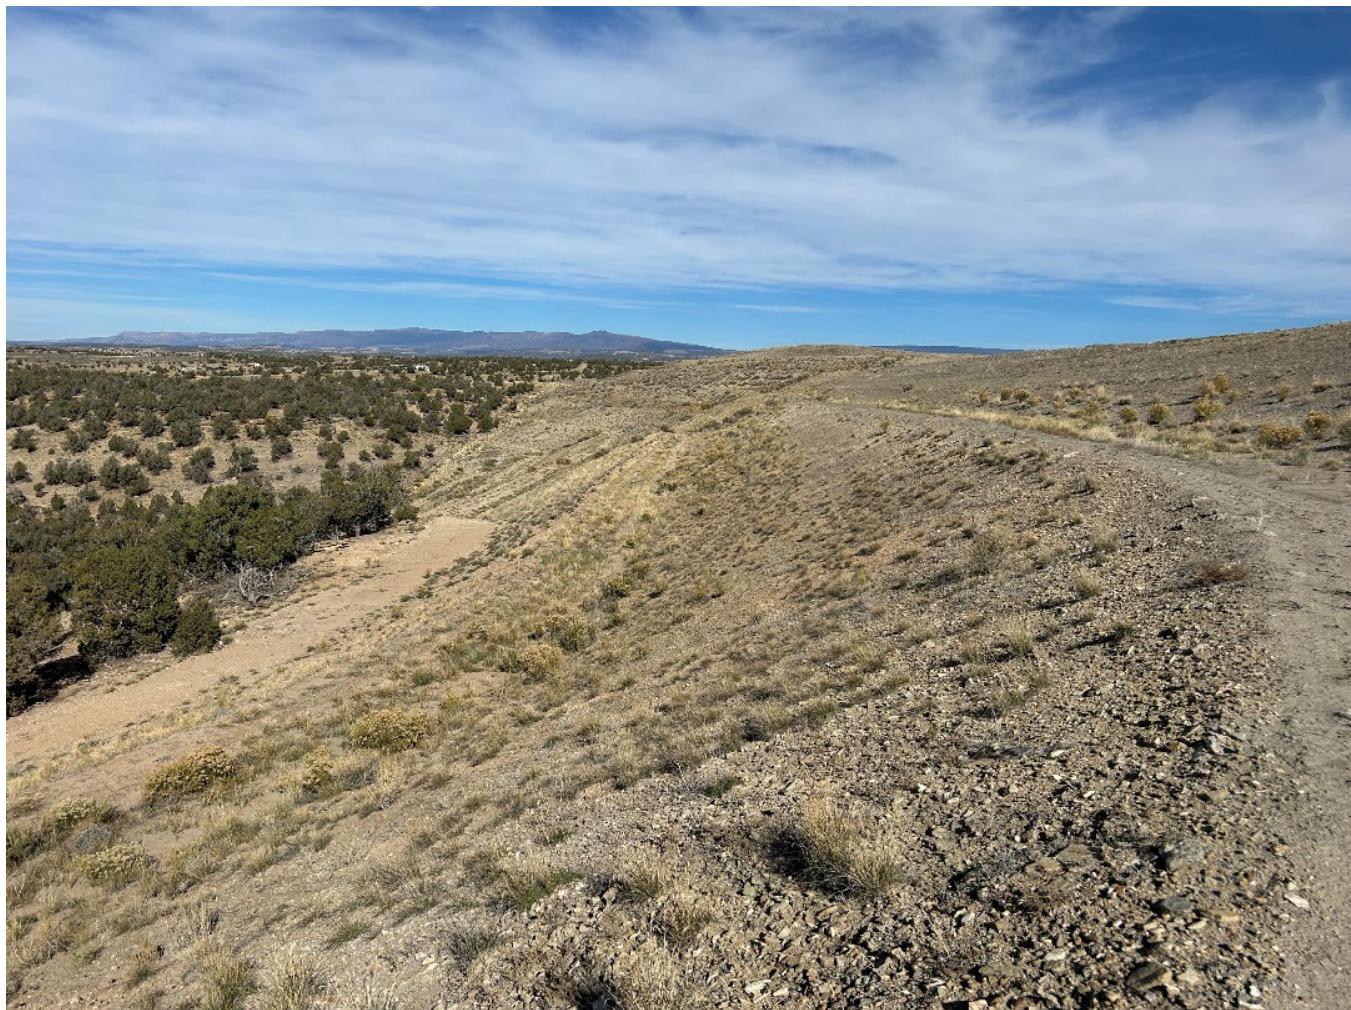
**Photograph 5: Typical Condition of the West, North, and East Embankment Slopes**

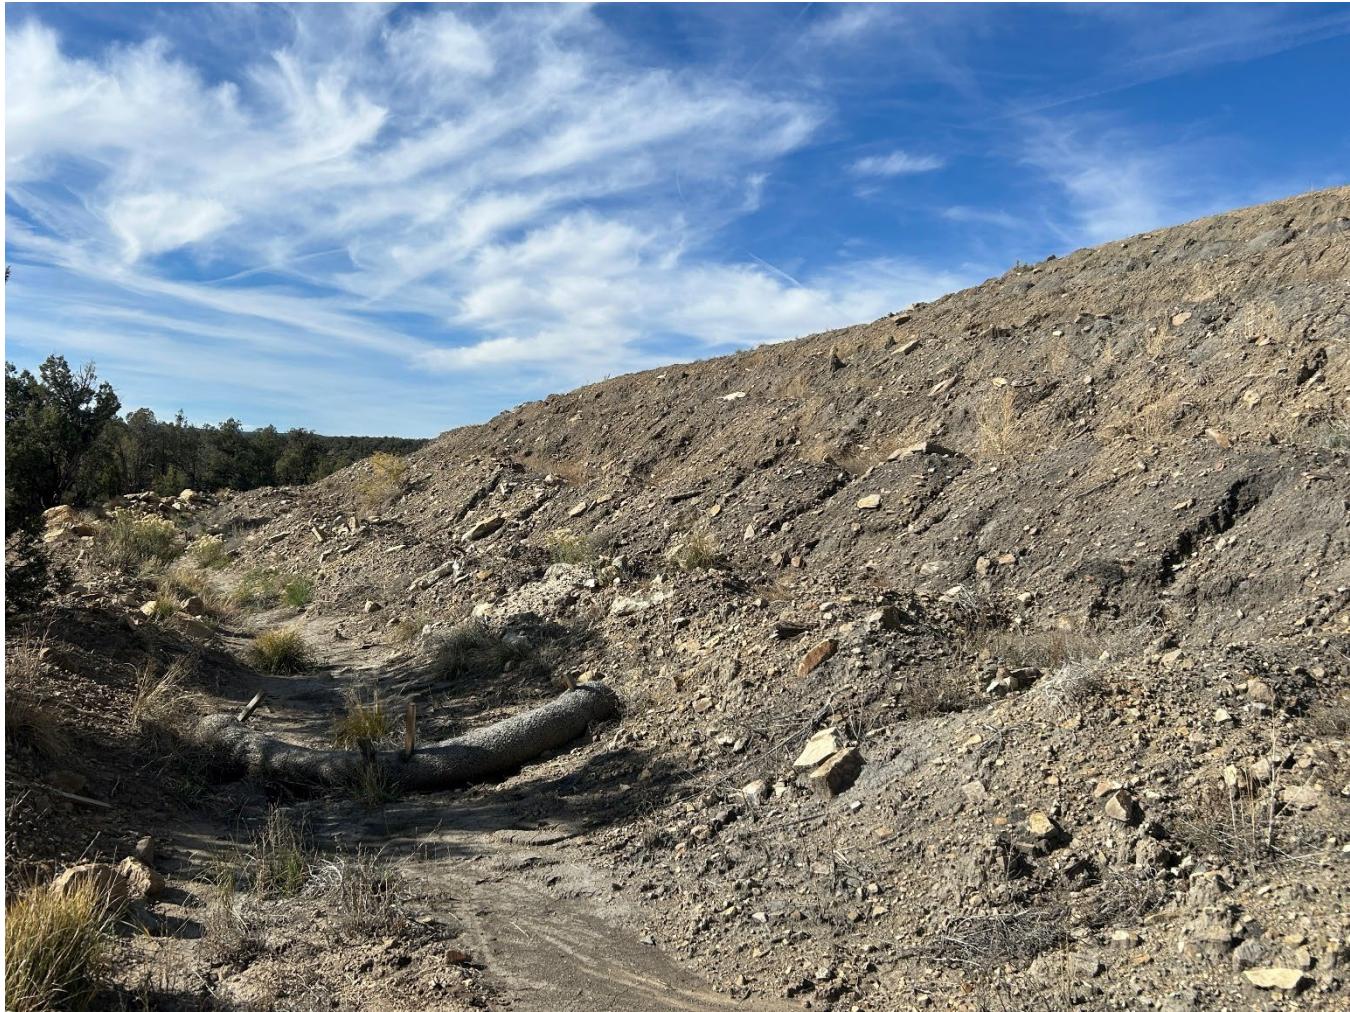
The embankment toe was observed to be in good condition. Signs of seepage, such as springs or boggy areas, were not observed along the embankment toe. The typical condition of the embankment toe is depicted in Photograph 6.

**Photograph 6: Typical Condition of the Embankment Toe**

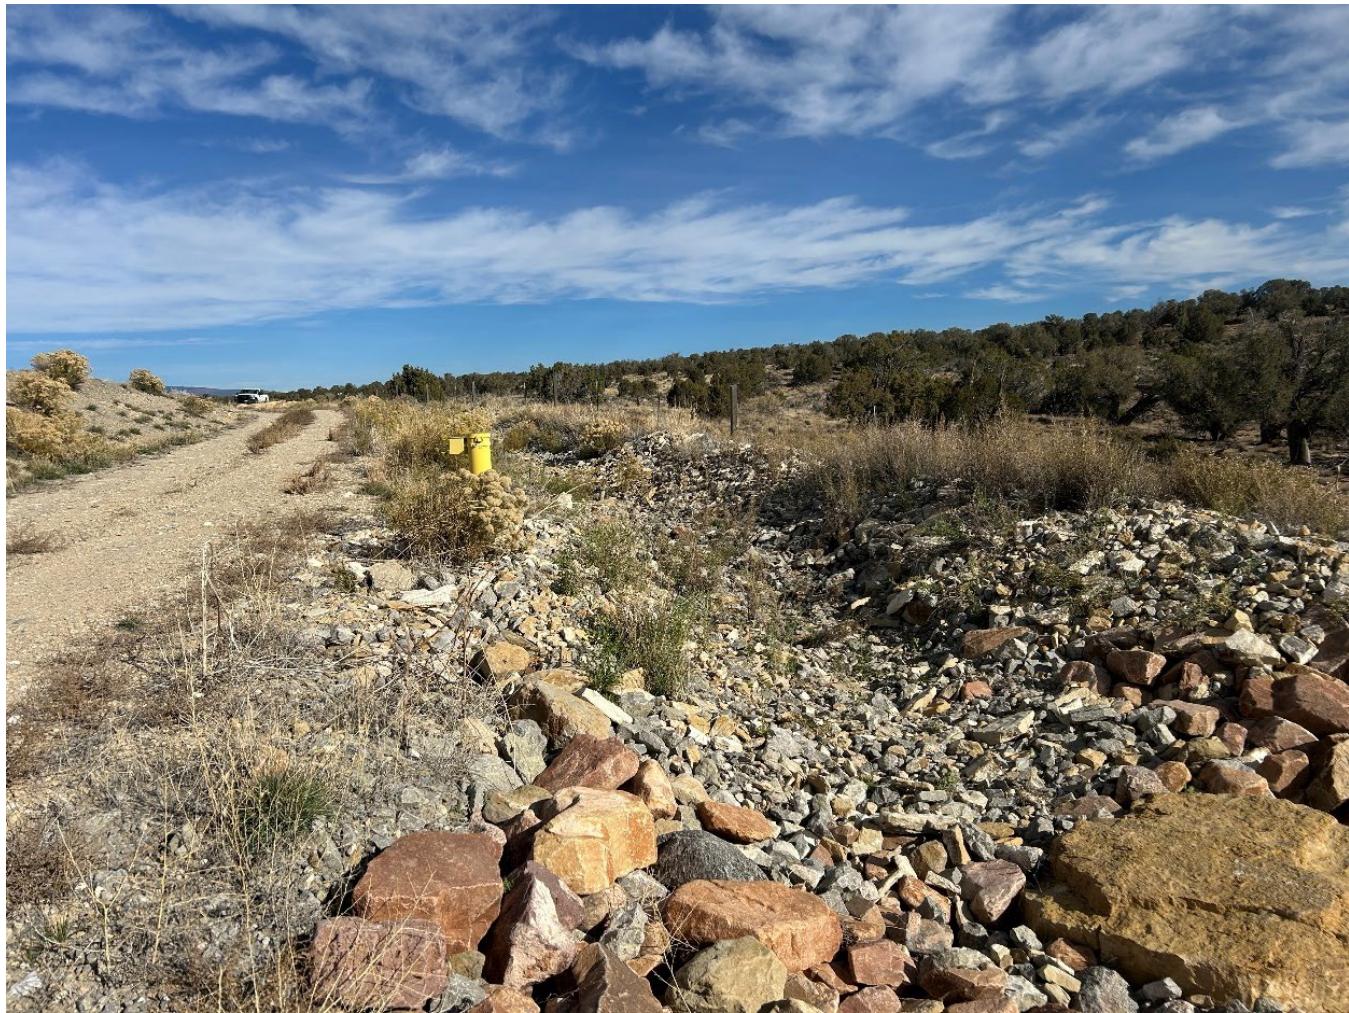
The stormwater control features at the facility were observed to be in fair to poor condition. Downchute channels and energy dissipation basins at the facility are constructed with riprap. Terrace channels at the facility are provided at approximate 20-foot vertical intervals. Erosion control wattles have been installed to control erosion and capture sediment in the terrace channels at appropriate intervals. A few animal burrows were observed within terrace channels where indicated in Appendix A. The animal burrows do not currently pose a threat to structural stability and did not hinder WSP's ability to inspect the facility. Perimeter channels are in place around the facility where they are needed to control stormwater. Perimeter channels at the facility are generally constructed with soil and rock. Erosion control wattles have been installed at appropriate intervals in the perimeter channels to control erosion and capture sediment. The typical condition of the perimeter channels is depicted in Photograph 7.

**Photograph 7: Typical Condition of Perimeter Channels**

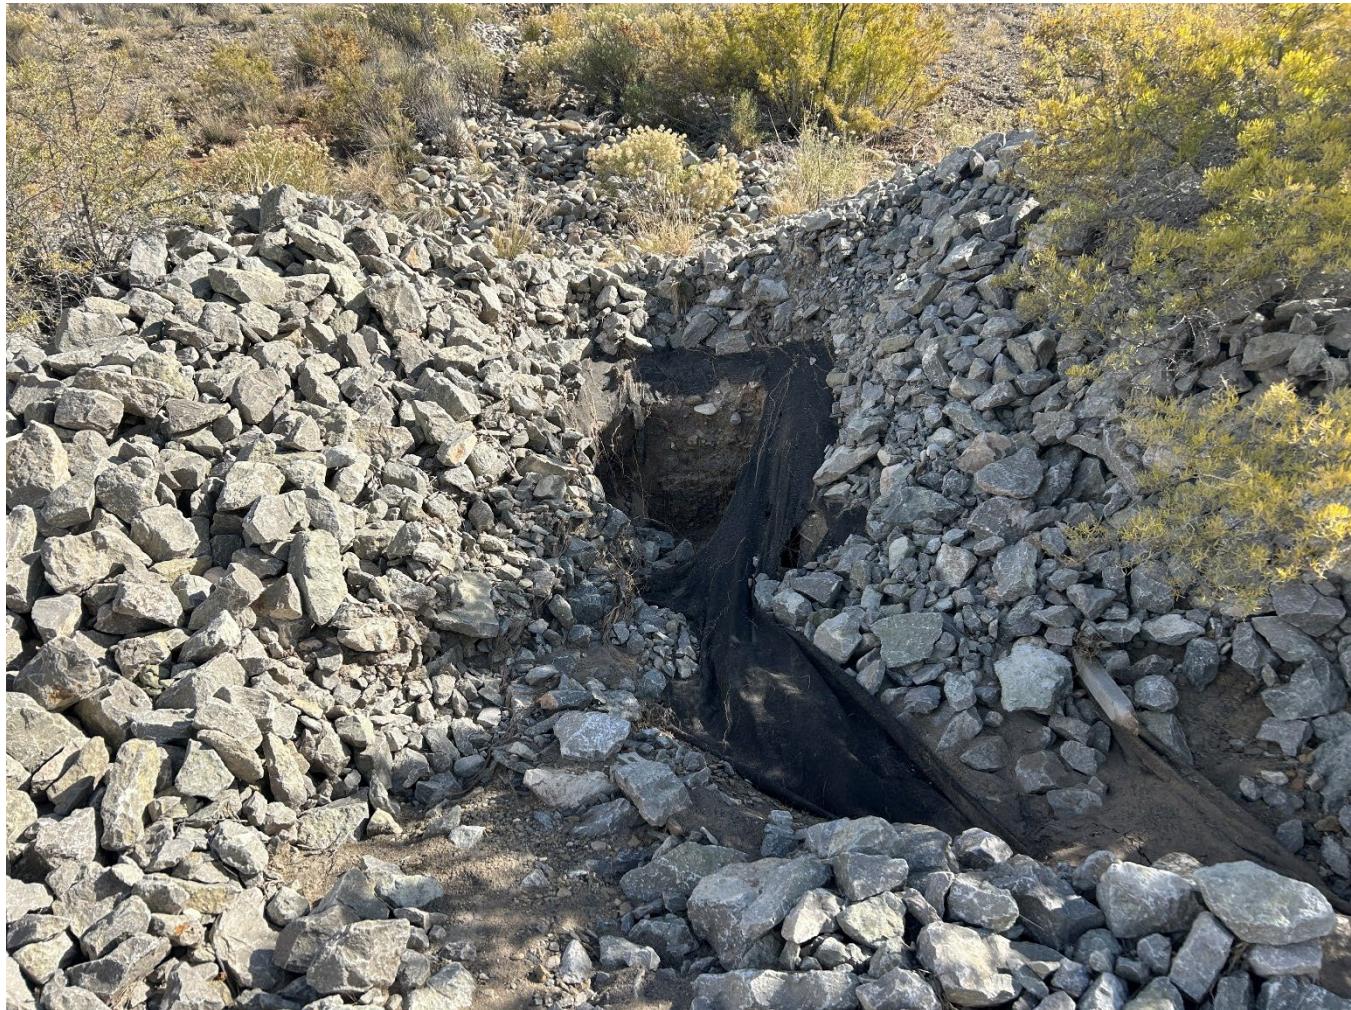
Between October 9 and October 12, 2025, the facility received approximately 2.3 inches of precipitation, as recorded by the on-site weather station. Stormwater runoff from the large precipitation event damaged several of the riprap-lined downchutes at the facility, as noted in Appendix A. Damage was typically located on the downstream sections of the downchutes and consisted of washed-out riprap, exposed geotextile, and eroded subgrade. Damaged downchutes should be restored to their previous conditions. Tri-State may also consider installing larger-diameter riprap at a few of the localized downchute segments that experienced significant erosion. The most severely damaged downchute is depicted in Photograph 8.

**Photograph 8: Downchute Channel Erosion**

b. H.1. Significant erosion and exposed subgrade and/or geotextile was noted in multiple downchutes. These downchutes should be repaired. Tri-State may consider placing larger, angular riprap in some of these locations to more effectively limit future erosion from large precipitation events.

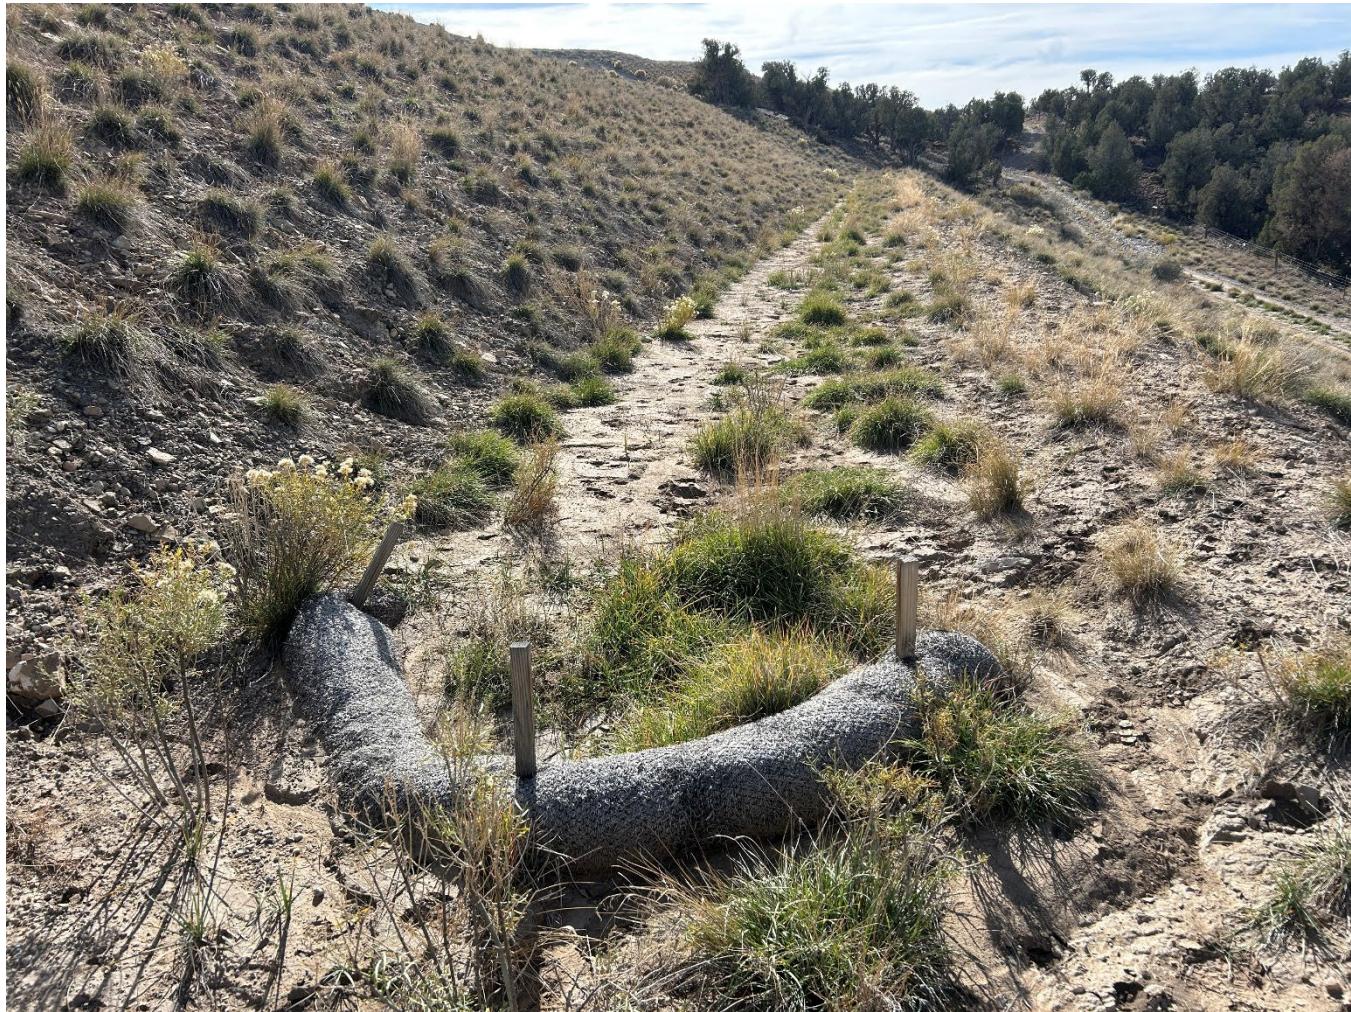
Minor sediment buildup was observed in many of the terrace channels. The amount of sediment buildup observed is not anticipated to impact the ability of the terrace channels to convey stormwater. Tri-State may consider proactively removing sediment from these terrace channels to promote drainage and reduce impacts on future stormwater routing. The typical condition of the terrace channels is depicted in Photograph 9.

**Photograph 9: Typical Condition of Terrace Channels**

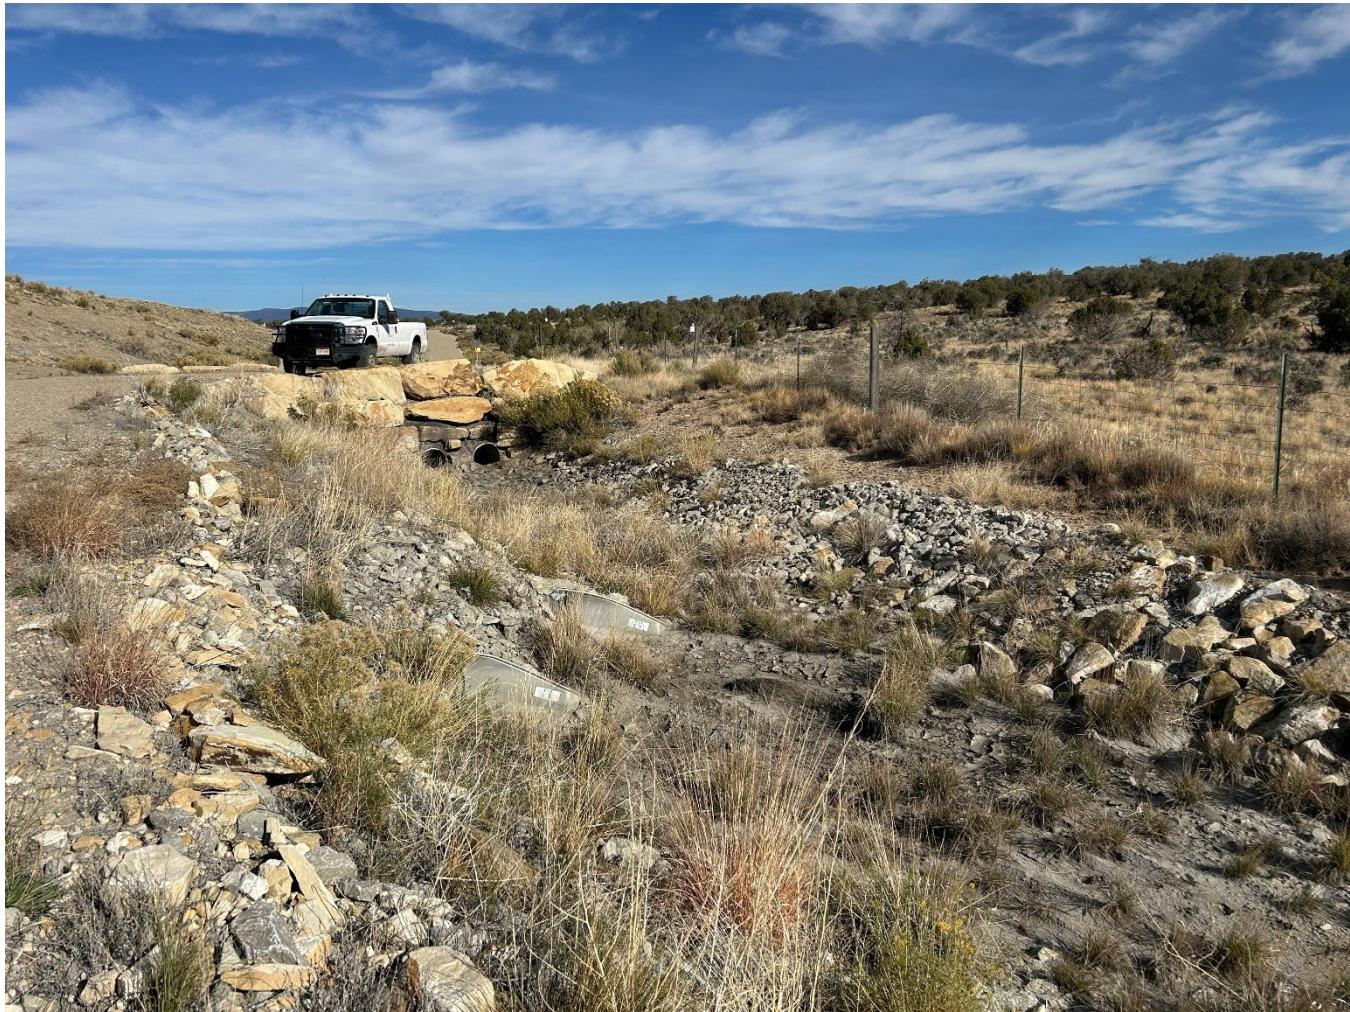
Culverts near the site entrance were inspected. The culverts were generally observed to be in good condition. Sediment buildup was not observed within the culverts, but the culverts should be periodically cleaned out if sediment is observed during monthly inspections. Straw wattles in the channels upstream of the culverts were observed to be in good condition. The culvert outlets are depicted in Photograph 10.

**Photograph 10: Culvert Outlets**
