# Active Coal Combustion Residuals Landfill Annual Inspection *Escalante Generating Station*

**Tri-State Generation and Transmission Association, Inc.**  
1100 West 116th Avenue Westminster, Colorado 80234

**Golder Associates Inc.**  
44 Union Boulevard, Suite 300 Lakewood, Colorado 80228

January 15, 2019

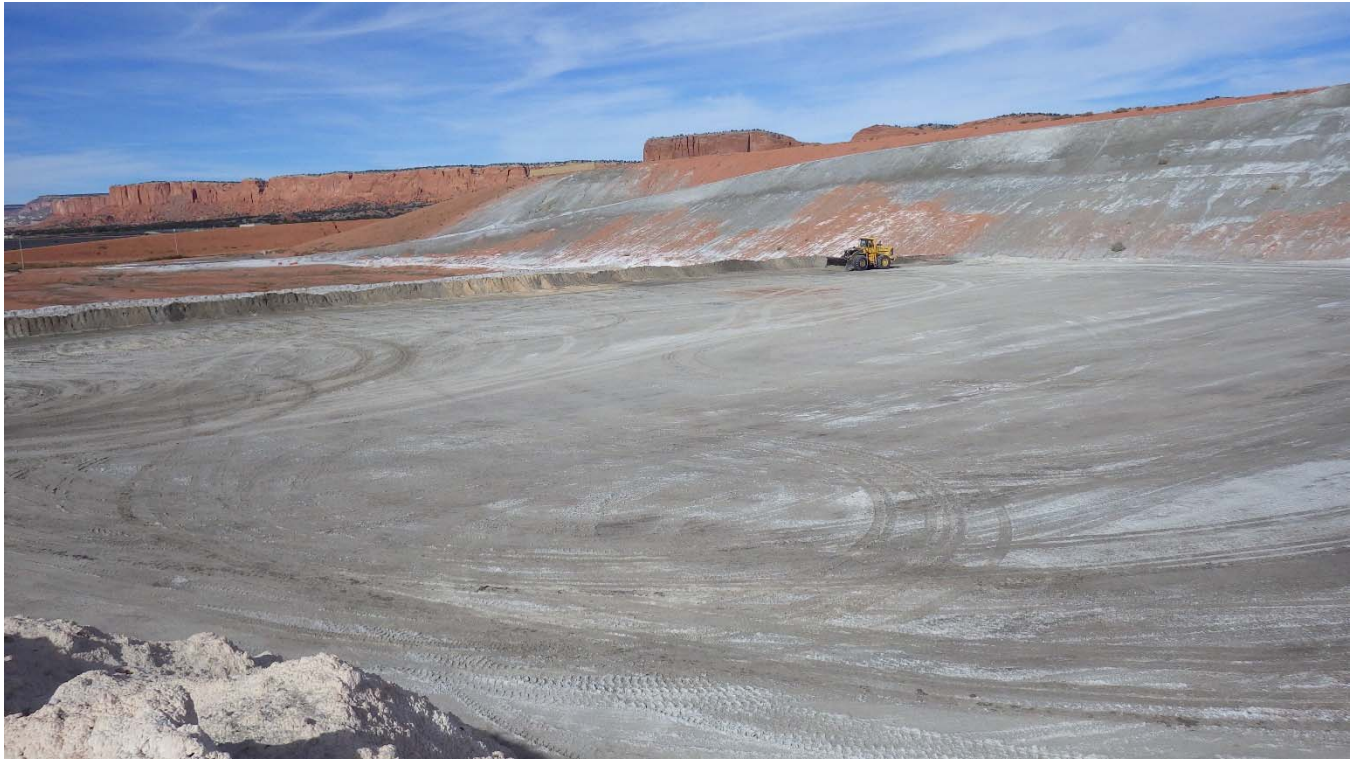
The deposition area was observed to be in good condition. Signs of ground movement, such as sloughing or sliding, cracking, subsidence, or bulging, were not observed in the deposition area. Deposition of CCRs was occurring at the time of the visual observation. The deposition methodology appeared to be appropriate. Appropriate grading had been established to collect contact water within the deposition area. A berm that was several feet in height was in place around the perimeter of the deposition area to prevent migration of contact water out of the deposition area. Fugitive dust was not observed at the time of the visual observation. The typical condition of the deposition area is depicted in Photograph 1.

**Photograph 1: Typical Deposition Area Condition**

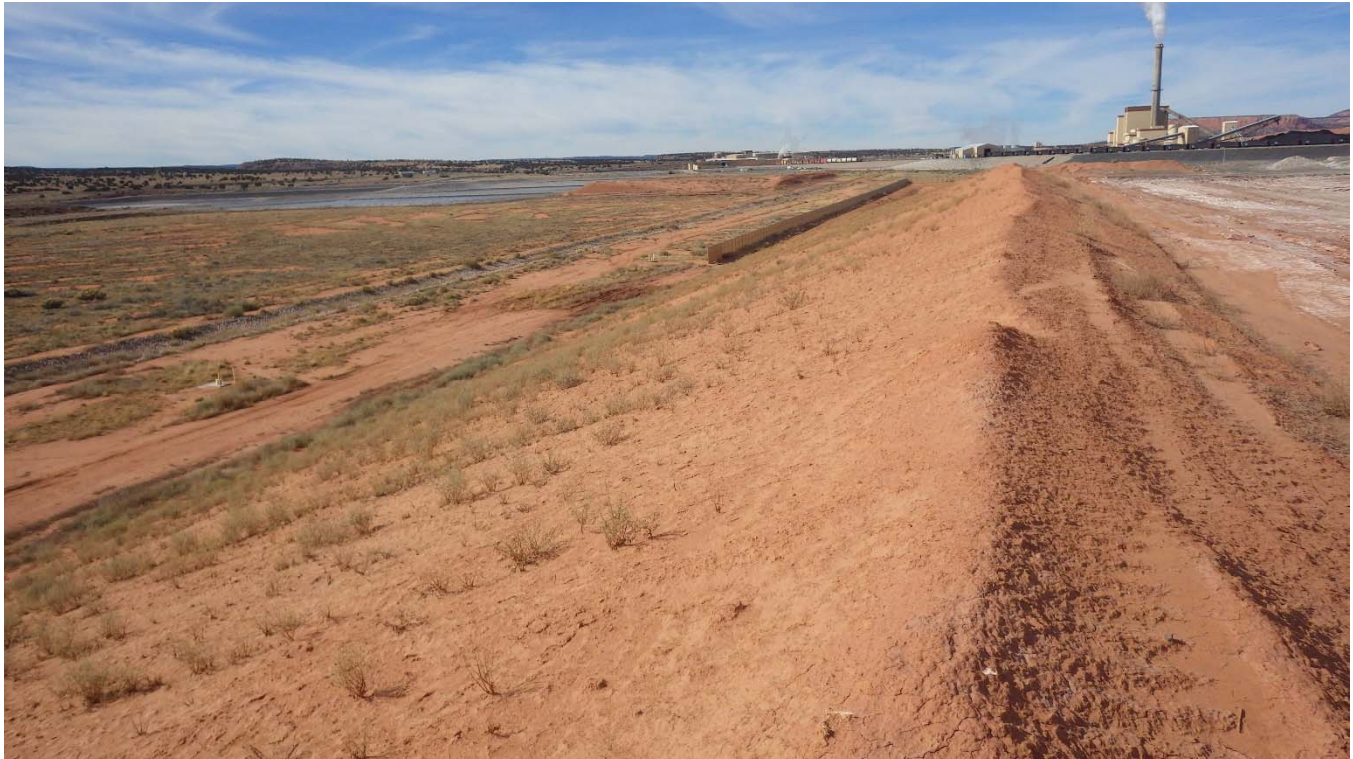
The embankment crest was observed to be in good condition. Cracking that would be indicative of ground movement was not observed along the embankment crest. Low areas that would be indicative of differential settlement were not observed along the embankment crest. The typical condition of the embankment crest is depicted in Photograph 2.

**Photograph 2: Typical Embankment Crest Condition**

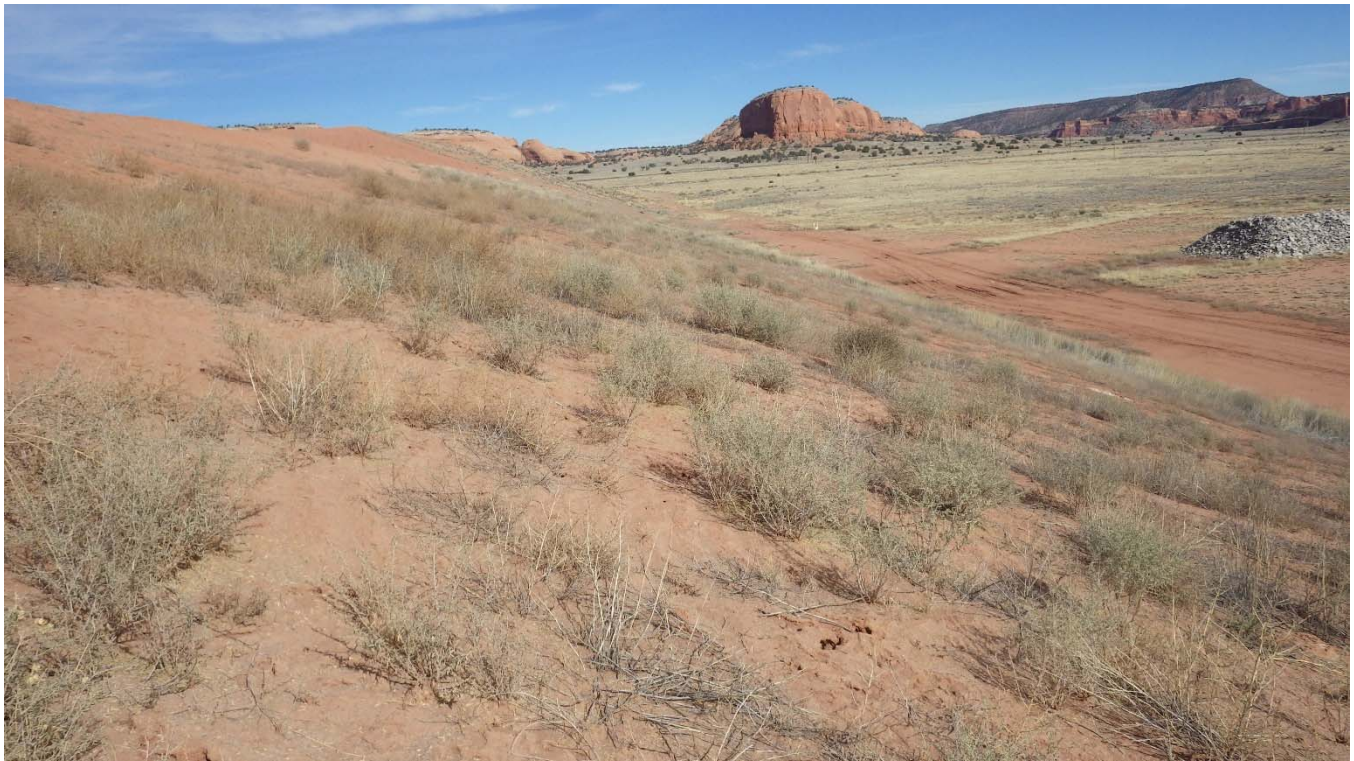
The embankment slopes were observed to be in fair condition. Signs of ground movement, such as sloughing or sliding, cracking, subsidence, or bulging, were not observed on the embankment slopes. Evidence of significant or excessive erosion or slope deterioration was not observed on the embankment slopes, although some rilling was observed on the south embankment slopes. The rilling does not pose a threat to structural stability. The most recent seeding effort appeared to have included the use of hydraulic mulch, which was observed to have created a crust at the ground surface that was helping to resist further rilling. Golder recommended that rill repair efforts be deferred until the rills become more severe (approximately 12 inches wide or 12 inches deep) or a reseeding attempt is planned, since repair efforts will disturb the crust.

Native vegetation is being established on the embankment slopes, but establishment of a mature vegetative community is challenging given the climatic conditions at the site. Unusually poor or thriving vegetative growth was not observed on the embankment slopes, but there was generally less vegetative coverage on the south embankment slope than on the east embankment slope due to the southern aspect. No trees or woody vegetation were observed on the embankment slopes. No evidence of recent animal burrowing was observed on the embankment slopes. The typical condition of the embankment slopes is depicted in Photograph 3.

**Photograph 3: Typical Embankment Slope Condition**

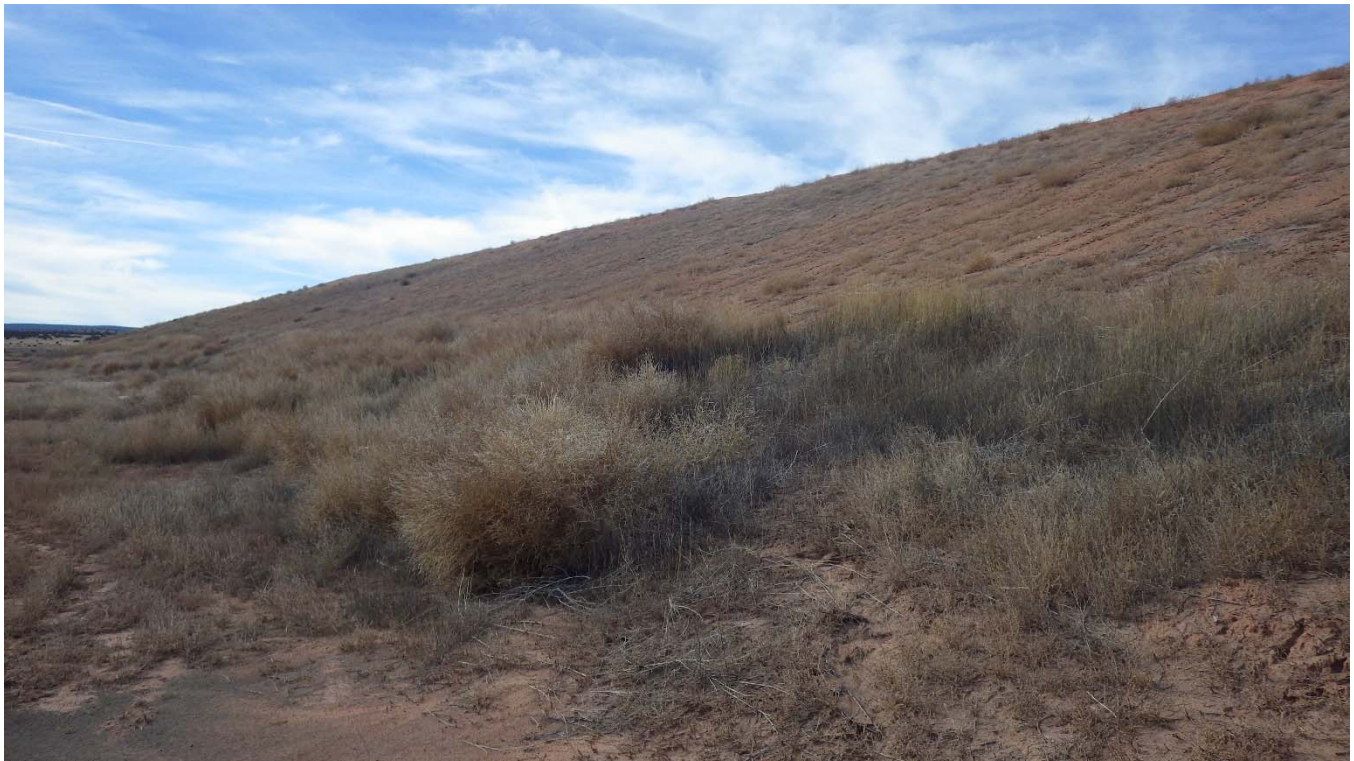
The embankment toe was observed to be in good condition. Signs of seepage, such as springs or boggy areas, were not observed along the embankment toe. A small area near the center of the east embankment toe was observed to have a white residue at the ground surface and some moisture in the near-surface soil. Golder recommended that Tri-State excavate a test pit at this location and observe it over the course of at least one week to verify that no signs of seepage, such as standing water in the base of the test pit or saturated soils in the test pit walls, are present. Tri-State excavated the test pit on December 17, 2018 and provided photographic documentation of the findings to Golder on December 19, 2018 and January 2, 2019. No signs of seepage were observed, and the test pit will be backfilled. The typical condition of the embankment toe is depicted in Photograph 4.

**Photograph 4: Typical Embankment Toe Condition**

| <b>F. Exterior Slopes</b> | | | | | | |
|---|---|---|---|---|---|---|
| a.    G.1. Excavation and observation of a test pit is recommended to assess whether preferential seepage is occurring at a location along the embankment toe (see Section J.). | | | | | | |

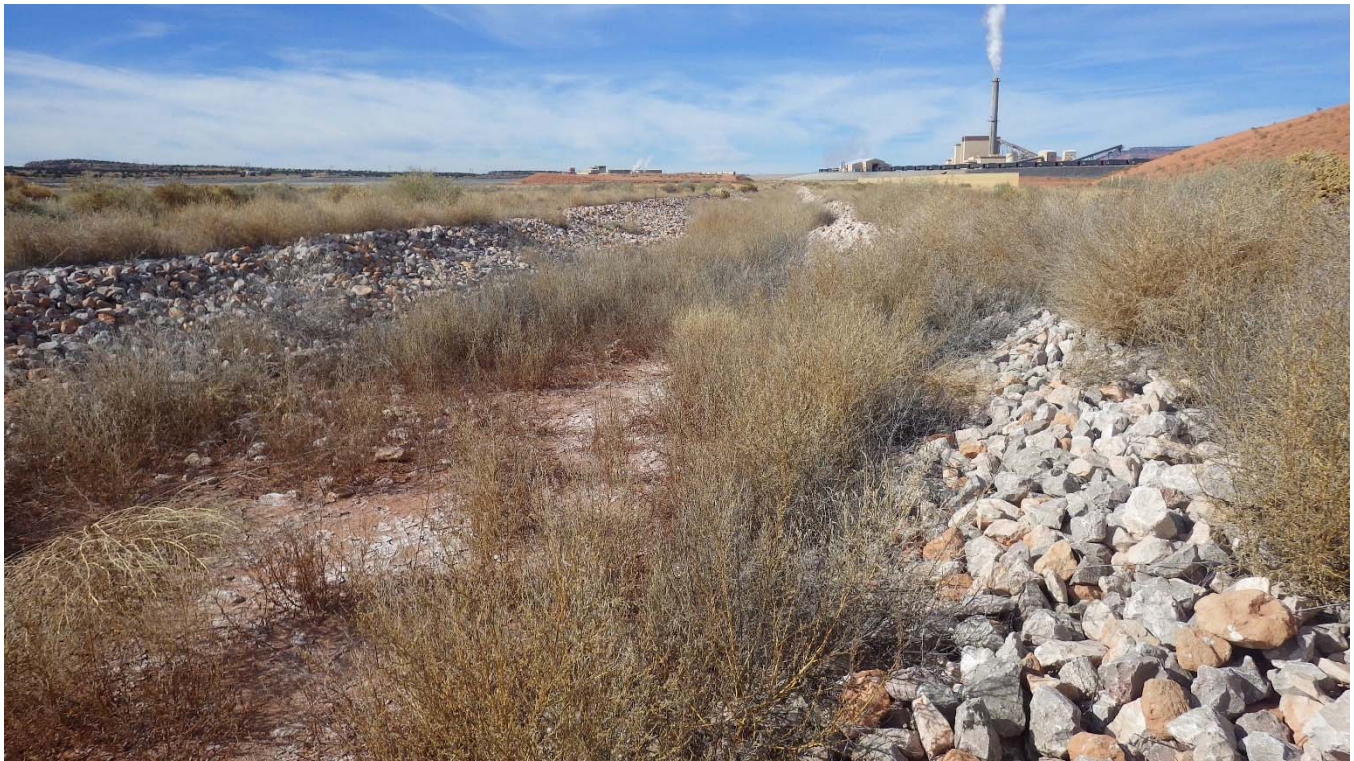
The storm water control features at the facility were observed to be in good condition. At the time of the visual observation, the only permanent storm water control feature at the facility was a run-on control channel that is designed to convey storm water from west to east along the south end of the facility. The run-on control channel is armored with riprap. Relatively large shrubs were observed to be growing in the flow path. The shrubs do not pose a threat to structural stability, but they should be removed periodically to help maintain the channel's flow capacity. The typical condition of the run-on control channel is depicted in Photograph 5.

**Photograph 5: Typical Storm Water Channel Condition**

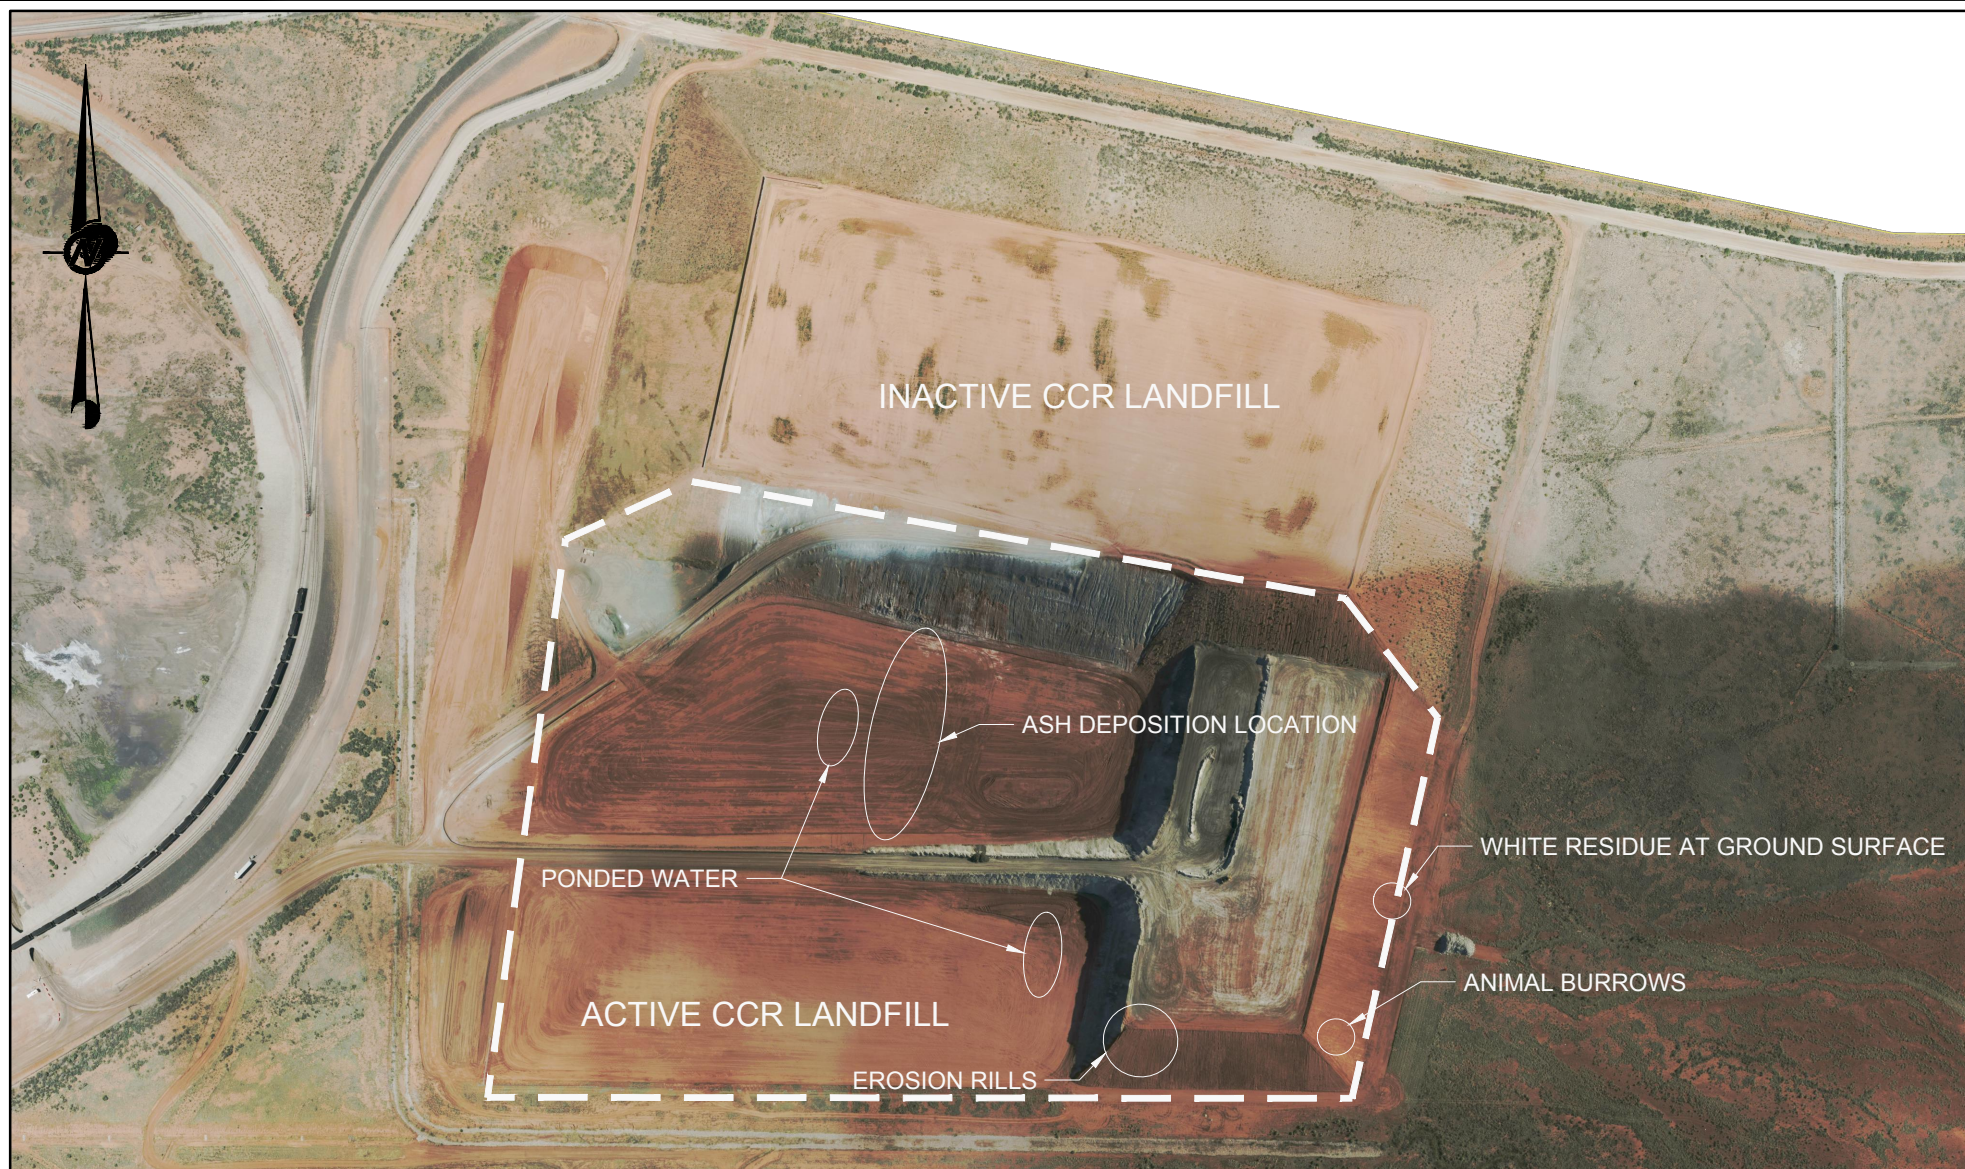
## ANNUAL INSPECTION FORM

| 1. Where are ash and/or other materials currently being deposited (indicate on the plan view on page 3 or write N/A)? See page 3 | | | | | | |
