REPORT

Unstable Areas Demonstration

Nucla Station Ash Disposal Facility

Tri-State Generation and Transmission Association, Inc.

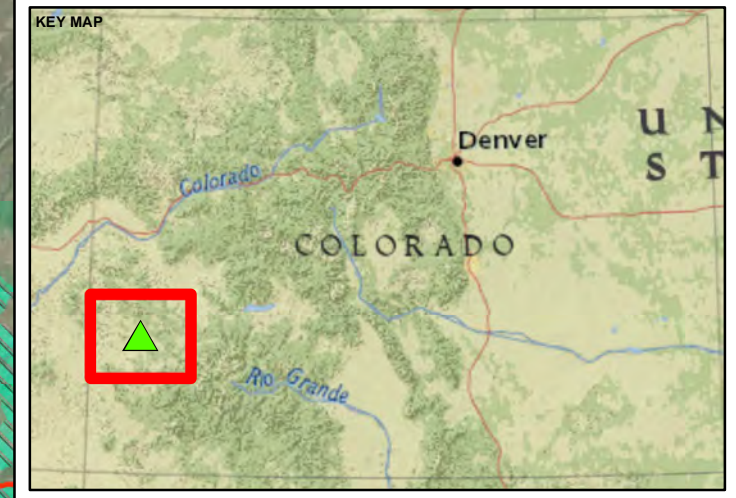
KARST TYPE

- FISSURES, TUBES AND CAVES GENERALLY LESS THAN 1,000 FT (300 M) LONG; 50 FT (15 M) OR LESS VERTICAL EXTENT; IN GENTLY DIPPING TO FLAT-LYING BEDS OF GYPSUM
- FISSURES, TUBES AND CAVES GENERALLY LESS THAN 1,000 FT (300 M) LONG; 50 FT (15 M) OR LESS VERTICAL EXTENT; IN MODERATELY TO STEEPLY DIPPING BEDS OF CARBONATE ROCK

FIGURE 1 QUATERNARY FAULTS AND KARST FEATURES IN PROXIMITY TO NUCLA CCR FACILITY

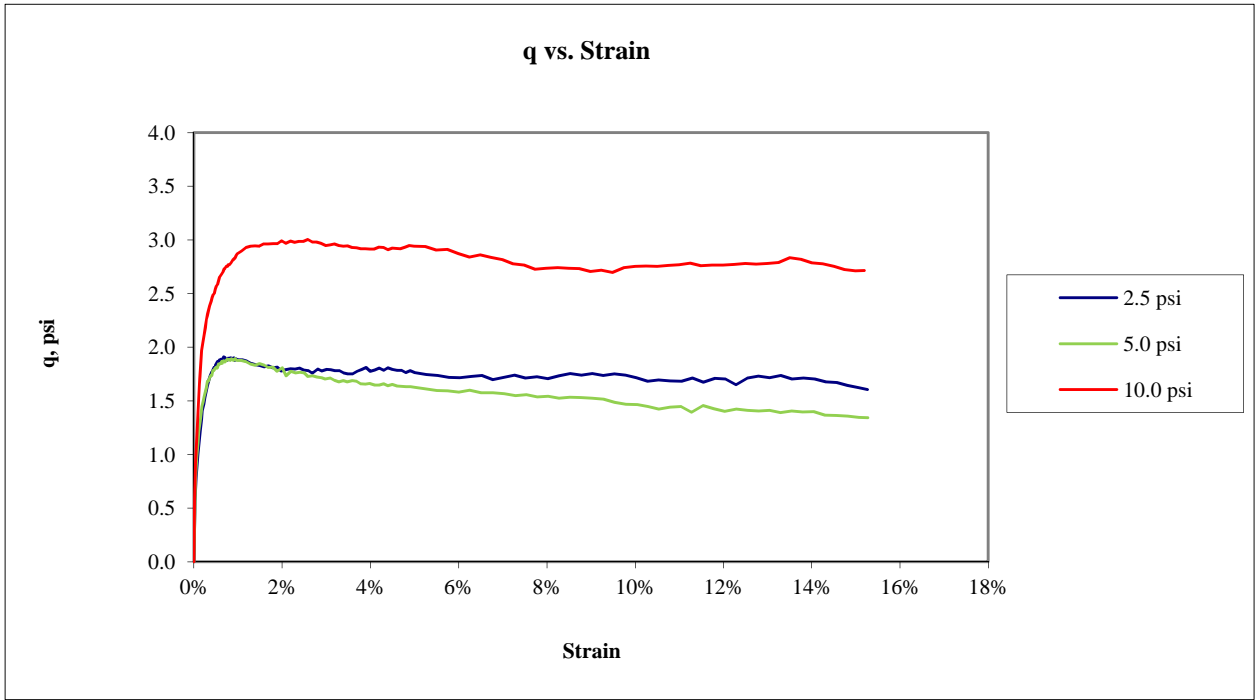
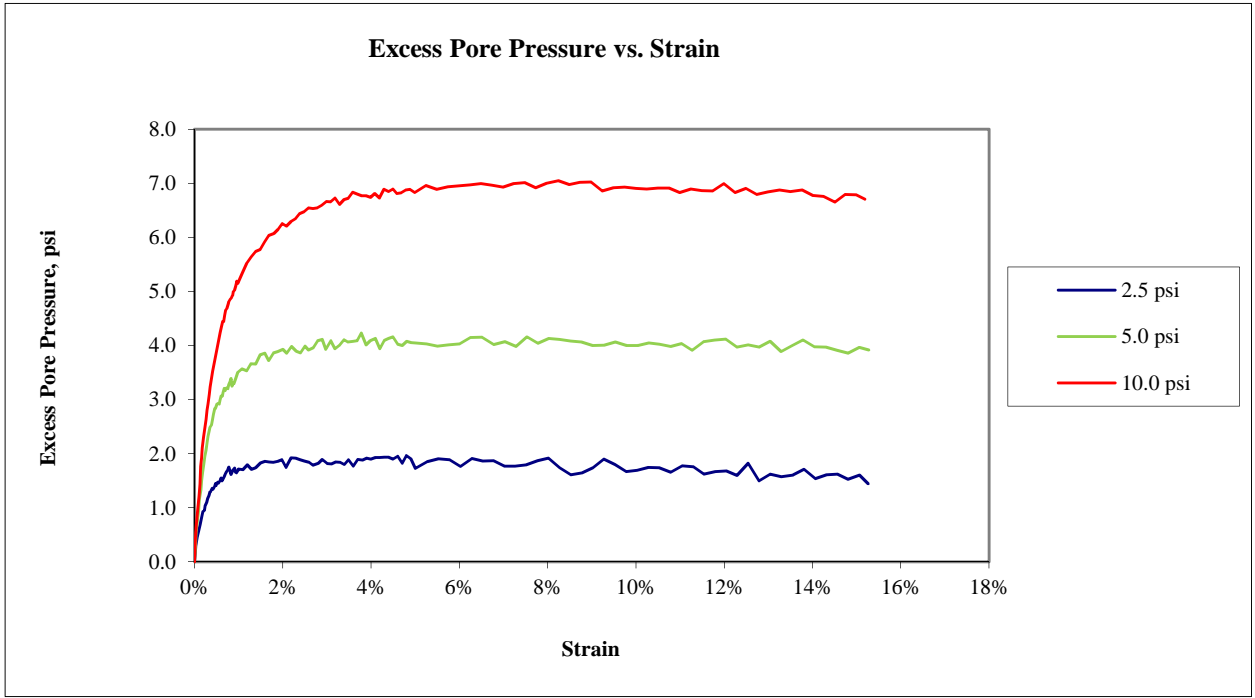
Title: ASTM D4767
CONSOLIDATED UNDRAINED TRIAXIAL COMPRESSION TEST REPORT
q AND EXCESS PORE PRESSURE PLOTS

Sample: TP-3A	Technician: RJM	Reviewed: JEO	Date: 7/9/2015	Job Number: 103-81938	Figure: 2
----------------------	------------------------	----------------------	-----------------------	------------------------------	------------------

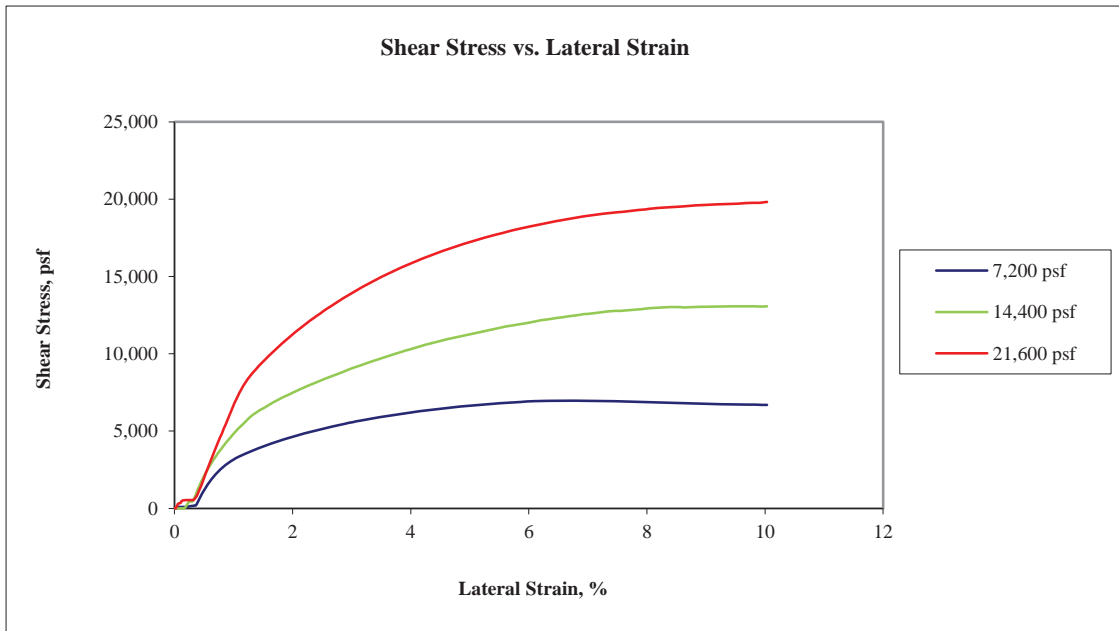
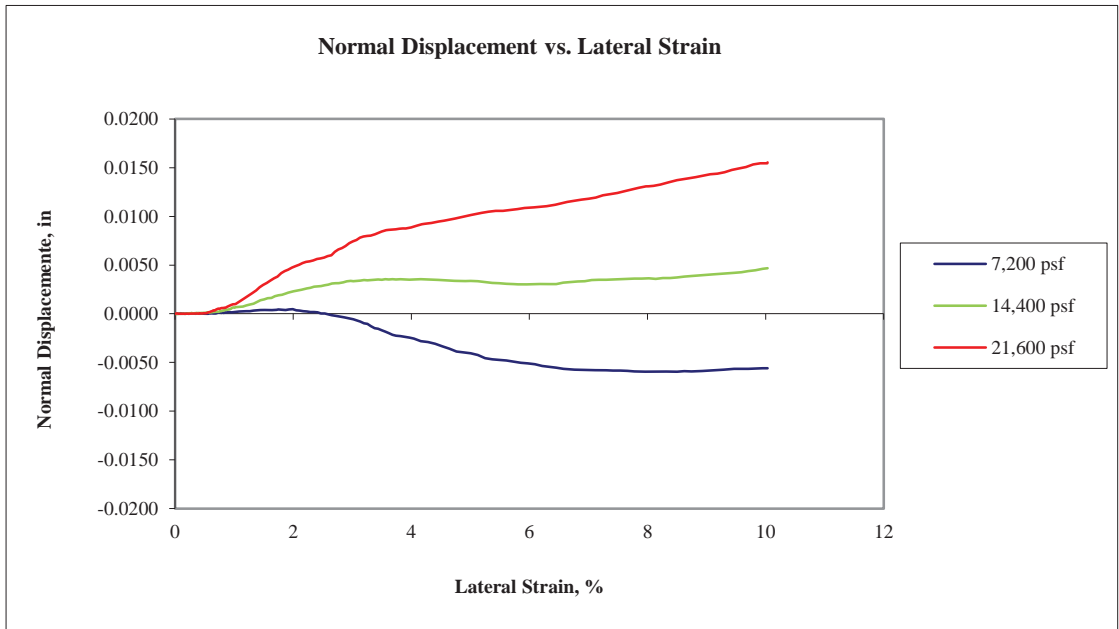
Point No.: 1			Point No.: 2			Point No.: 3		
Normal Stress =	7,200	psf	Normal Stress =	14,400	psf	Normal Stress =	21,600	psf
Shear Rate =	0.0033	in/min	Shear Rate =	0.0033	in/min	Shear Rate =	0.0033	in/min
Shear Stress	Lateral Strain	Normal Displacement	Shear Stress	Lateral Strain	Normal Displacement	Shear Stress	Lateral Strain	Normal Displacement
psf	%	in	psf	%	in	psf	%	in
96	0.1	0.0000	0	0.1	0.0000	334	0.1	0.0000
99	0.2	0.0000	175	0.2	0.0000	536	0.2	0.0000
162	0.3	0.0000	453	0.3	0.0001	546	0.3	0.0000
325	0.4	0.0001	1,093	0.4	0.0001	976	0.4	0.0000
1,065	0.5	0.0000	1,970	0.5	0.0001	1,755	0.5	0.0000
1,652	0.6	0.0001	2,677	0.6	0.0001	2,826	0.6	0.0002
2,153	0.7	0.0000	3,284	0.7	0.0002	3,841	0.7	0.0004
2,548	0.8	0.0001	3,826	0.8	0.0003	4,802	0.8	0.0006
2,864	0.9	0.0001	4,309	0.9	0.0004	5,747	0.9	0.0007
3,123	1.0	0.0002	4,777	1.0	0.0006	6,515	1.0	0.0010
3,936	1.4	0.0004	6,365	1.4	0.0014	9,475	1.5	0.0030
4,618	2.0	0.0005	7,463	2.0	0.0023	11,175	2.0	0.0047

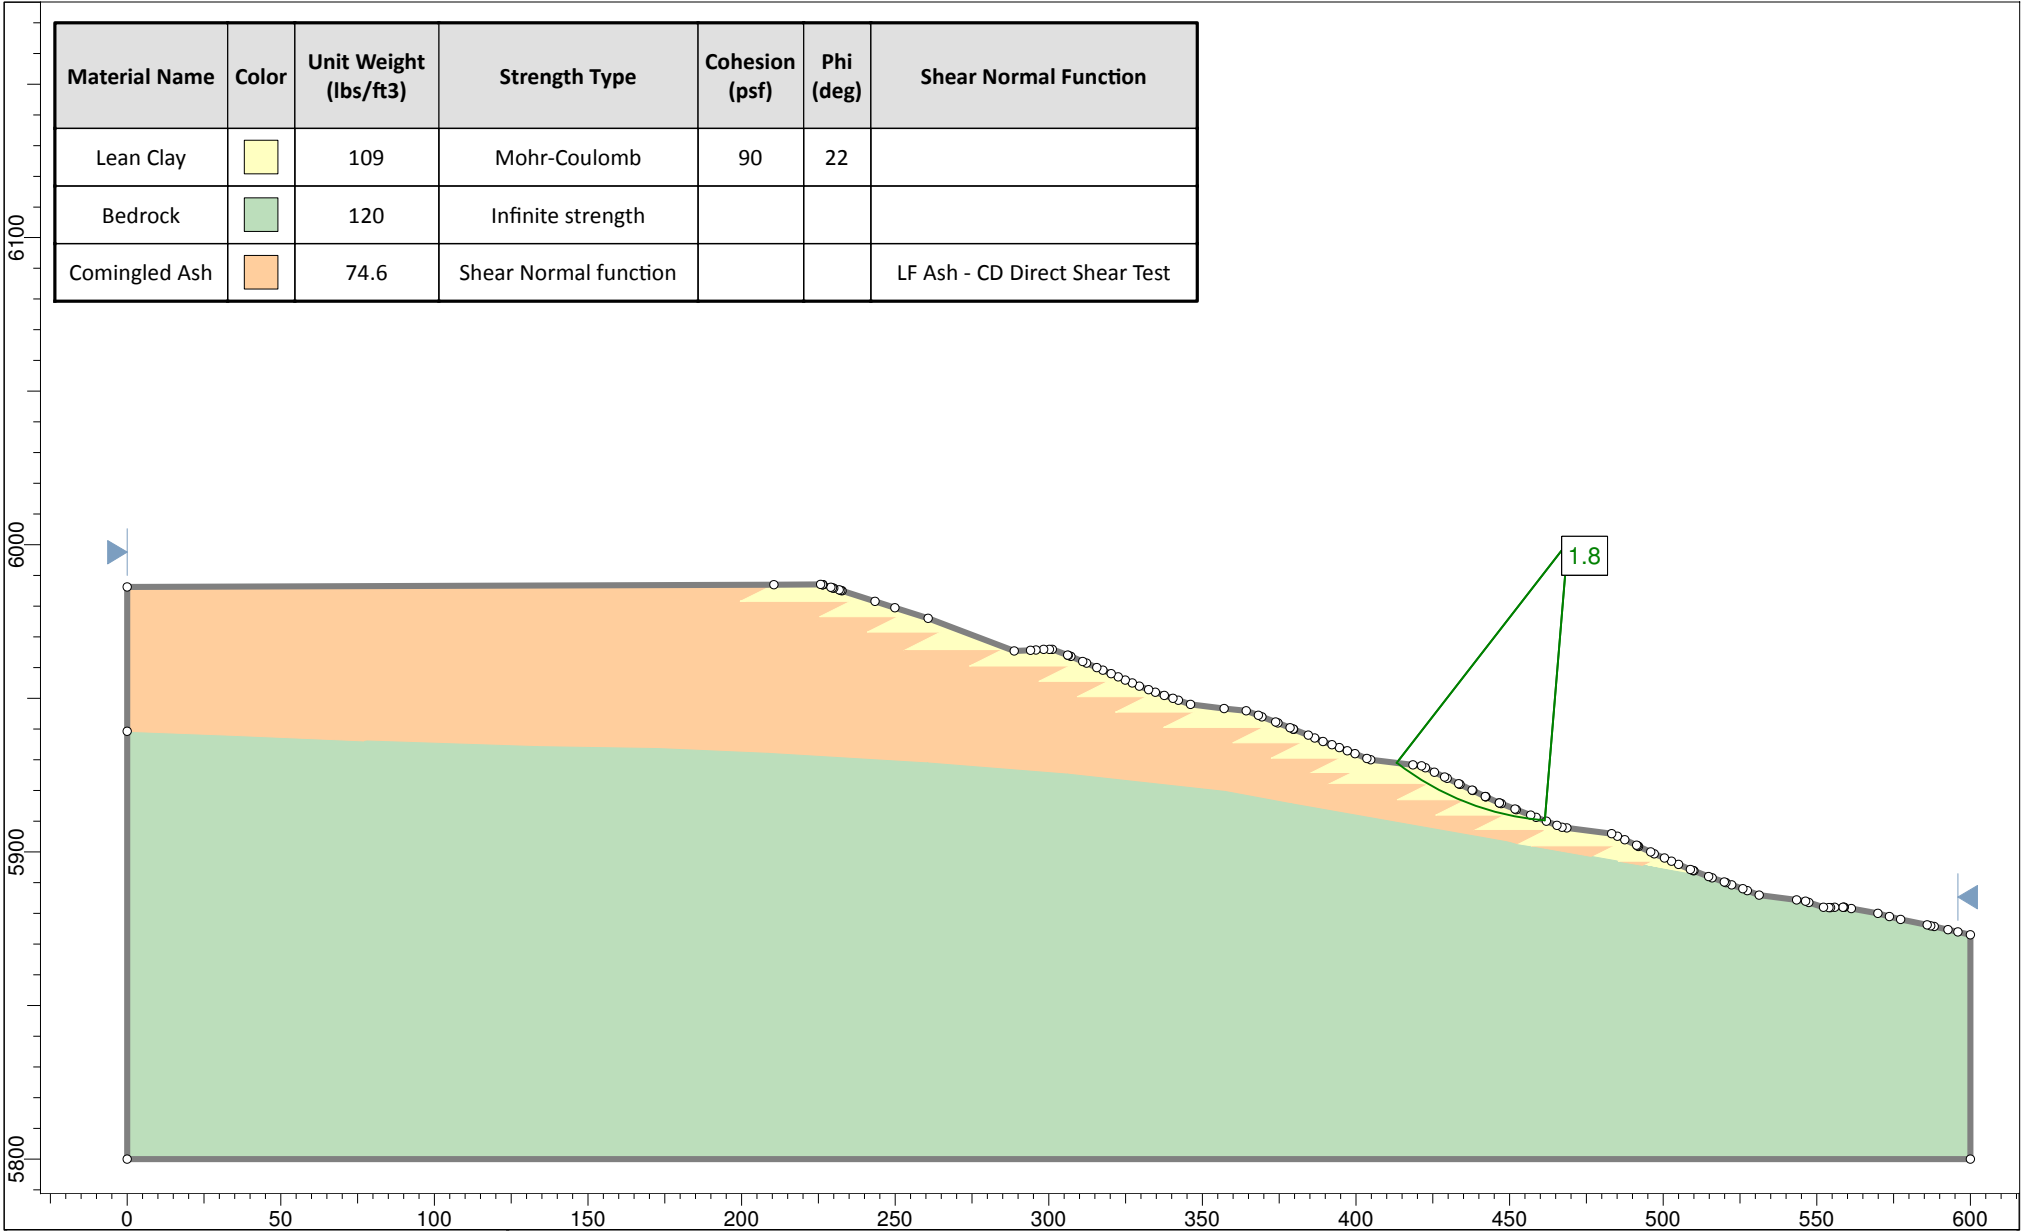
Project		Nucla Station Ash Disposal Site	
	Analysis Description		South Section - Shallow Slip Surfaces - Static Loading	
	Drawn By	ALEBrown	Company	Golder Associates Inc.
	Date	02/09/2017, 11:53:52 AM	File Name	South-Shallow-09FEB2017.slim

- Slope stability analyses for the Facility indicate a factor of safety equal to 1.5 for static conditions and a factor of safety equal to 1.1 under design seismic loading (Golder 2017b). The associated critical slip surfaces are limited to the cover soils (shallow depth) and do not pass into the ash or rock underlying the Facility. The slope stability analyses for the Facility are summarized in Appendix A.

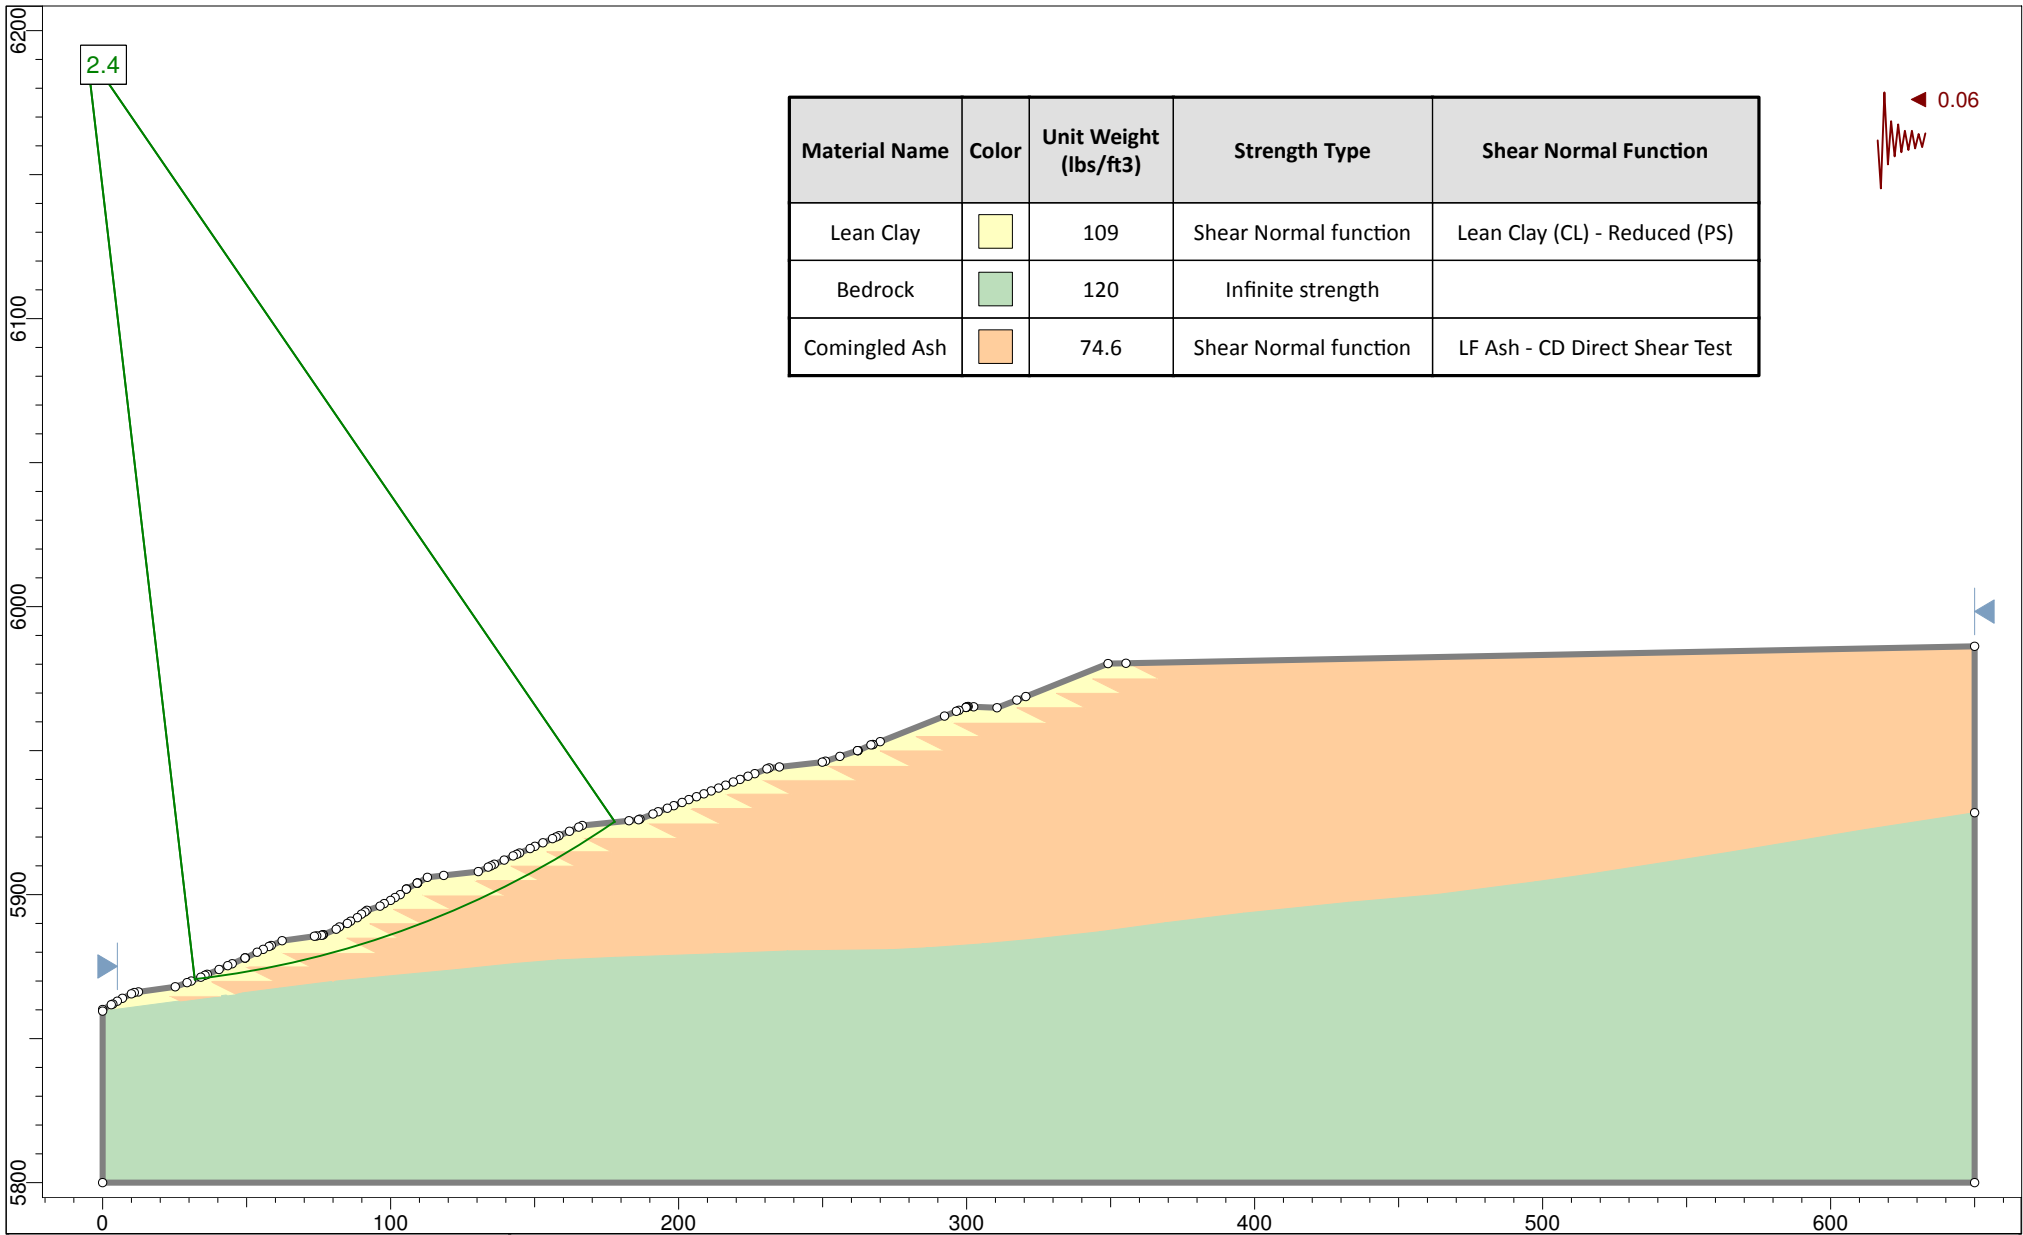
Project		Nucla Station Ash Disposal Site	
	Analysis Description		West Section - Deeper Slip Surfaces - Static Loading	
	Drawn By	ALEBrown	Company	Golder Associates Inc.
	Date	02/09/2017, 11:53:52 AM	File Name	West-Deep-09FEB2017.slim

Material Name	Color	Unit Weight (lbs/ft3)	Strength Type	Shear Normal Function
Lean Clay

slip surfaces into the comingled ash. The slope stability analyses were performed to evaluate the minimum factors of safety under static and seismic loading conditions.
