COAL COMBUSTION RESIDUALS LANDFILL ANNUAL INSPECTION REPORT

Nucla Station Ash Disposal Site

January 16, 2017

1657746

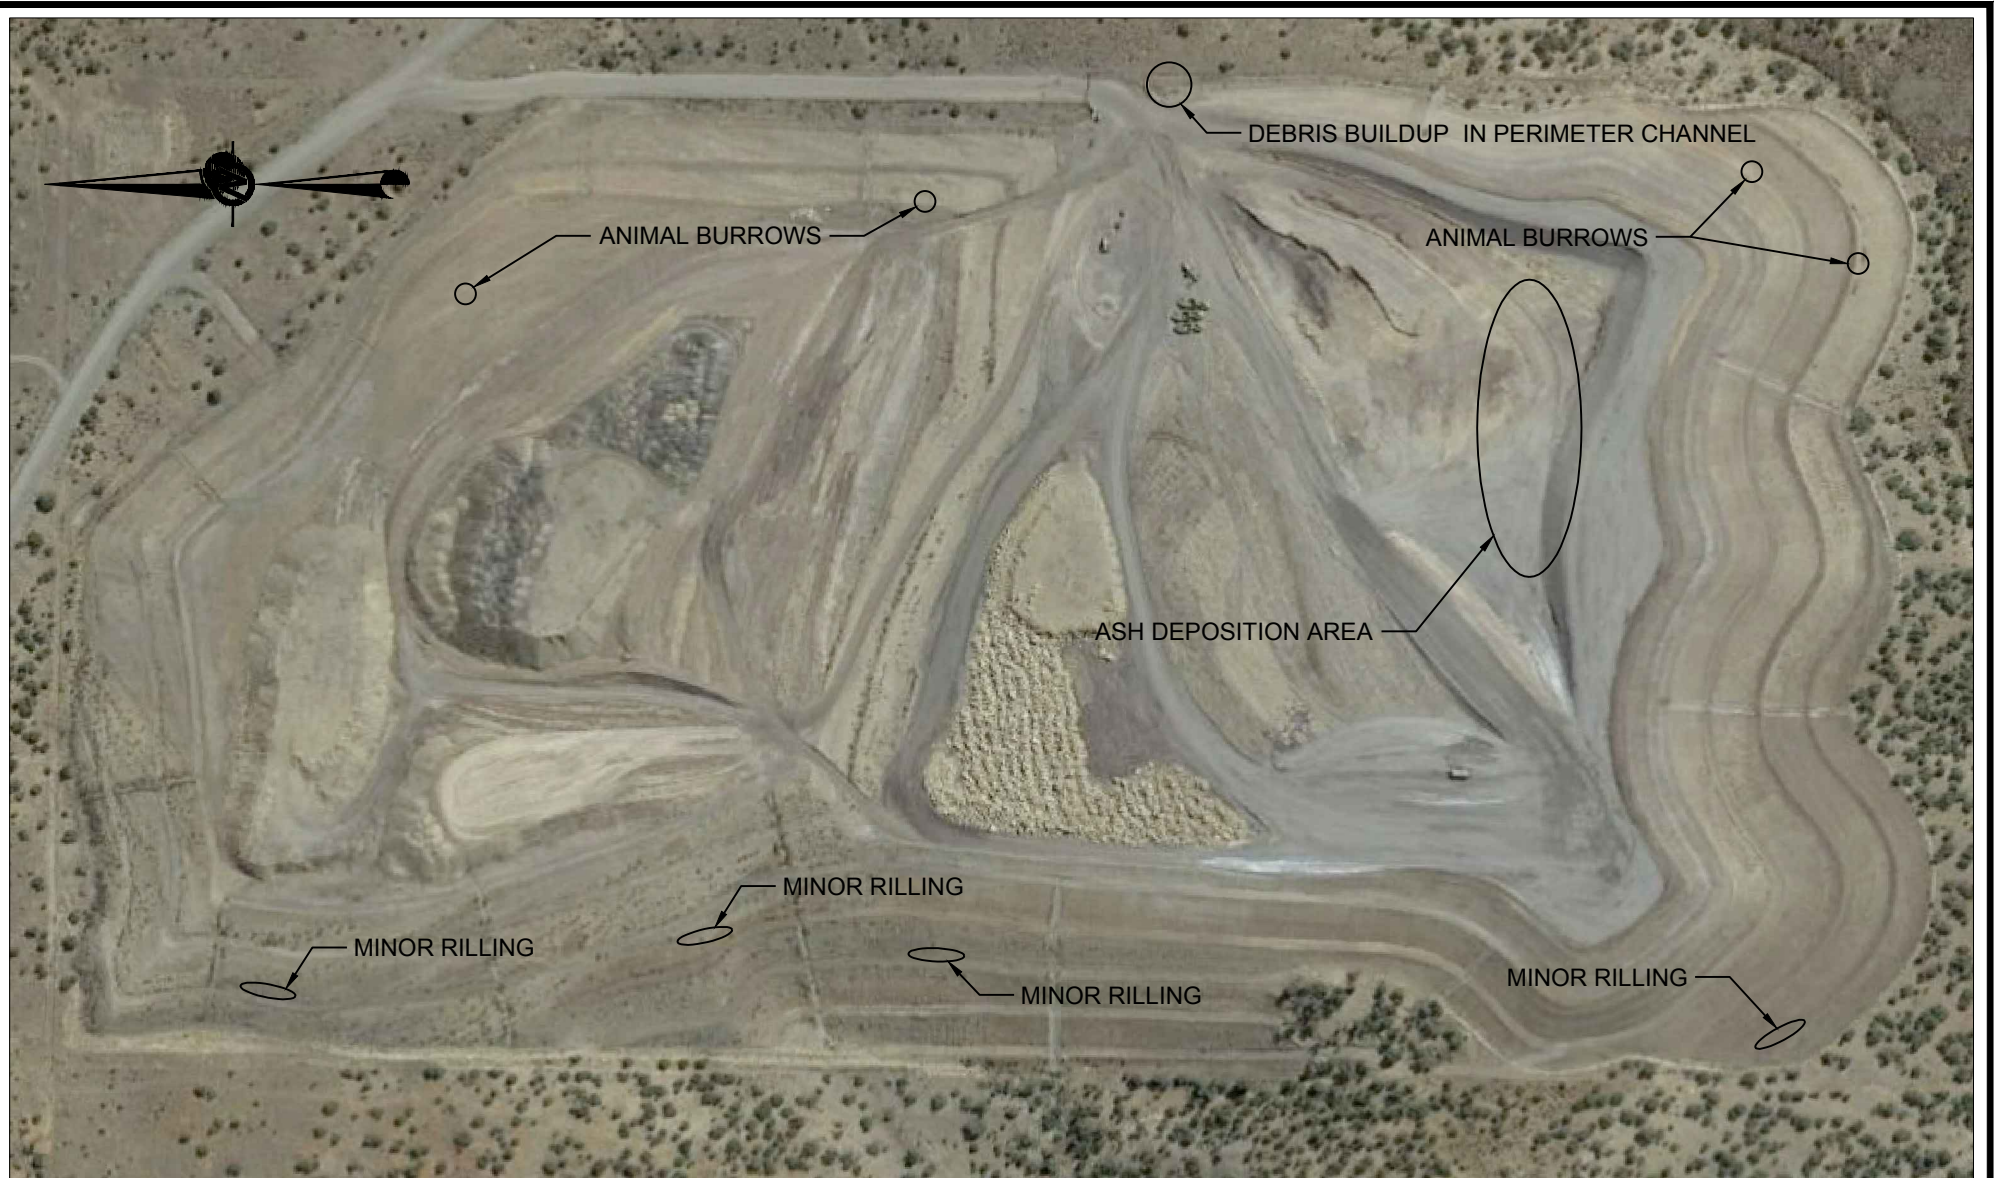
ANNUAL INSPECTION FORM
TRI-STATE GENERATION AND TRANSMISSION ASSOCIATION
NUCLA STATION ASH DISPOSAL SITE

a.						
b.						
c.						
d.						
e.						
J. Elaboration						
Identify the specific item number (for instance, F.2.) and elaborate on each deficiency or issue identified during the annual inspection. Attach documentation (photographs or sketches) if practical.						
D.1. The power plant was in a generation outage and was not producing ash at the time of observation. The most recent ash deposition area is shown on page 3.						
F.3. Minor rilling was observed on the west exterior slopes. Rilling was not excessive, and immediate action is not required. Rilling is being proactively addressed within a reasonable timeframe after it is observed during Tri-State's weekly inspections.						
F.4. Some woody shrubs were observed on the embankment slopes. This type of vegetation is typical of the surrounding area, and mitigation is not considered to be necessary.						
F.5. The extent of animal burrows appeared to be minor, and mitigation is not considered to be necessary. Tri-State conducted extermination in August 2016, so the burrows may be inactive.

H.1. Removal of shrubs from flow paths should be conducted periodically.						
H.3. Removal of debris buildup should be conducted at the outlet of the corrugated metal culverts under the entrance road as soon as practical and periodically thereafter.
