Coal Combustion Residuals Landfill Annual Inspection

Nucla Station Ash Disposal Facility

Tri-State Generation and Transmission Association, Inc.

December 20, 2019

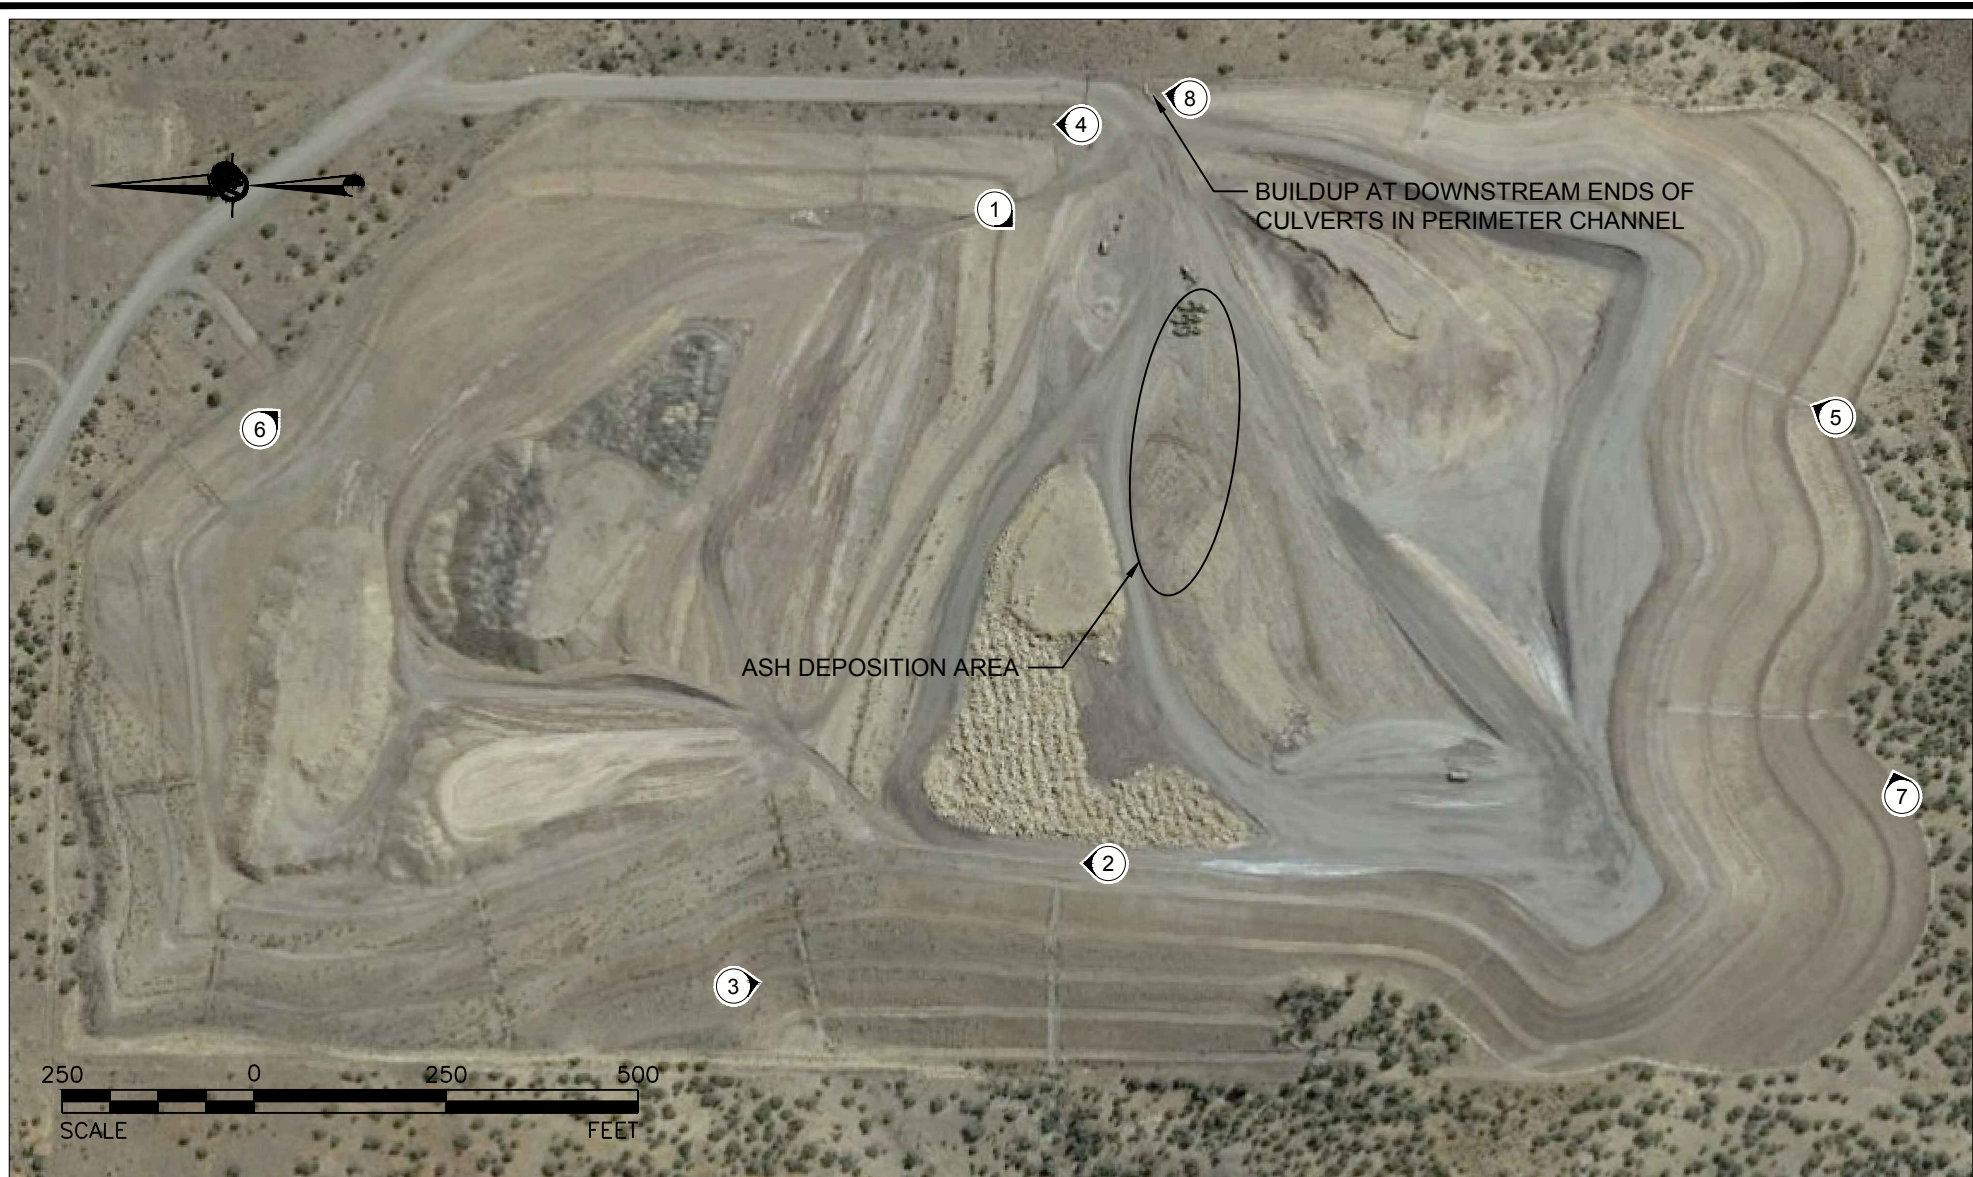
d.						
e.						
J. Elaboration						
<i>Identify the specific item number (for instance, F.2.) and elaborate on each deficiency or issue identified during the annual inspection. Attach documentation (photographs or sketches) if practical.</i>						
H.3. Sediment and debris were observed to be partially clogging the outlets of the culverts that pass beneath the site entrance road (see the location marked on page 3).

a. H.3. Clear out the sediment and debris buildup at the downstream ends of the culverts that pass beneath the site entrance road.						
b.						
c.
