**Active Coal Combustion Residuals Disposal Facility
2023 Annual Inspection**
Escalante Station

Tri-State Generation and Transmission Association, Inc.

21453429.000-001-RPT-0

January 13, 2024

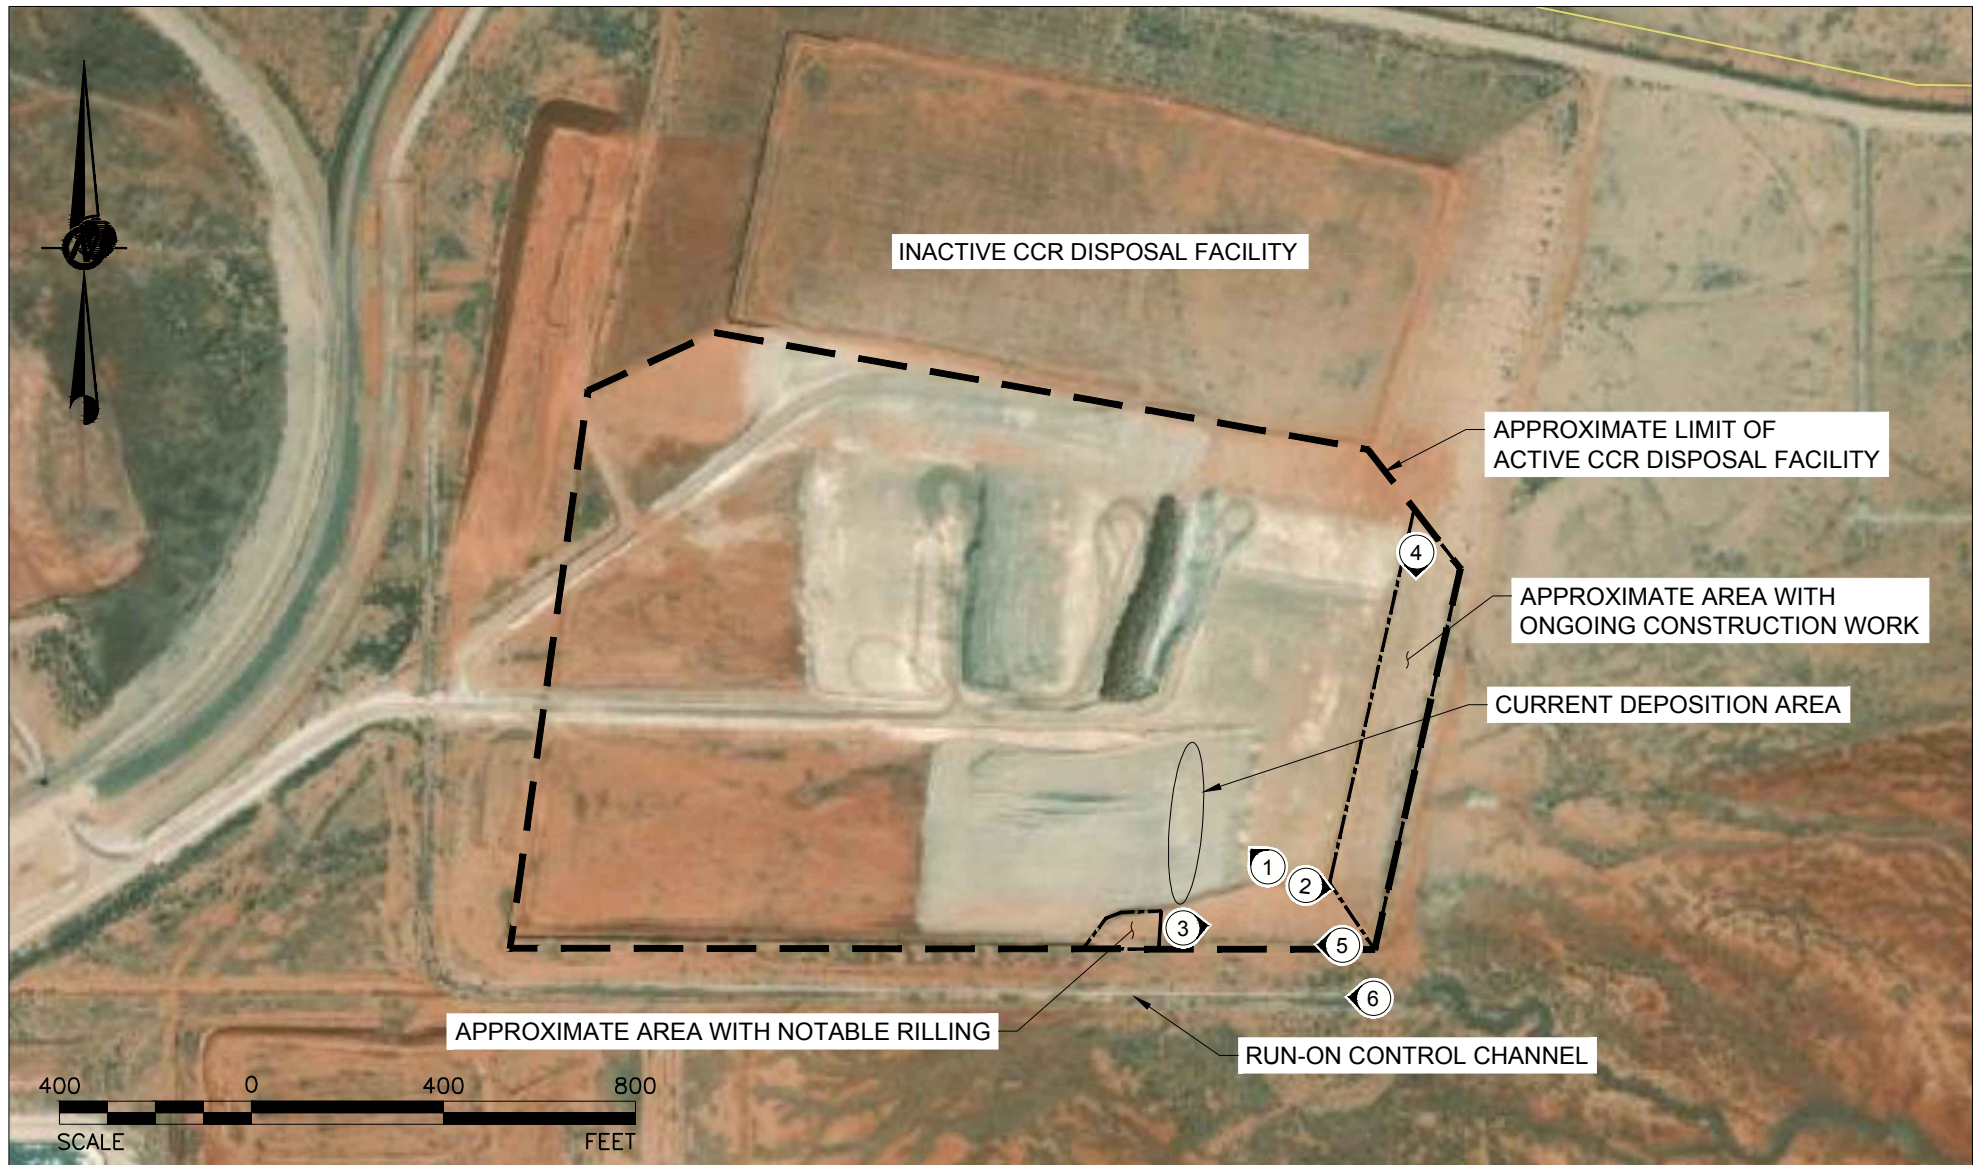
a.						
b.						
c.						
d.						
e.						
J. Elaboration						
Identify the specific item number (for instance, F.2.) and elaborate on each deficiency or issue identified during the annual inspection. Attach documentation (photographs or sketches) if practical.						
A.1.a. Work was underway on the east embankment slope to prepare for construction of a mid-slope bench (see page 3 for the approximate extents of construction work on the east embankment slope at the time of the visual observation), and the referenced area was disturbed and unvegetated. The east embankment slope will need to be revegetated or armored after the construction work is complete.						
F.3. Rilling was observed on the south embankment slope, with severity increasing near the western end (see page 3 for the approximate extents of notable rilling). The severity of the rilling was observed to be about the same as during the two previous annual inspections. The rilling does not currently pose a threat to structural stability and is not disrupting the operation or safety of the facility, so immediate repair is not required. The rilling should be monitored and addressed if it becomes excessive.
