Coal Combustion Residuals Landfill Inspection
Nucla Station Ash Disposal Facility

Tri-State Generation and Transmission Association, Inc.

21453425.003-002-RPT-0

December 15, 2023

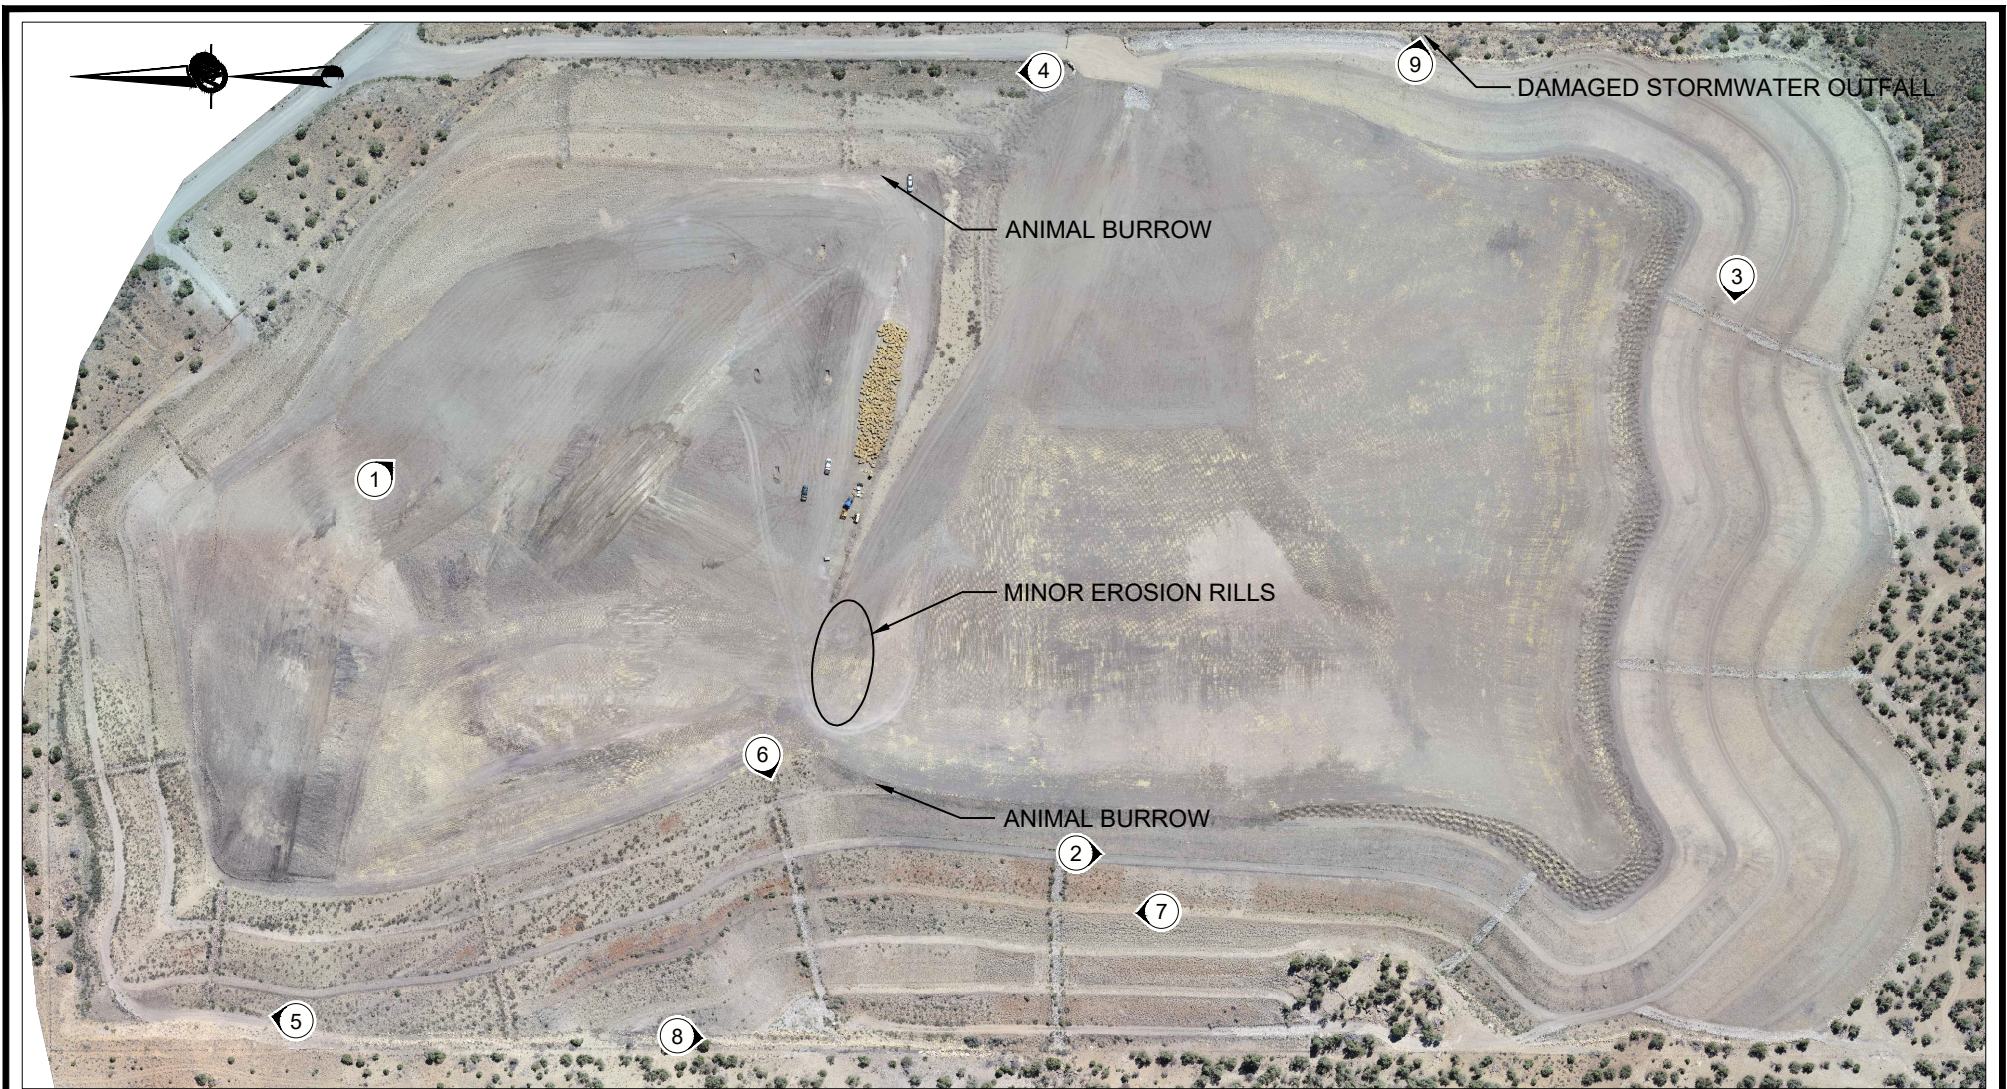
e.						
J. Elaboration						
Identify the specific item number (for instance, F.2.) and elaborate on each deficiency or issue identified during the inspection. Attach documentation (photographs or sketches) if practical.						
A.1.a/H.4. The stormwater outfall on the southern half of the east perimeter (see the map on page 3) was damaged by major storm events in late September and early October 2022, according to Tri-State personnel. Repair work is needed and is scheduled to be implemented in December 2023, weather permitting.						
D.4. Tri-State personnel indicated that Halogeton has been identified in some areas on the top surface.						
D.5. Small animal burrows were observed in two locations on the top surface (see the map on page 3). The burrows did not appear to be active.						
F.4. The south embankment slopes have not yet been reseeded after being roughened to create an undulating surface. Reseeding should be carried out during the appropriate season.

a. Erosion repairs at the stormwater outfall on the southern half of the east perimeter						
b. Reseeding of the south embankment slopes						
c.						
d.
