Coal Combustion Residuals Landfill 2024 Annual Inspection

Nucla Station Ash Disposal Facility

31403149.3795-001-RPT-0

December 13, 2024

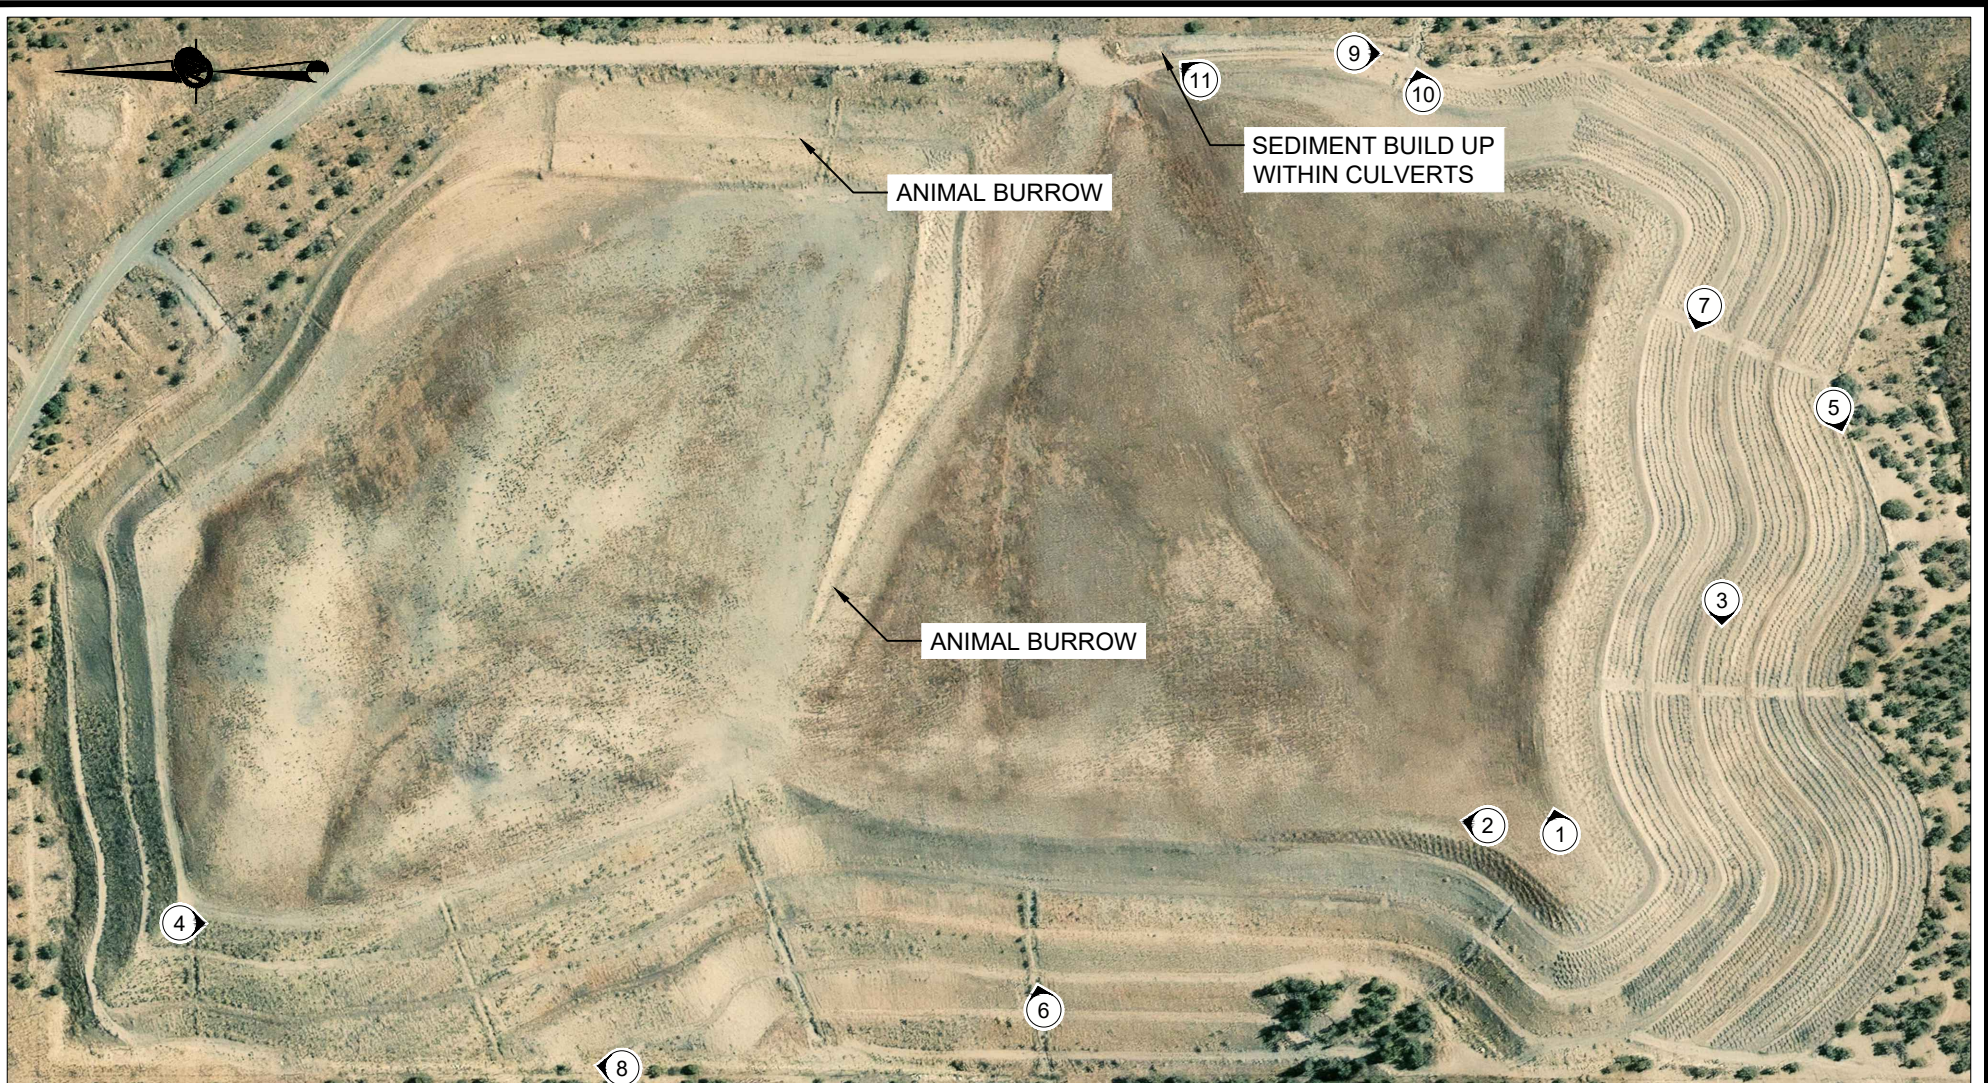
a.						
b.						
c.						
d.						
e.						
J. Elaboration						
Identify the specific item number (for instance, F.2.) and elaborate on each deficiency or issue identified during the inspection. Attach documentation (photographs or sketches) if practical.						
D.4. Halogeton was identified in some areas on the top surface.						
D.5. Small animal burrows were observed in one location on the top surface and one location within a terrace channel (see page 3). The burrows did not appear to be active.						
H.3. Sediment buildup was observed at the culvert outlets near the site entrance.
