# Coal Combustion Residuals Landfill 2025 Inspection

## *Nucla Station Ash Disposal Facility*

31403149.2403-002-RPT-0

December 15, 2025

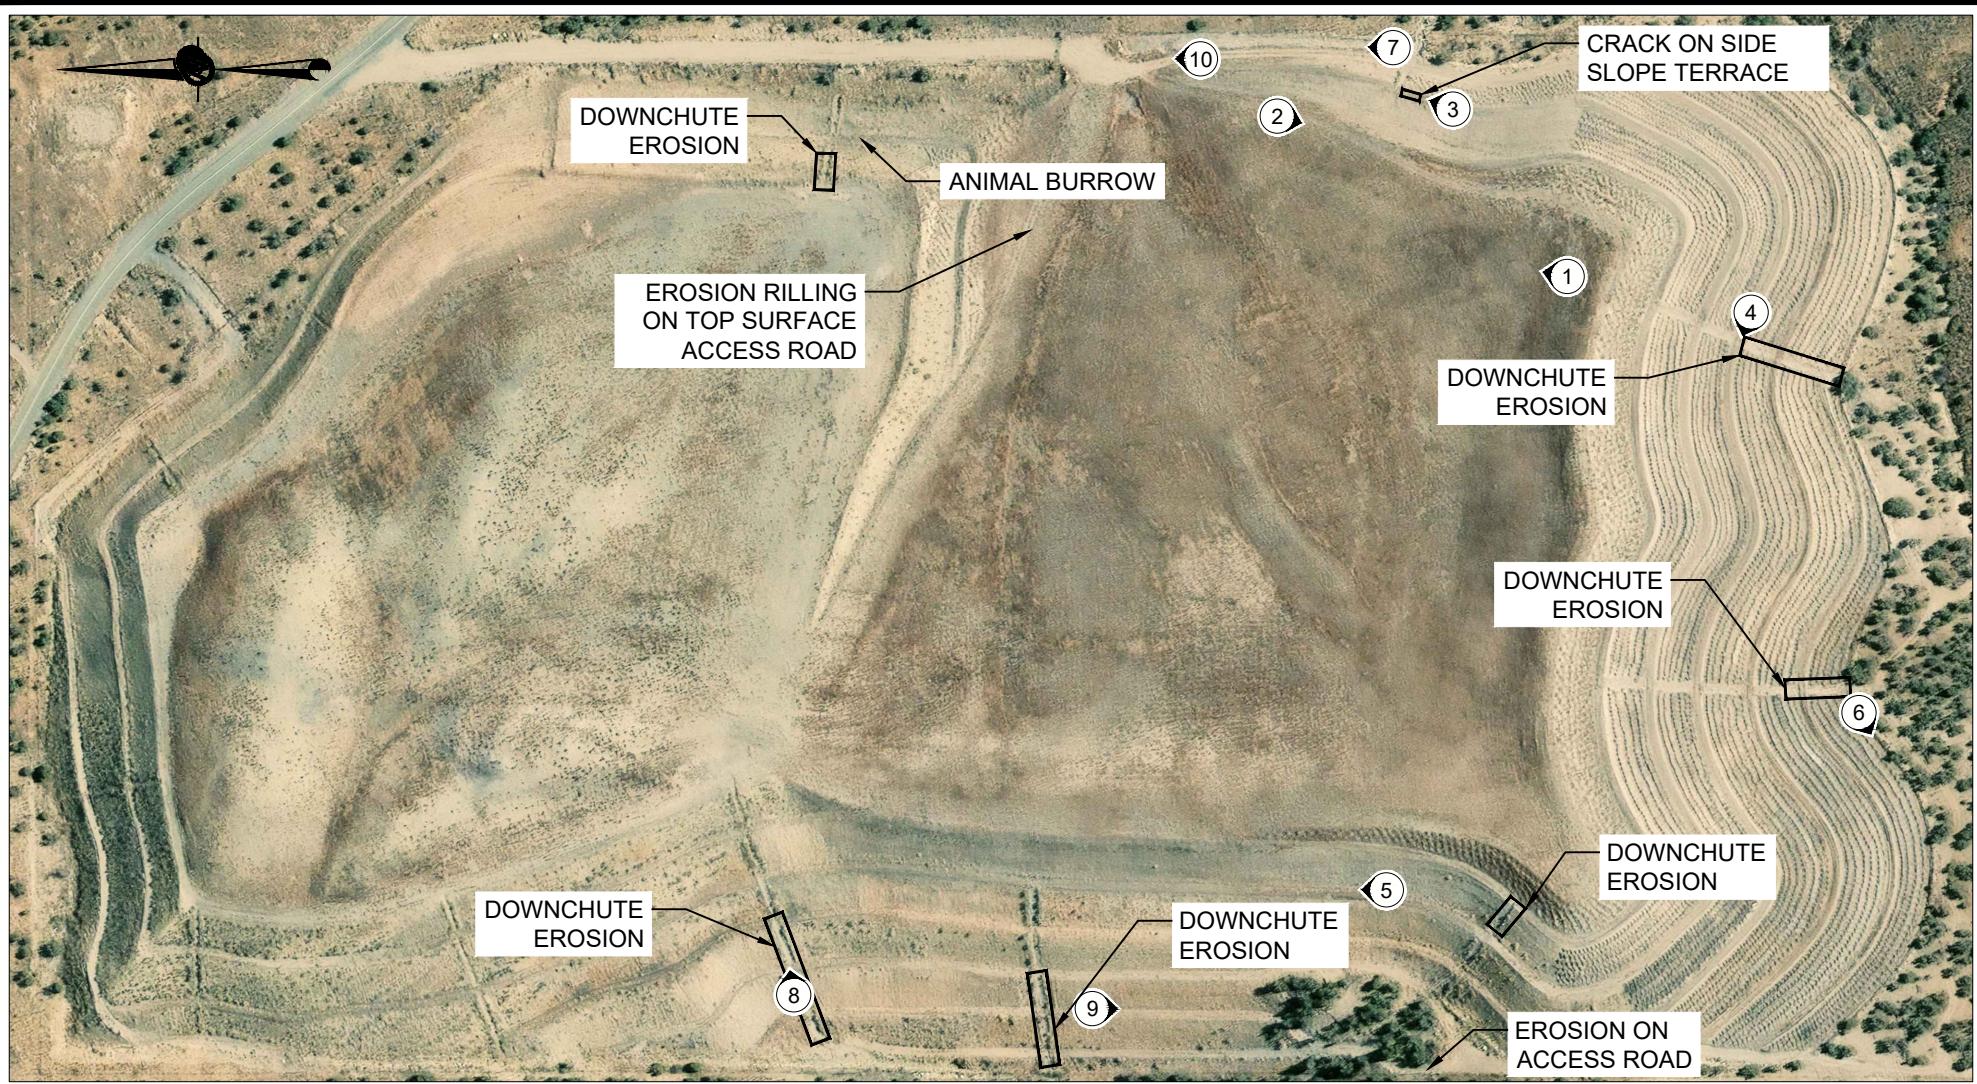
① PHOTOGRAPH LOCATION AND DIRECTION

c.						
d.						
e.						
<b>J. Elaboration</b>						
<i>Identify the specific item number (for instance, F.2.) and elaborate on each deficiency or issue identified during the inspection. Attach documentation (photographs or sketches) if practical.</i>						
C.1. Erosion was identified along the access road near the southwest corner of the landfill and along the top surface access road (see page 3). Erosion repairs may be made as necessary to facilitate site access.						
D.4. Vegetation growth on the top surface was poor. Halogeton was identified in some areas on the top surface.						
F.2. Cracking was observed along a terrace channel (see page 3). See Section I for further discussion.						
F.4. Poor vegetative growth was observed on the south embankment slope.						
F.5. Small animal burrows were observed in one location within a terrace channel (see page 3).						
H.1. Erosion was observed within multiple downchutes, primarily on the south and west sides of the facility. See Section I for further discussion.

b. H.1. Significant erosion and exposed subgrade and/or geotextile was noted in multiple downchutes. These downchutes should be repaired. Tri-State may consider placing larger, angular riprap in some of these locations to more effectively limit future erosion from large precipitation events.
